REPORT

Phase One Environmental Site Assessment

8243 Wellington Country Road 19, Fergus, Ontario

February 18, 2022

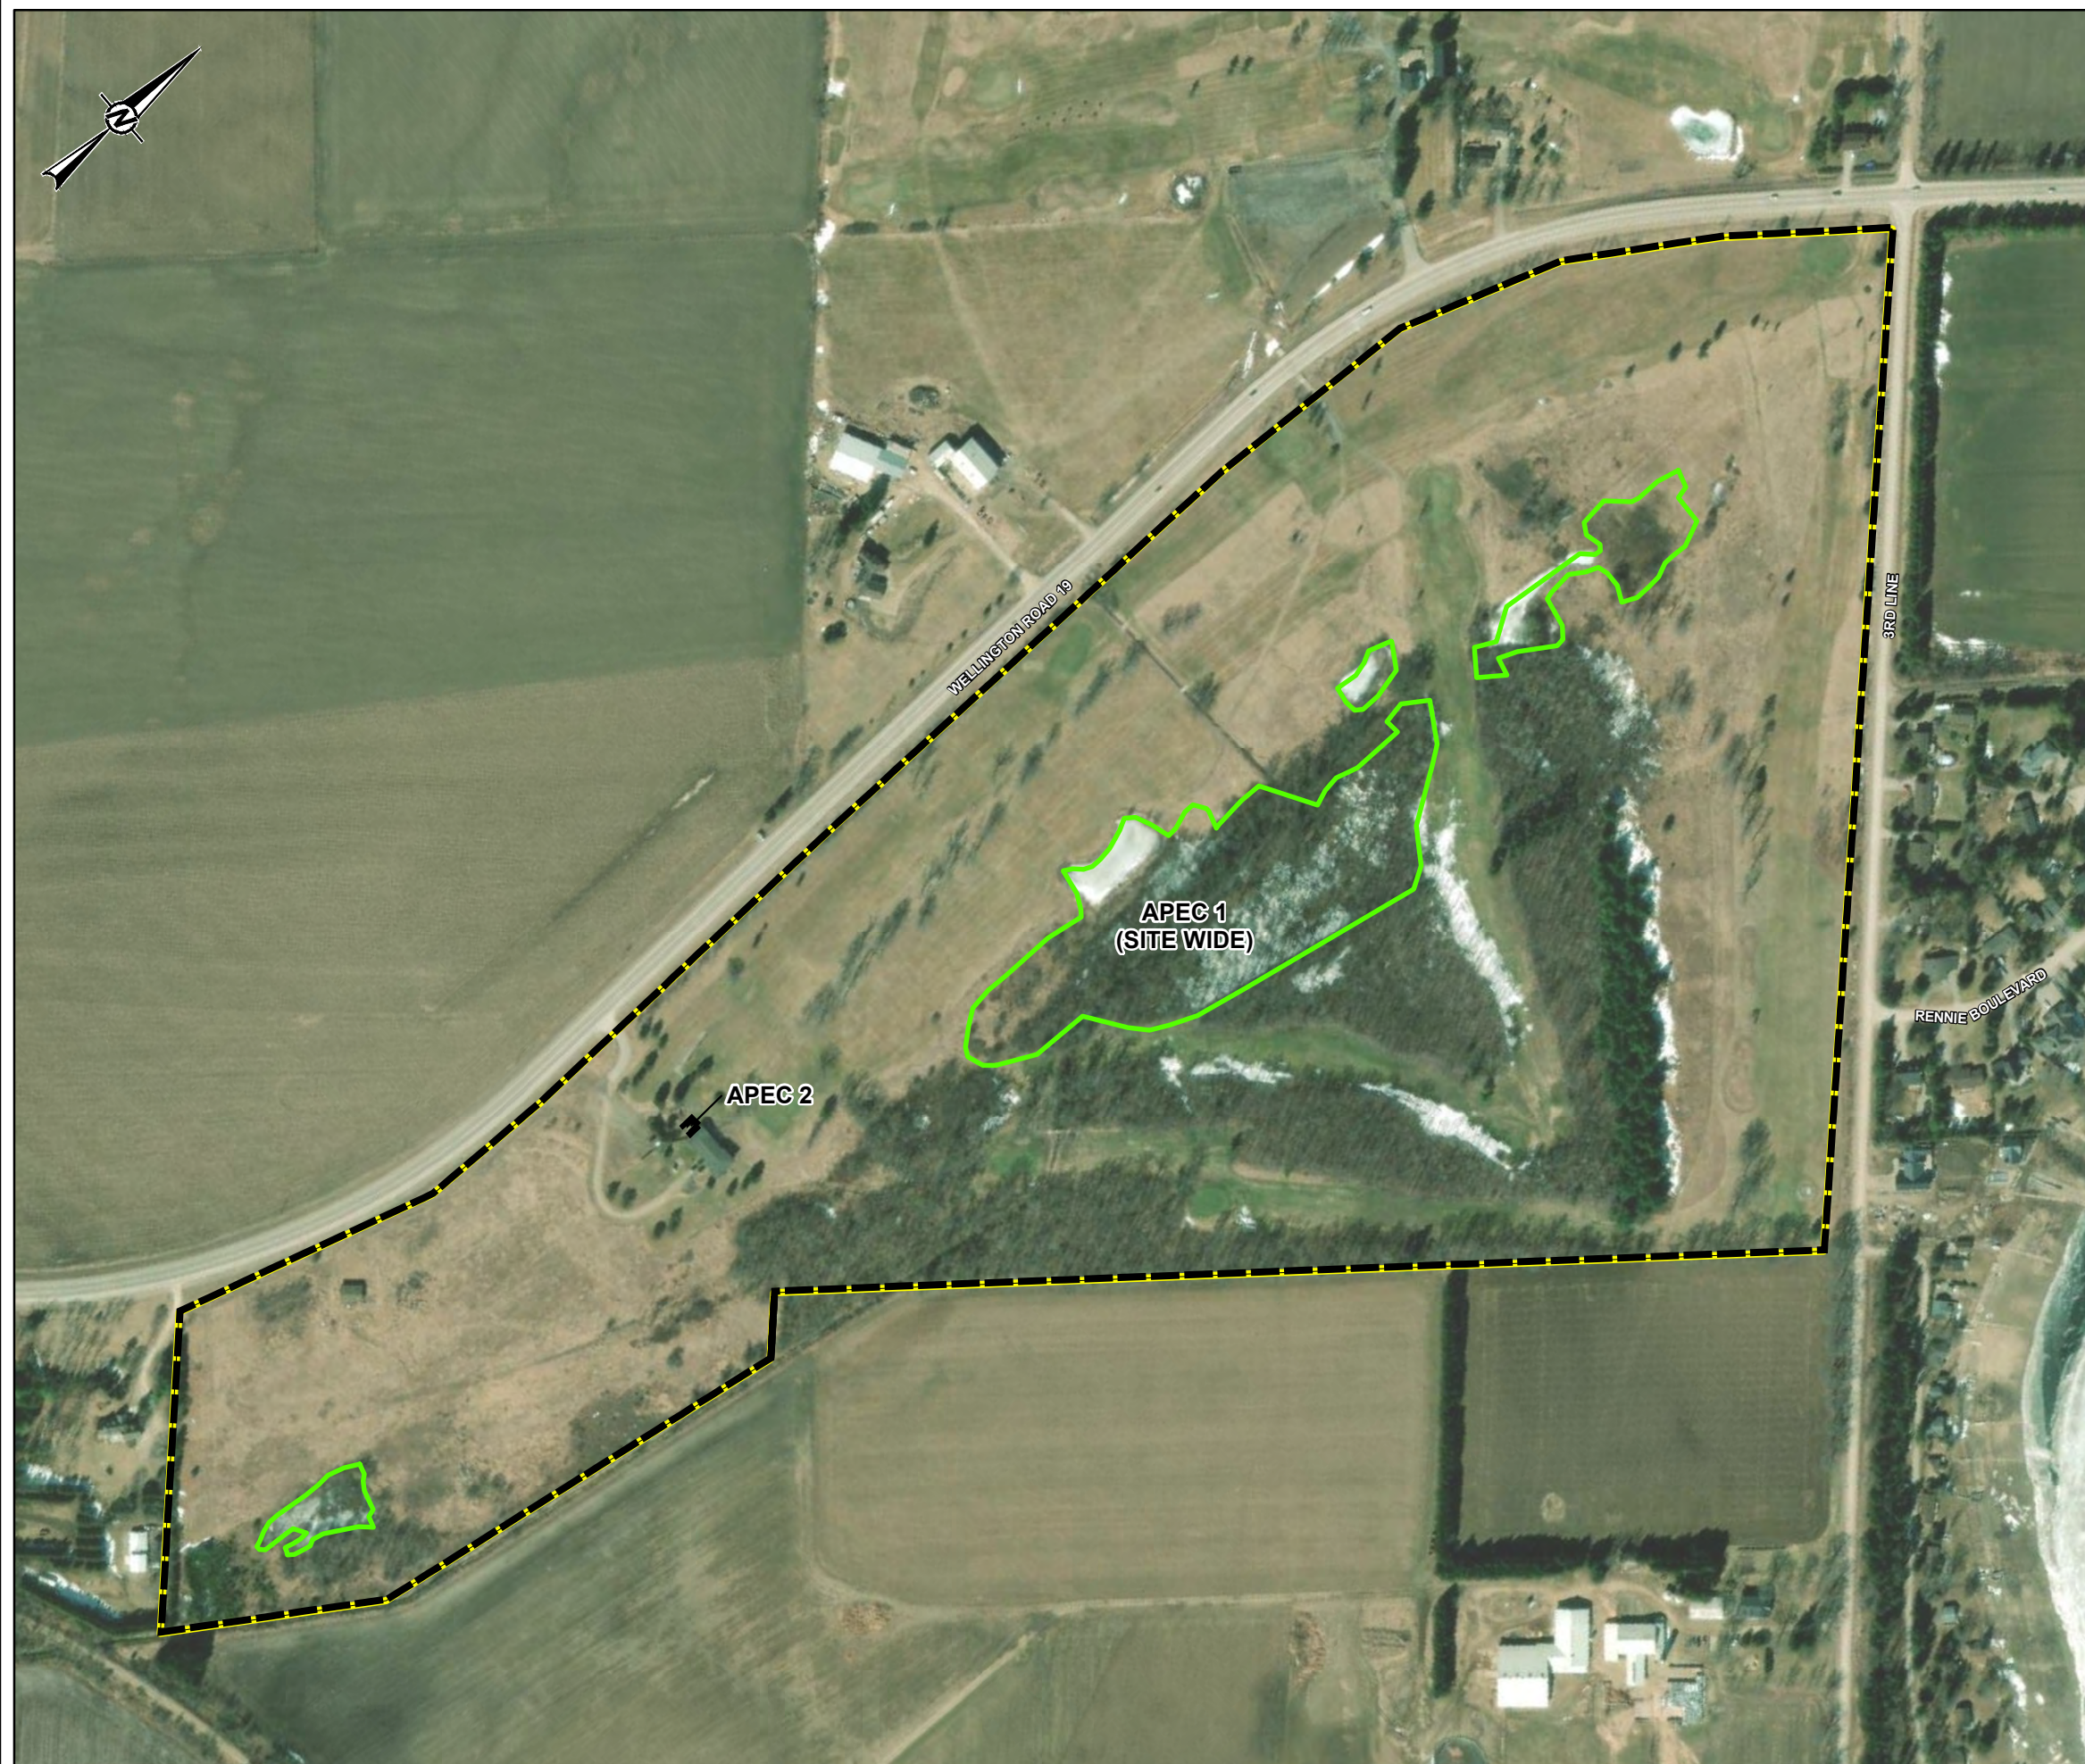
APEC	AREA OF POTENTIAL ENVIRONMENTAL CONCERN
1	APEC 1- FUNGICIDES AND HERBICIDES ARE ROUTINELY APPLIED TO MAINTAIN THE GREENS AND FAIRWAYS.
2	APEC 2 - AN OUT-OF-SERVICE HEATING FUEL TANK (REPORTEDLY EMPTY) WAS OBSERVED ON THE WEST FACING WALL OF THE RESIDENCE.

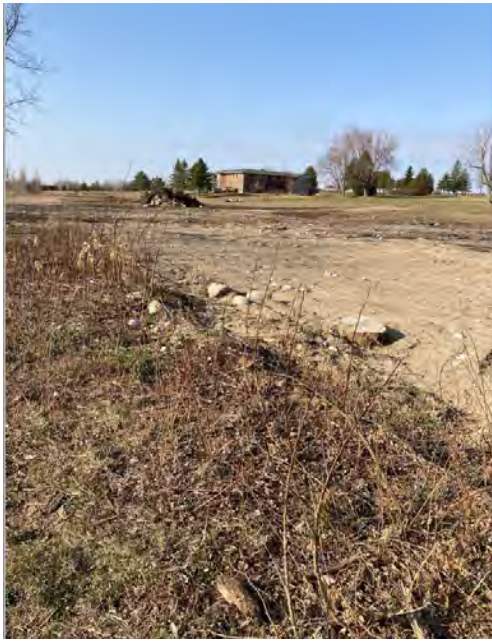
Photo 1 – View from Wellington Road 19 looking east. The residence can be seen in the background.

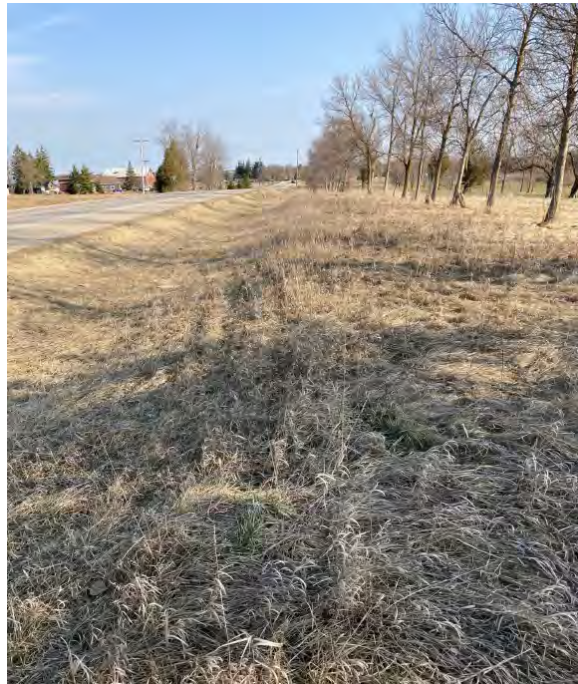
Photo 2 – Looking north on Wellington Road 19 from the driveway of the residence.

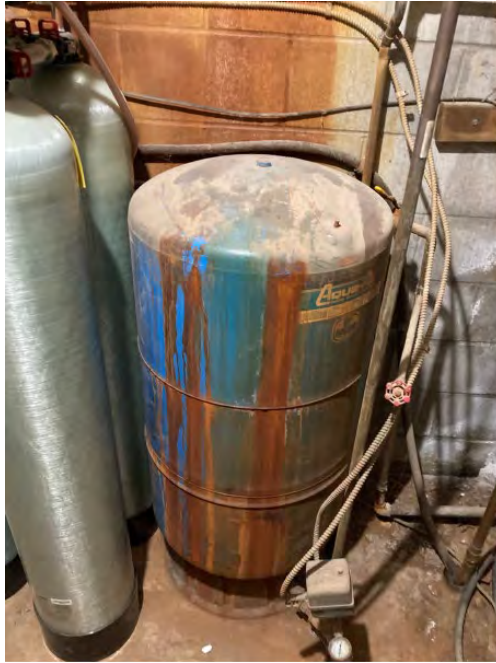
Photo 3 – View in the furnace room in the residence.

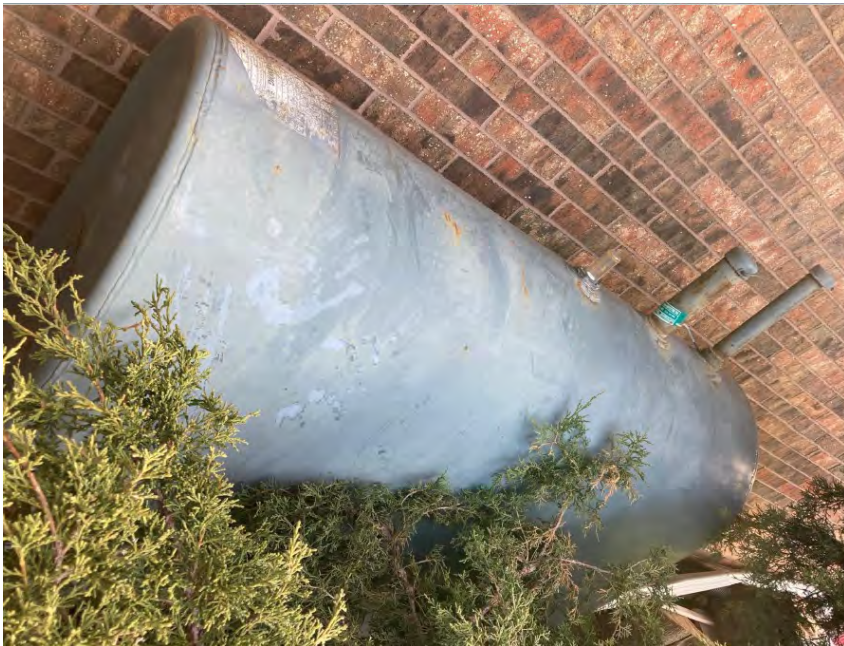
#28 Gasoline and Associated Product Store in Fixed Tanks – An out-of-service heating fuel AST (reportedly empty) was observed on the west facing wall of the residence.	Site observations and Site Representatives	The PCA is located on the Phase One Property and must be identified as an APEC.
Phase One Study Area (excluding the Phase One Property)	#28 Gasoline and Associated Product Store in Fixed Tanks: Aboveground fuel storage tanks are stored on the property adjacent to the west (8282 Wellington Road 19). Number of tanks, location, type of fuel stored and quantities are unknown.	Site Representatives	Based on the cross-gradient location of this PCA to the Site, and the nature of the impacts associated with this PCA which may migrate through groundwater, the presence of this PCA may impact the Phase One Property.

Photo 4 – View of the above ground storage tank adjacent to the residence.

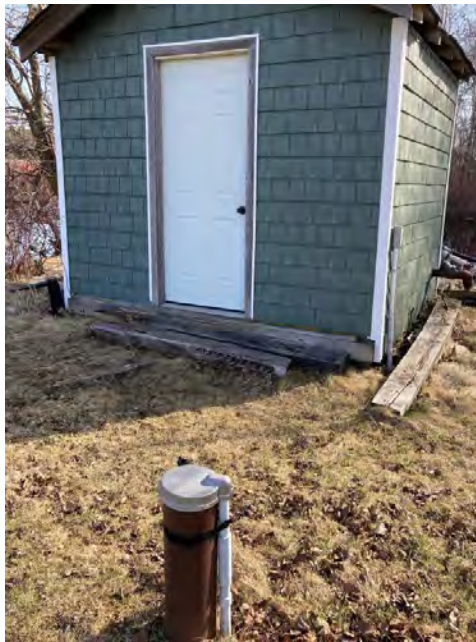
Photo 5 – View looking east towards maintenance shed with domestic water well.

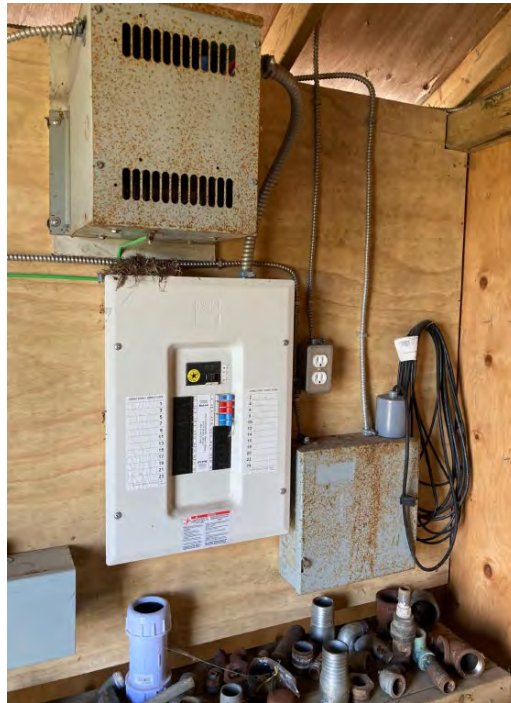
Photo 6 – View inside the maintenance shed.

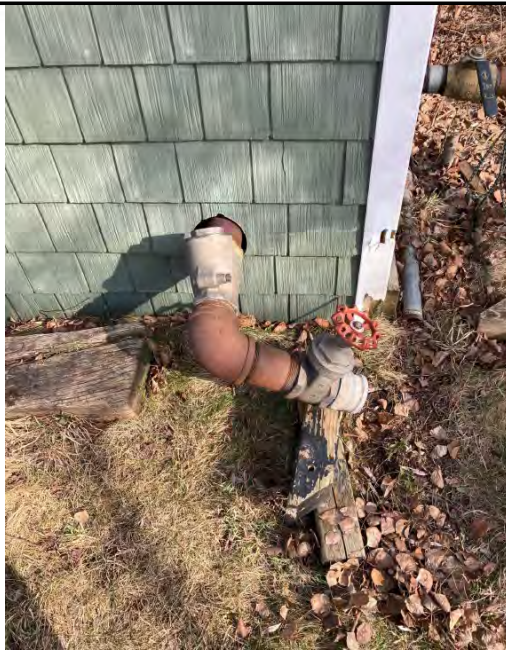
Photo 7 – Side of maintenance shed with pump for water intake for turf irrigation.

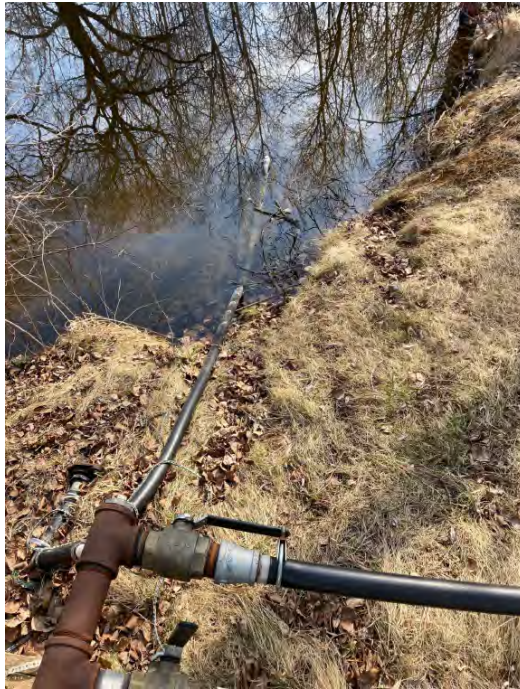
Photo 8 – Looking east behind the maintenance shed towards the unnamed pond showing water intake for turf irrigation.

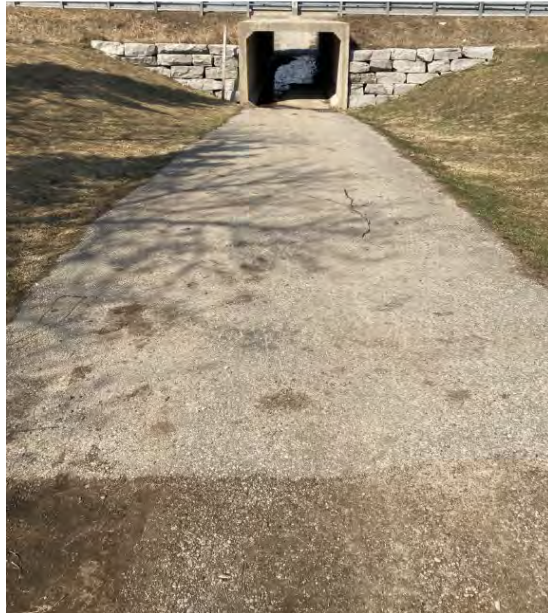
Photo 9 – Looking west towards the tunnel under Wellington Road 19 on the northwest end of the Site.

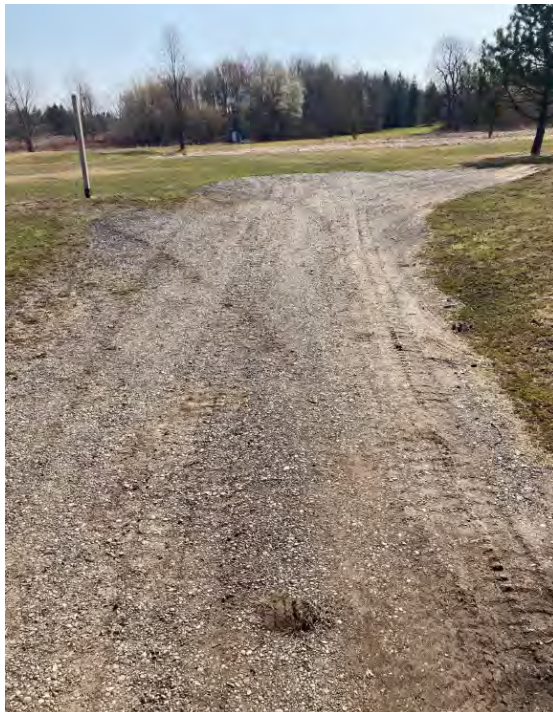
Photo 10 – Looking east from Wellington Road 19 from the tunnel leading to the adjacent golf course to the west. The maintenance shed can be viewed in the background.

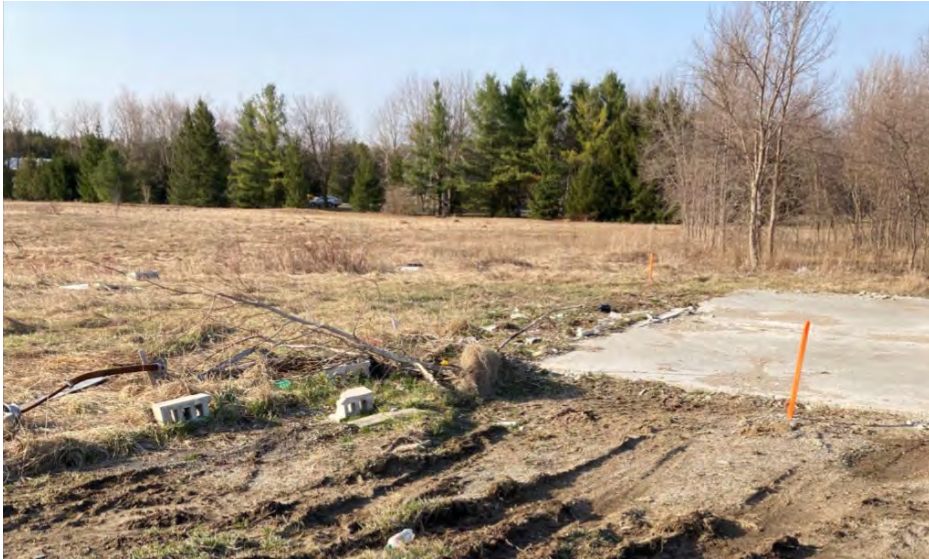
Photo 11 – Looking east from Wellington Road 19 to the remnant floor slab where a previous structure was identified in the 1980 aerial photo and the Google image from 2016.

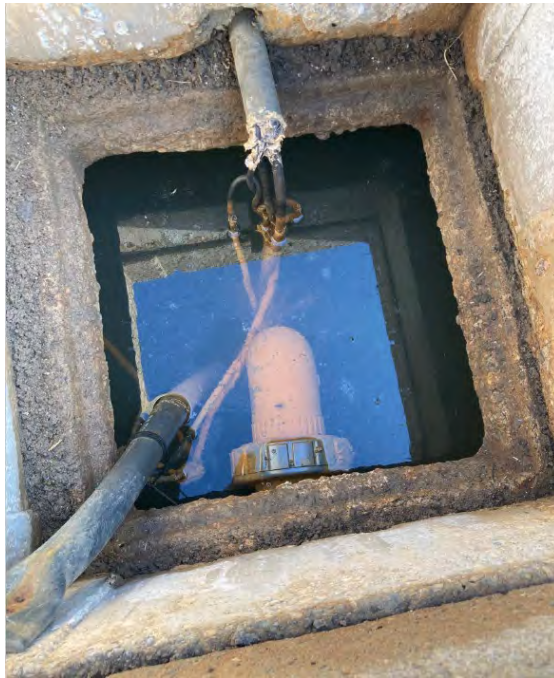
- The Phase One Property includes only private services and it is assumed the residence on the property has a septic tank. Groundwater from the building foundation is collected in a sump located 2 to 3 metres from the residence along the driveway. Based on the PCAs identified, underground utilities are unlikely to provide a migration pathway for contaminants of concern in groundwater.

Photo 12 – Sump pump located in the front yard near the driveway, approximately 2 to 3 metres from the residence.
