**Building Condition Assessment
965 Gartshore Street, Fergus**

Township of Centre Wellington

**November 17, 2022
300055234.0000**

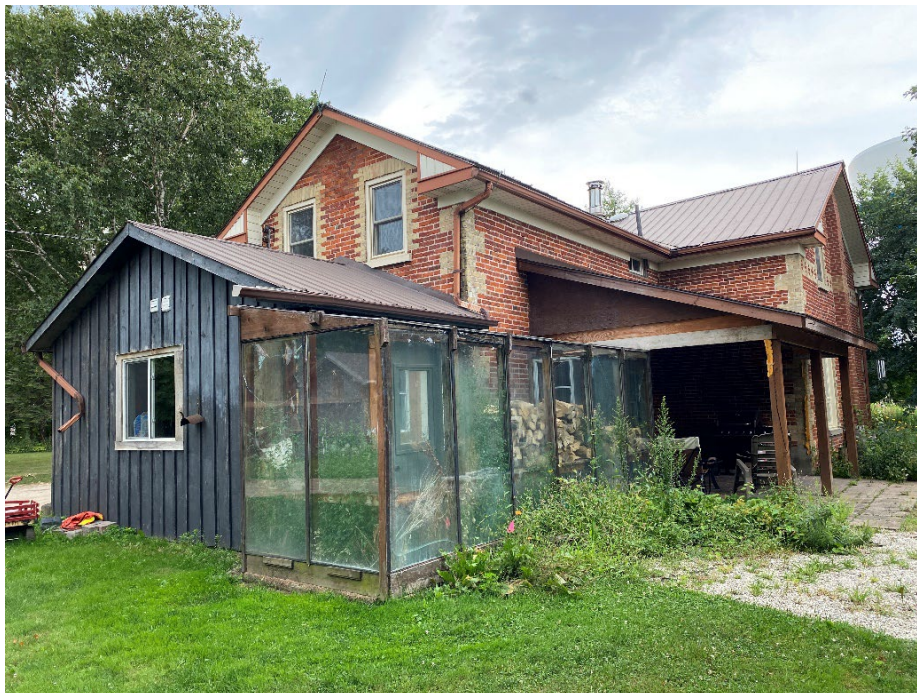
The mudroom addition which is “attached” to the house appears to be supported on a concrete slab-on-grade, which is not appropriate given the possibility of heaving. Likewise, the greenhouse and covered porch is also inappropriately supported on grade and attached to the house (Photo 2). The porch is supported on a ledger that is bolted to the clay masonry, which is not ideal and is generally not acceptable even if the house has multi-wythe load bearing clay masonry (Photo 14) due to risk of the anchors failing as masonry deteriorates. The porch’s wood support posts extend below grade, likely within concrete similar to how a fence is constructed, and are generally not plumb (Photo 2).

Photo 2: View of south west elevation, note the mudroom, greenhouse and canopy structures. Note canopy posts extend below grade.

- A structural review should be completed to determine if any of the structural wood members in the basement and attic have suffered moisture related damage, at a cost of about \$10,000 depending on access needed and any testing.
- The mudroom addition, the greenhouse structure and the covered porch should all be removed as they are not original to the structure (detract from building aesthetics), were constructed improperly, and are in poor condition. Further, when the foundation walls are excavated and waterproofed as discussed in 2.1.1, these structures would impede this work. The cost to demolish and dispose these structures would be in the order of \$10,000 if completed in conjunction with the foundation wall work.

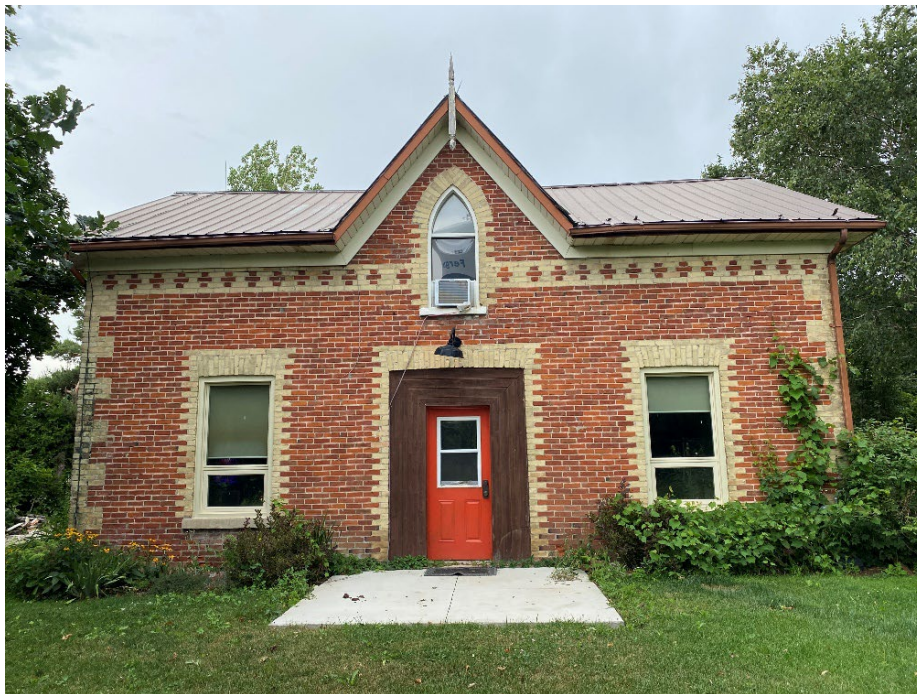
The sloped roofs are protected with a low quality, prefinished, corrugated metal roofing system with overlapped joints. The metal panels are aged, and some panels have been replaced (Photos 4 and 8).

Photo 4: View of south east elevation.

- The sheet metal roofing system is aged and will likely require replacement within the next 10 years. The driver for its replacement will be determined on this building's future use. If the farmhouse is to remain in full use with all of the interior space being heated and cooled year-round, and the Township wishes to restore the exterior aesthetics in general conformance to any heritage "requirements" (building does not appear to have any designation / listing), all of the roof components discussed above should be replaced at the same time, including a retrofit of roof insulation and ventilation. The sheet metal cladding elements would be replaced with painted wood cladding (possibly adding ornate wood accents), and troughs replaced with period materials and fabrication techniques. The roofing may have to become tin/zinc/lead, cedar, copper or even slate depending on the Township's wishes. To complete all this work, save the insulation and ventilation retrofit, using conventional sheet metal systems, like for like, the cost would be in the order of \$40,000.

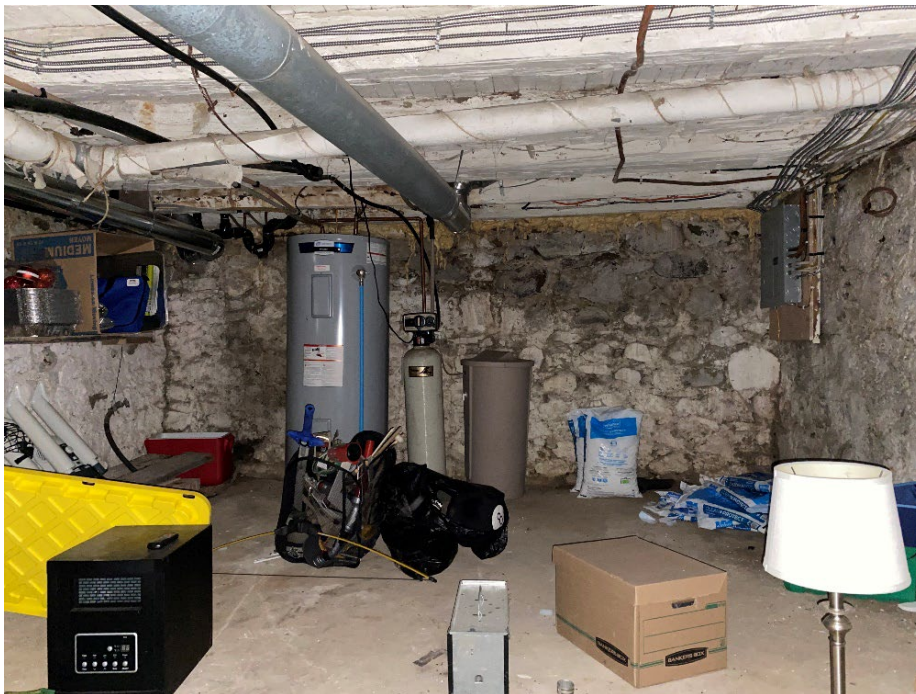
The foundation walls are of rubble wall construction (Photo 6), with one section of the basement stabilized with poured concrete which appears to be in good condition (Photo 5 -Located on RDHA drawing in Appendix D). The basement height varies, with most areas appearing to be 6 feet high or less. There are timber columns (logs) within the interior of the basement which pass through the concrete slab-on-grade. The concrete floor slab is likely not original to construction and was cast-in-place around the timber columns. The clay brick masonry extends below grade (likely 2 to 4 courses though no test pits were completed to verify) with active leakage at the transition from foundation to masonry at the first-floor level framing, with some of these transitions being foamed to mitigate the leaks. The rubble wall foundations were generally covered with efflorescence, and active leaks were noted throughout both basement areas. The timber columns that pass through the slab-on-grade have moisture wicking stains and possible wood rot extending up from the concrete slab surface (Photo 5) though we were not able to determine the extent or severity of the deterioration without further testing.

Photo 6: View of rubble wall foundation, note the extensive efflorescence.

- To remediate the moisture issues in the basement, a general excavation, waterproofing and weeping tile (complete with a sump pump) installation program will be required. This will also require general regrading of the exterior such that the foundation is exposed at least 6". The exterior face of the rubble wall foundation will require a general parging surface application to provide a suitable substrate for the waterproofing and to cover the exposed portion of the foundation after regrading. It is likely that the lime binder in the original mortar has leached out over time, so lime grout injection to stabilize the rubble foundation walls may also be required. A further evaluation of the foundation wall by extracting cores should be considered at an expected cost of about \$8,000. The cost to complete the waterproofing work would be in the order of \$200,000. Further review would be required to ascertain the cost of any required structural repairs to the stone rubble foundation wall and to

better understand the extent of deterioration and its impact to the existing timber columns.

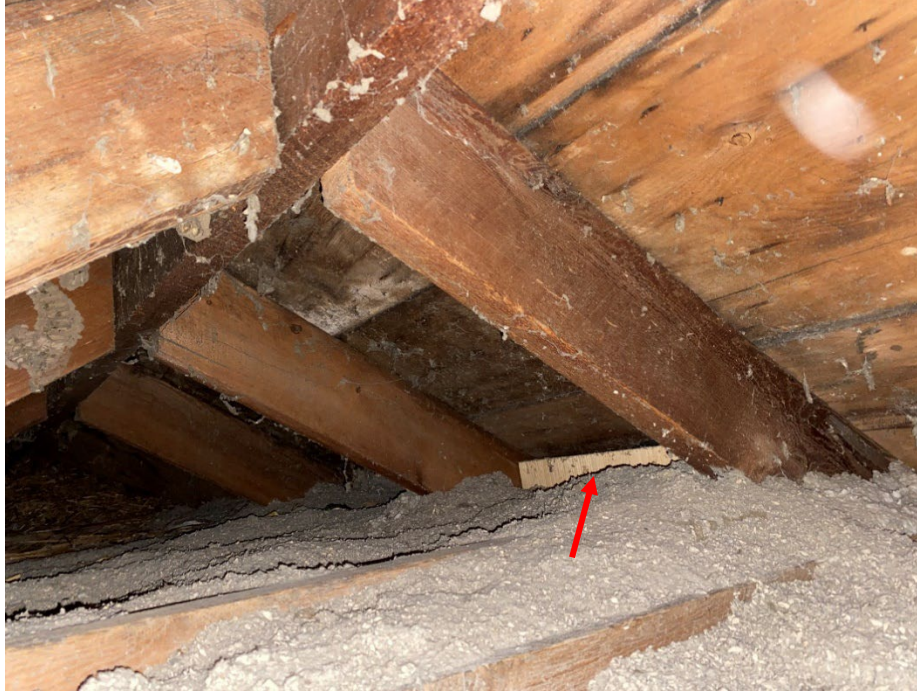
The second floor has cathedral ceilings with small roof attic spaces near the peak. From ground level only three small vents near the roof ridges were observed (2 appear to be dryer vents), with at least one belonging to a bathroom vent exhaust. Individual soffit vents (perforated metal panels) were provided at 6 to 8 foot spacings and at the one attic hatch accessed, insulation was reduced at rafters some with plywood bulkheads at several locations (Photo 7), but no Moore vents or plywood baffles were observed. The exposed roof framing and sheathing is moisture stained because of the inadequate ventilation. No obvious signs of past leaks were observed at interior finishes.

Photo 7: View of attic insulation, likely bulkhead for soffit ventilation.

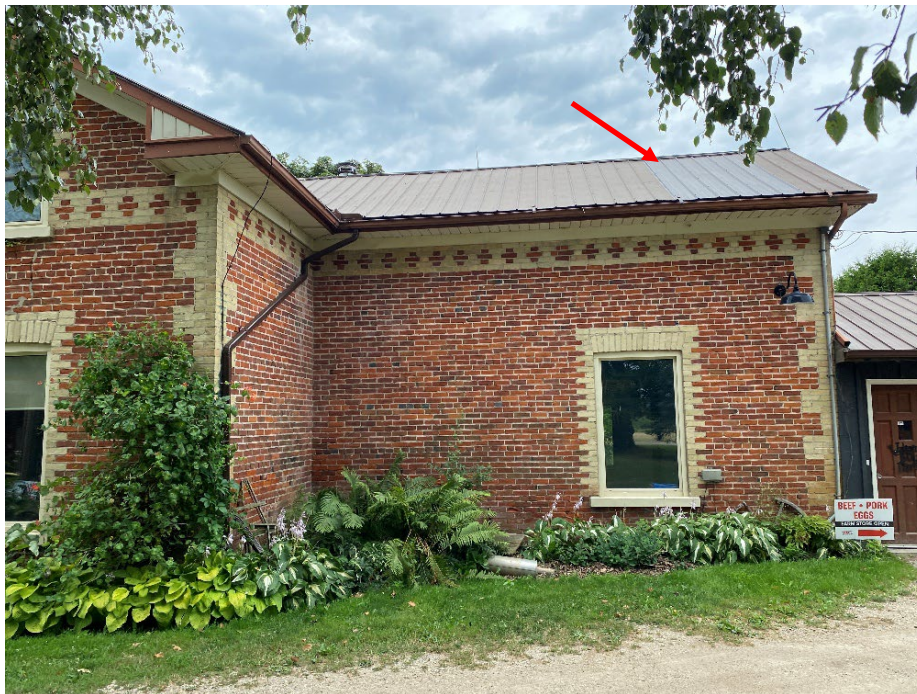
Photo 8: View of metal roofing and replaced panel section.

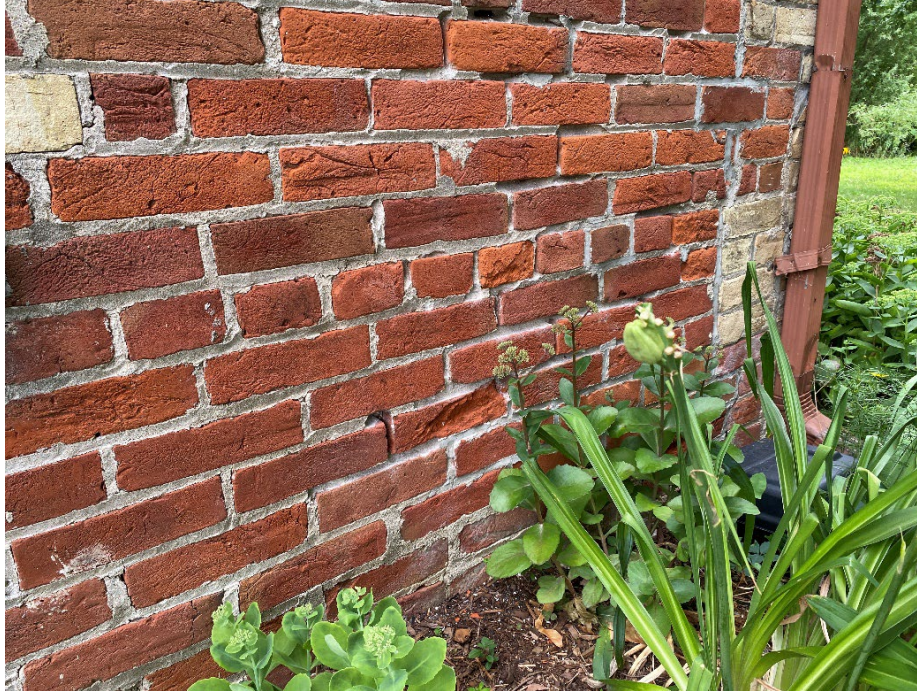
In general, the clay brick veneer is in fair to poor condition with extensive spalling and mortar joint deterioration on all elevations, which is more extensive at grade. Some step cracking and mortar repairs were observed. Some form of parging “repair” was completed overtop the clay masonry at the porch/greenhouse area (Photo 14).

Photo 9: View of masonry deterioration. Note masonry extends below grade.

- A significant masonry repair program will be required to properly restore the clay brick veneer. This will require extensive masonry unit replacement and mortar joint pointing repairs. Reclaimed brick will have to be sourced to match colour and dimensions of the existing brick. If it is not possible to source some or all of the brick required and consistent aesthetics is desired by the Township, tinting of the brick may be an option. A more detailed study should be undertaken to evaluate the true extent of repairs needed, which would likely cost in the order of \$10,000 depending on if openings and site access requirements. A preliminary budget of \$80,000 should be assumed for repairs until the study is completed, with work completed in conjunction with the foundation wall project recommended in 2.1.1, to take advantage of economies of scale, mobilization, and since the masonry extends below grade. If this work is completed separately, costs would be higher.

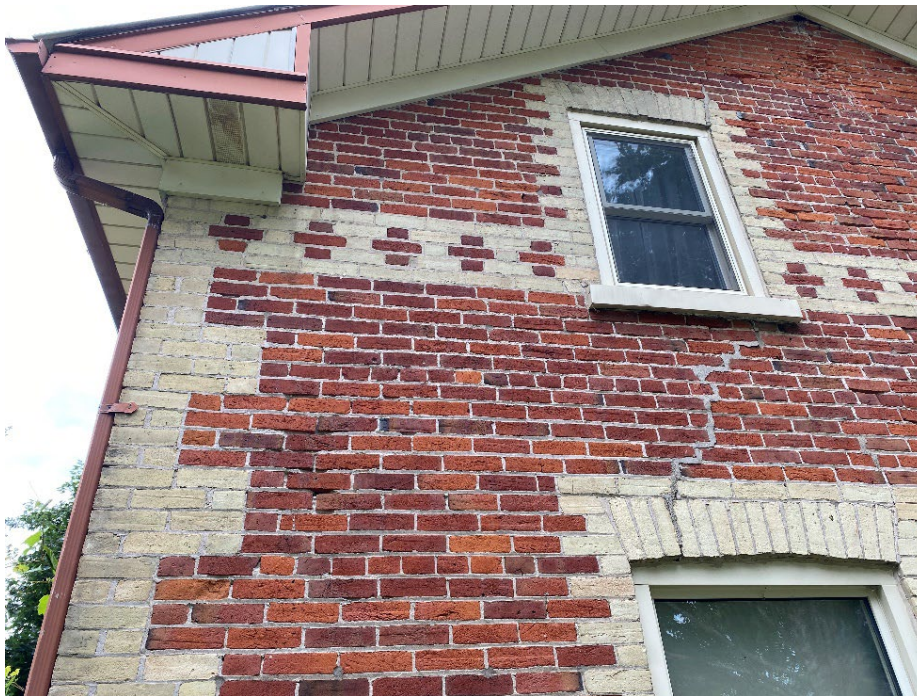
Photo 10: View of deteriorated brick.

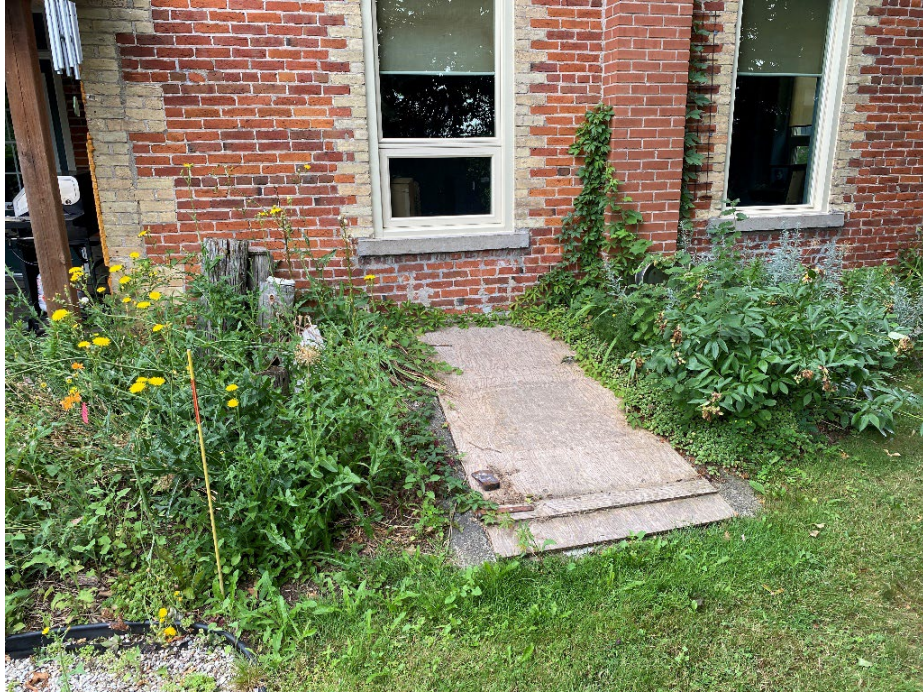
There is an exterior access hatch structure for the basement (Photo 11). Active water penetration was noted below the door, which could not be opened. The exterior hatch could also not be opened.

Photo 11: View of windows, basement hatch.

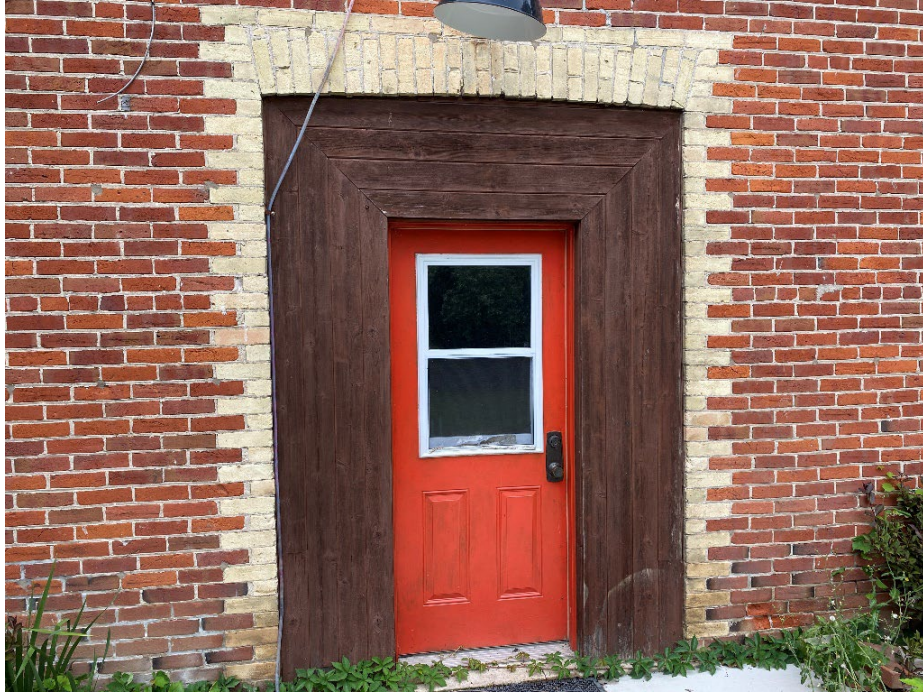
There are three doors, two are insulated steel with vision units containing IGUs, and one at the building entrance within the mudroom being solid wood. They are all in serviceable condition (Photos 13 and 14). The main entrance door assembly (the original main entrance) was reduced in size, whereby the original door was likely larger and had a curved vision unit above. The arched door opening bounded by the ornate brick pattern was infilled with wood to accommodate the insertion of the existing conventional insulated steel door (Photo 13).

Photo 13: View of front door with infilled wood cladding.

- The doors can remain in service for the next ten years and beyond, and once replacement is required, they are generally replaced as needed which is below the threshold of this report. Painted finishes should be renewed as necessary under operating budgets. It is likely the Township will want to investigate what type of door assembly originally existed at the main entrance, and possibly fabricate a replica door assembly which may cost upwards of \$20,000 (this cost not included in the summary table as it is optional).

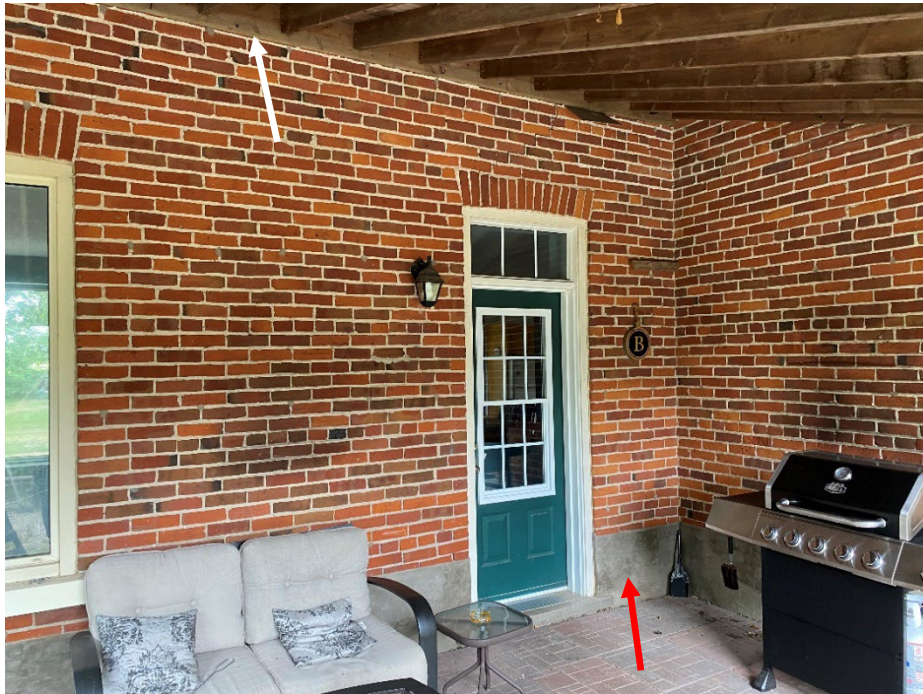
Photo 14: View of side door. Note canopy supported by the brick veneer (white arrow). Note cementitious parging over brick (red arrow).

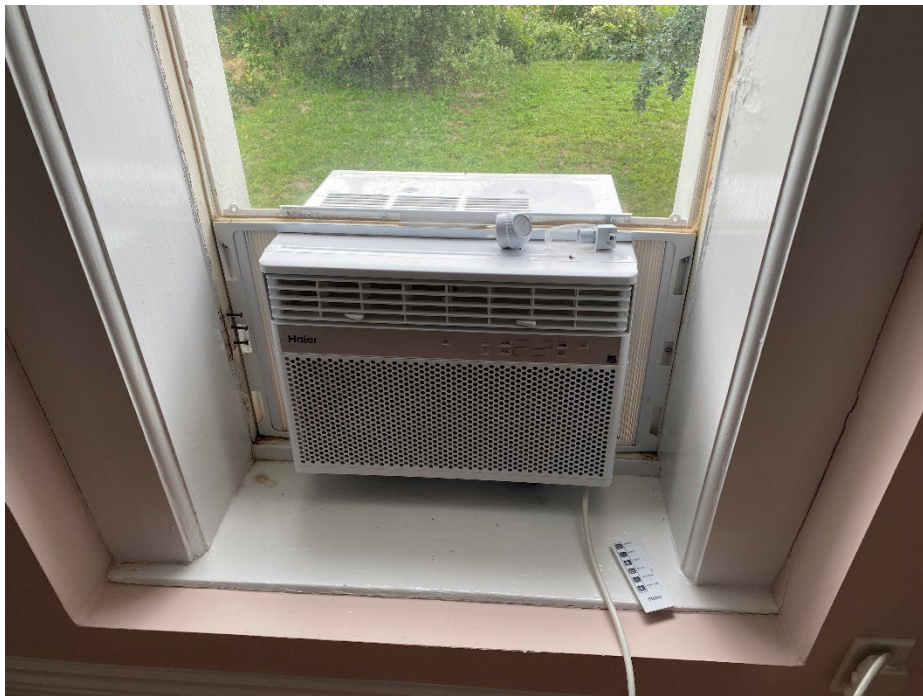
Photo 18:

There is a pass-through air conditioner installed to provide localized air-conditioning (Photo 18). The PTAC is manufactured by Haier and has a model # QHM08LXW1, a serial # FR030920H. A manufactured date cannot be confirmed.

- Major replacement is considered to occur around 2024, or once maintenance / service frequency increases, replacement parts are no longer readily available, or once any other major issues arise.

The PTAC may have R22 refrigerant and if so, any cooling issue will likely require replacement of the unit at that time

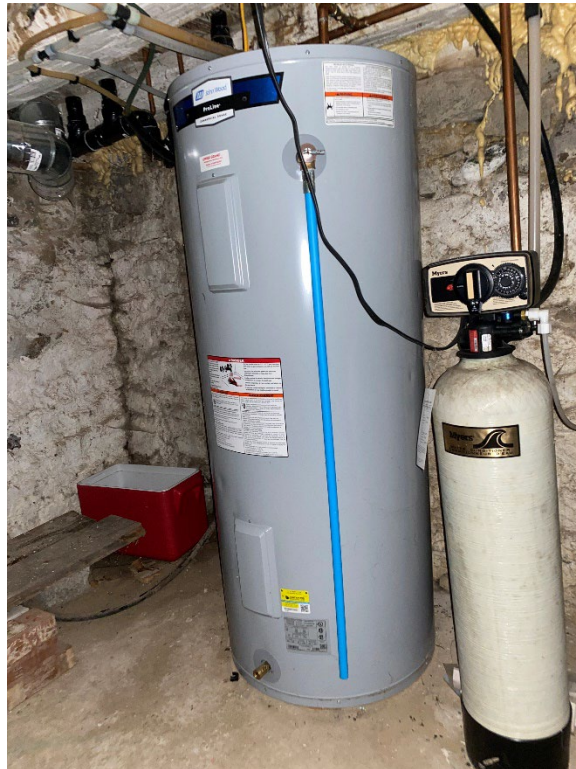
Photo 22:

The fixtures throughout the building are supplied with hot water from one electrical hot water tank (Photo 22) and was manufactured by A.O. Smith and has a model # E80TE-45240 250, serial #1724106540175 with a capacity of 287 L, a rating of 3,000 W and was manufactured in 2017. It appears to be in serviceable condition.

- The HWT appears to be in good condition, and major replacement is expected to occur around 2031, or once maintenance / service frequency increases, replacement parts are no longer readily available, or any other major issues arise. In our opinion the cost to replace each HWT is in the order of \$3,500.

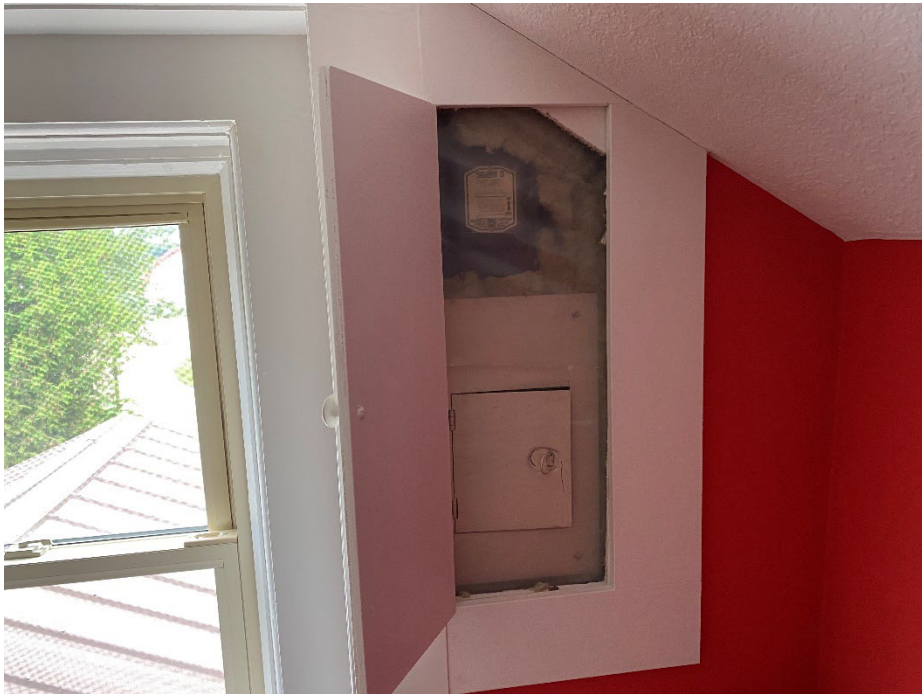
Photo 32:

Electrical service to this building enters through the exterior wall (Photo 30). Burnside was unable to locate the hydro meter. The power is supplied to the main 100A electrical panel in the basement (Photo 31) and a 60A sub-panel and disconnect switch on the second floor. (Photo 32).

The age of the electrical panels and disconnect switch is unknown, but they are operational. Wiring material (copper or aluminum) could not be determined based on a non-destructive visual review. Typical manufacturer quoted life expectancy of switches and circuit breakers are 30 years, but experience shows that well-maintained equipment can remain in service for much longer periods. The biggest threat to electrical equipment is heat (overloaded circuits). Equipment that has reached its useful life should be considered for future replacement but in the meantime, continue to be maintained. Due to their age, as a preventive maintenance measure, infrared imaging of the equipment every two or three years would provide thermographs which would reveal potential hot spots and other problems.

- The main electrical panel appears to have been replaced recently and major replacement would be considered beyond the scope of this report. The main sub-panel appears to be dated but is operational and should be considered for major replacement. In our opinion the cost to replace the 60A sub-panel is expected to fall below the ASTM 2008-15 reporting threshold of \$3,000 individually or \$10,000 in the aggregate.
