April 20, 2022

ARBORIST REPORT
223 St. Andrew's Street E, Fergus, Ontario

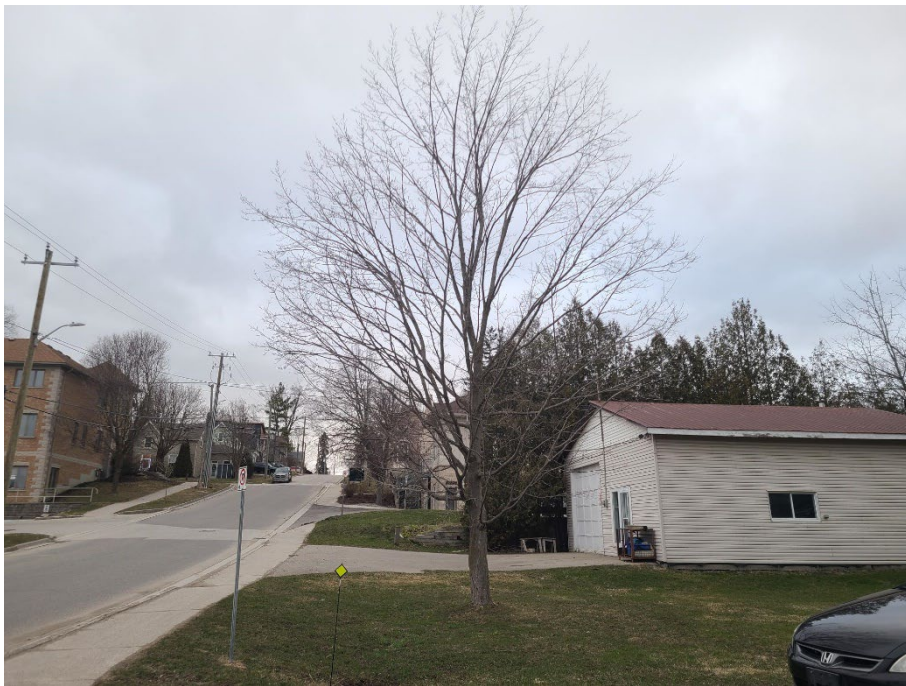
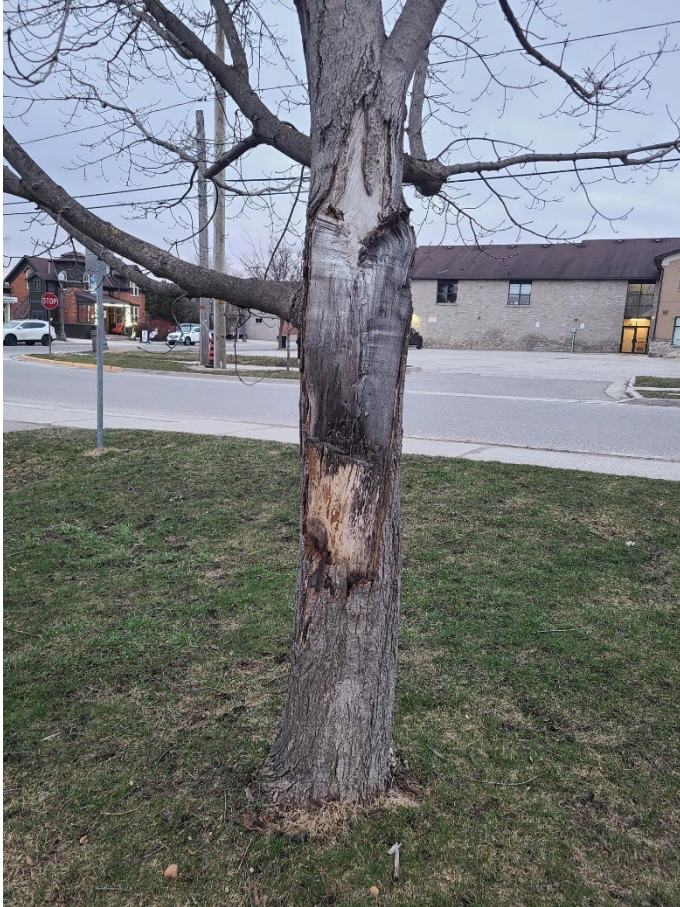
Tree # 12

12	Silver Maple	Acer saccharinum	34	14	2.4	F/P	P	Major past structural failure at north side of tree	Remove due to condition
A	Cedar Hedge	Thuja Sp.	15-25			F-F/G		~20 stems	Retain
B	Cedar Hedge	Thuja Sp.	4-15			Fair to Poor		~50 stems, Approximately 18-20 stems dead in portions close to the south eastern part of the property	Retain

After conducting our investigations, we conclude that trees #2 and #12 should be removed due to their state of health, while trees #5 and #11 should be removed due to their conflict with the proposed development. All other trees identified for retention can be successfully retained if the recommendations contained herein are followed. Special care shall be taken when working within or near the tree protection zones of trees that are to be retained. Where applicable, permit applications are to be submitted to the Township of Centre Wellington pursuant to the relevant Tree By-laws and permits shall be in hand prior to any removals.
