Tree Inventory & Assessment Report

350 Wellington Road 7 - We Merchandise Space Inc.

Project Location: 350 Wellington Road 7, Elora, ON

Report Issued: 2022-05-12

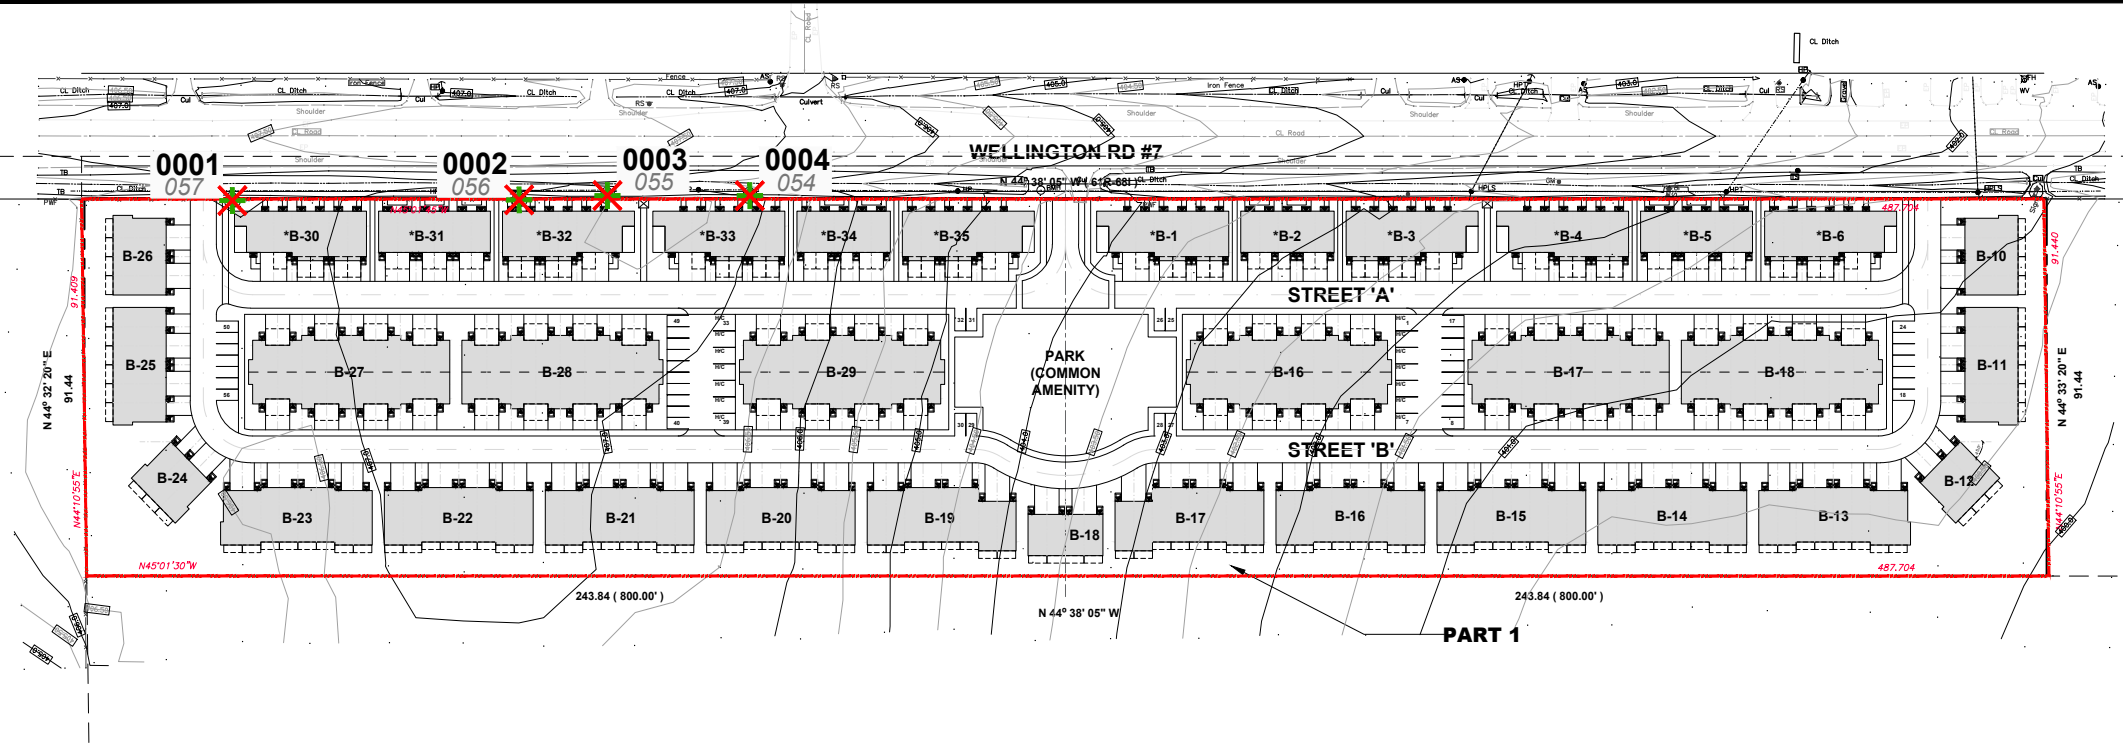
Drawing Title:
TREE INVENTORY & REMOVALS PLAN

Tree No.	Tree Tag No.	Species		Condition				DBH of Ind. Stems (cm)**	Approx. Canopy Width (m)	Ownership Category ****	Notes	Recommendations *
		Botanical Name	Common Name	Structure	Health	Form	Overall					
1	057	Sorbus sp.	Mountain Ash Species	Poor	Poor	Poor	Poor	26	7	Private	Adjacent to wire fence, multiple suckers clumped at base (s), fungus/decay on branches, dense internal branching structure, conflict with overhead utility	A
2	056	Fraxinus americana	White Ash	Poor	Poor	Fair	Poor	23	7	Private	Evidence of Emerald Ash Borer infestation, suckers emerging from base (l)	A
3	055	Fraxinus americana	White Ash	Poor	Poor	Poor	Poor	48	11	Town	Evidence of Emerald Ash Borer infestation, mostly dead wood, overhead utility conflict	A
4	054	Fraxinus americana	White Ash	Poor	Poor	Poor	Poor	40	12	Town	Pruned to avoid utility conflict, wounds on stem with decay, 10% dead wood	A

*Recommendations
 A - Removal of tree required due to conflicts with proposed construction & grading. (4 trees)

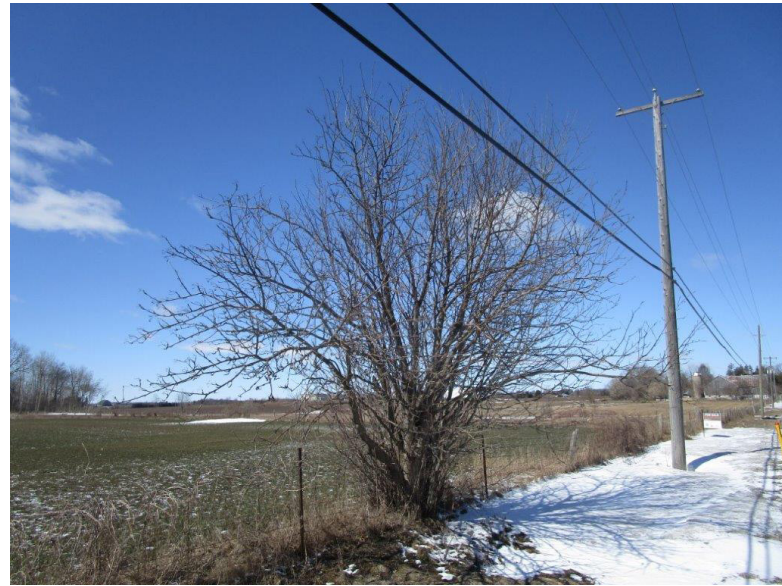
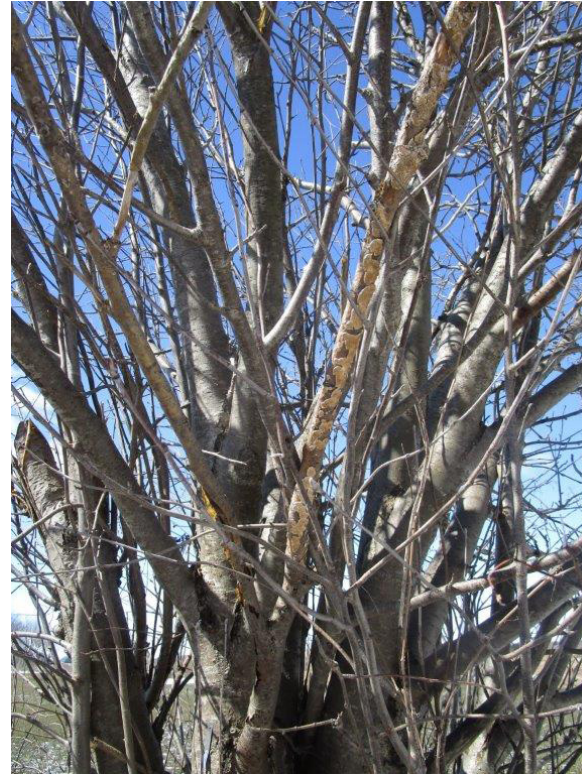
Tree 1

Tree No.	Tree Tag No.	Species		Condition				DBH of Ind. Stems (cm)**	Approx. Canopy Width (m)	Ownership Category ****	Notes	Recommendations *
		Botanical Name	Common Name	Structure	Health	Form	Overall					
1	057	Sorbus sp.	Mountain Ash Species	Poor	Poor	Poor	Poor	26	7	Private	Adjacent to wire fence, multiple suckers clumped at base (s), sapwood rot on branches, dense internal branching structure, conflict with overhead utility	A
2	056	Fraxinus americana	White Ash	Poor	Poor	Fair	Poor	23	7	Private	Evidence of Emerald Ash Borer infestation, suckers emerging from base (l)	A
3	055	Fraxinus americana	White Ash	Poor	Poor	Poor	Poor	48	11	Town	Evidence of Emerald Ash Borer infestation, mostly dead wood, overhead utility conflict	A
4	054	Fraxinus americana	White Ash	Poor	Poor	Poor	Poor	40	12	Town	Pruned to avoid utility conflict, wounds on stem with decay, 10% dead wood	A

A - Removal of tree required due to conflicts with proposed construction & grading. (4 trees)
