Arborist Report

Elora Clayton

Township of Centre Wellington

July 2022 221469

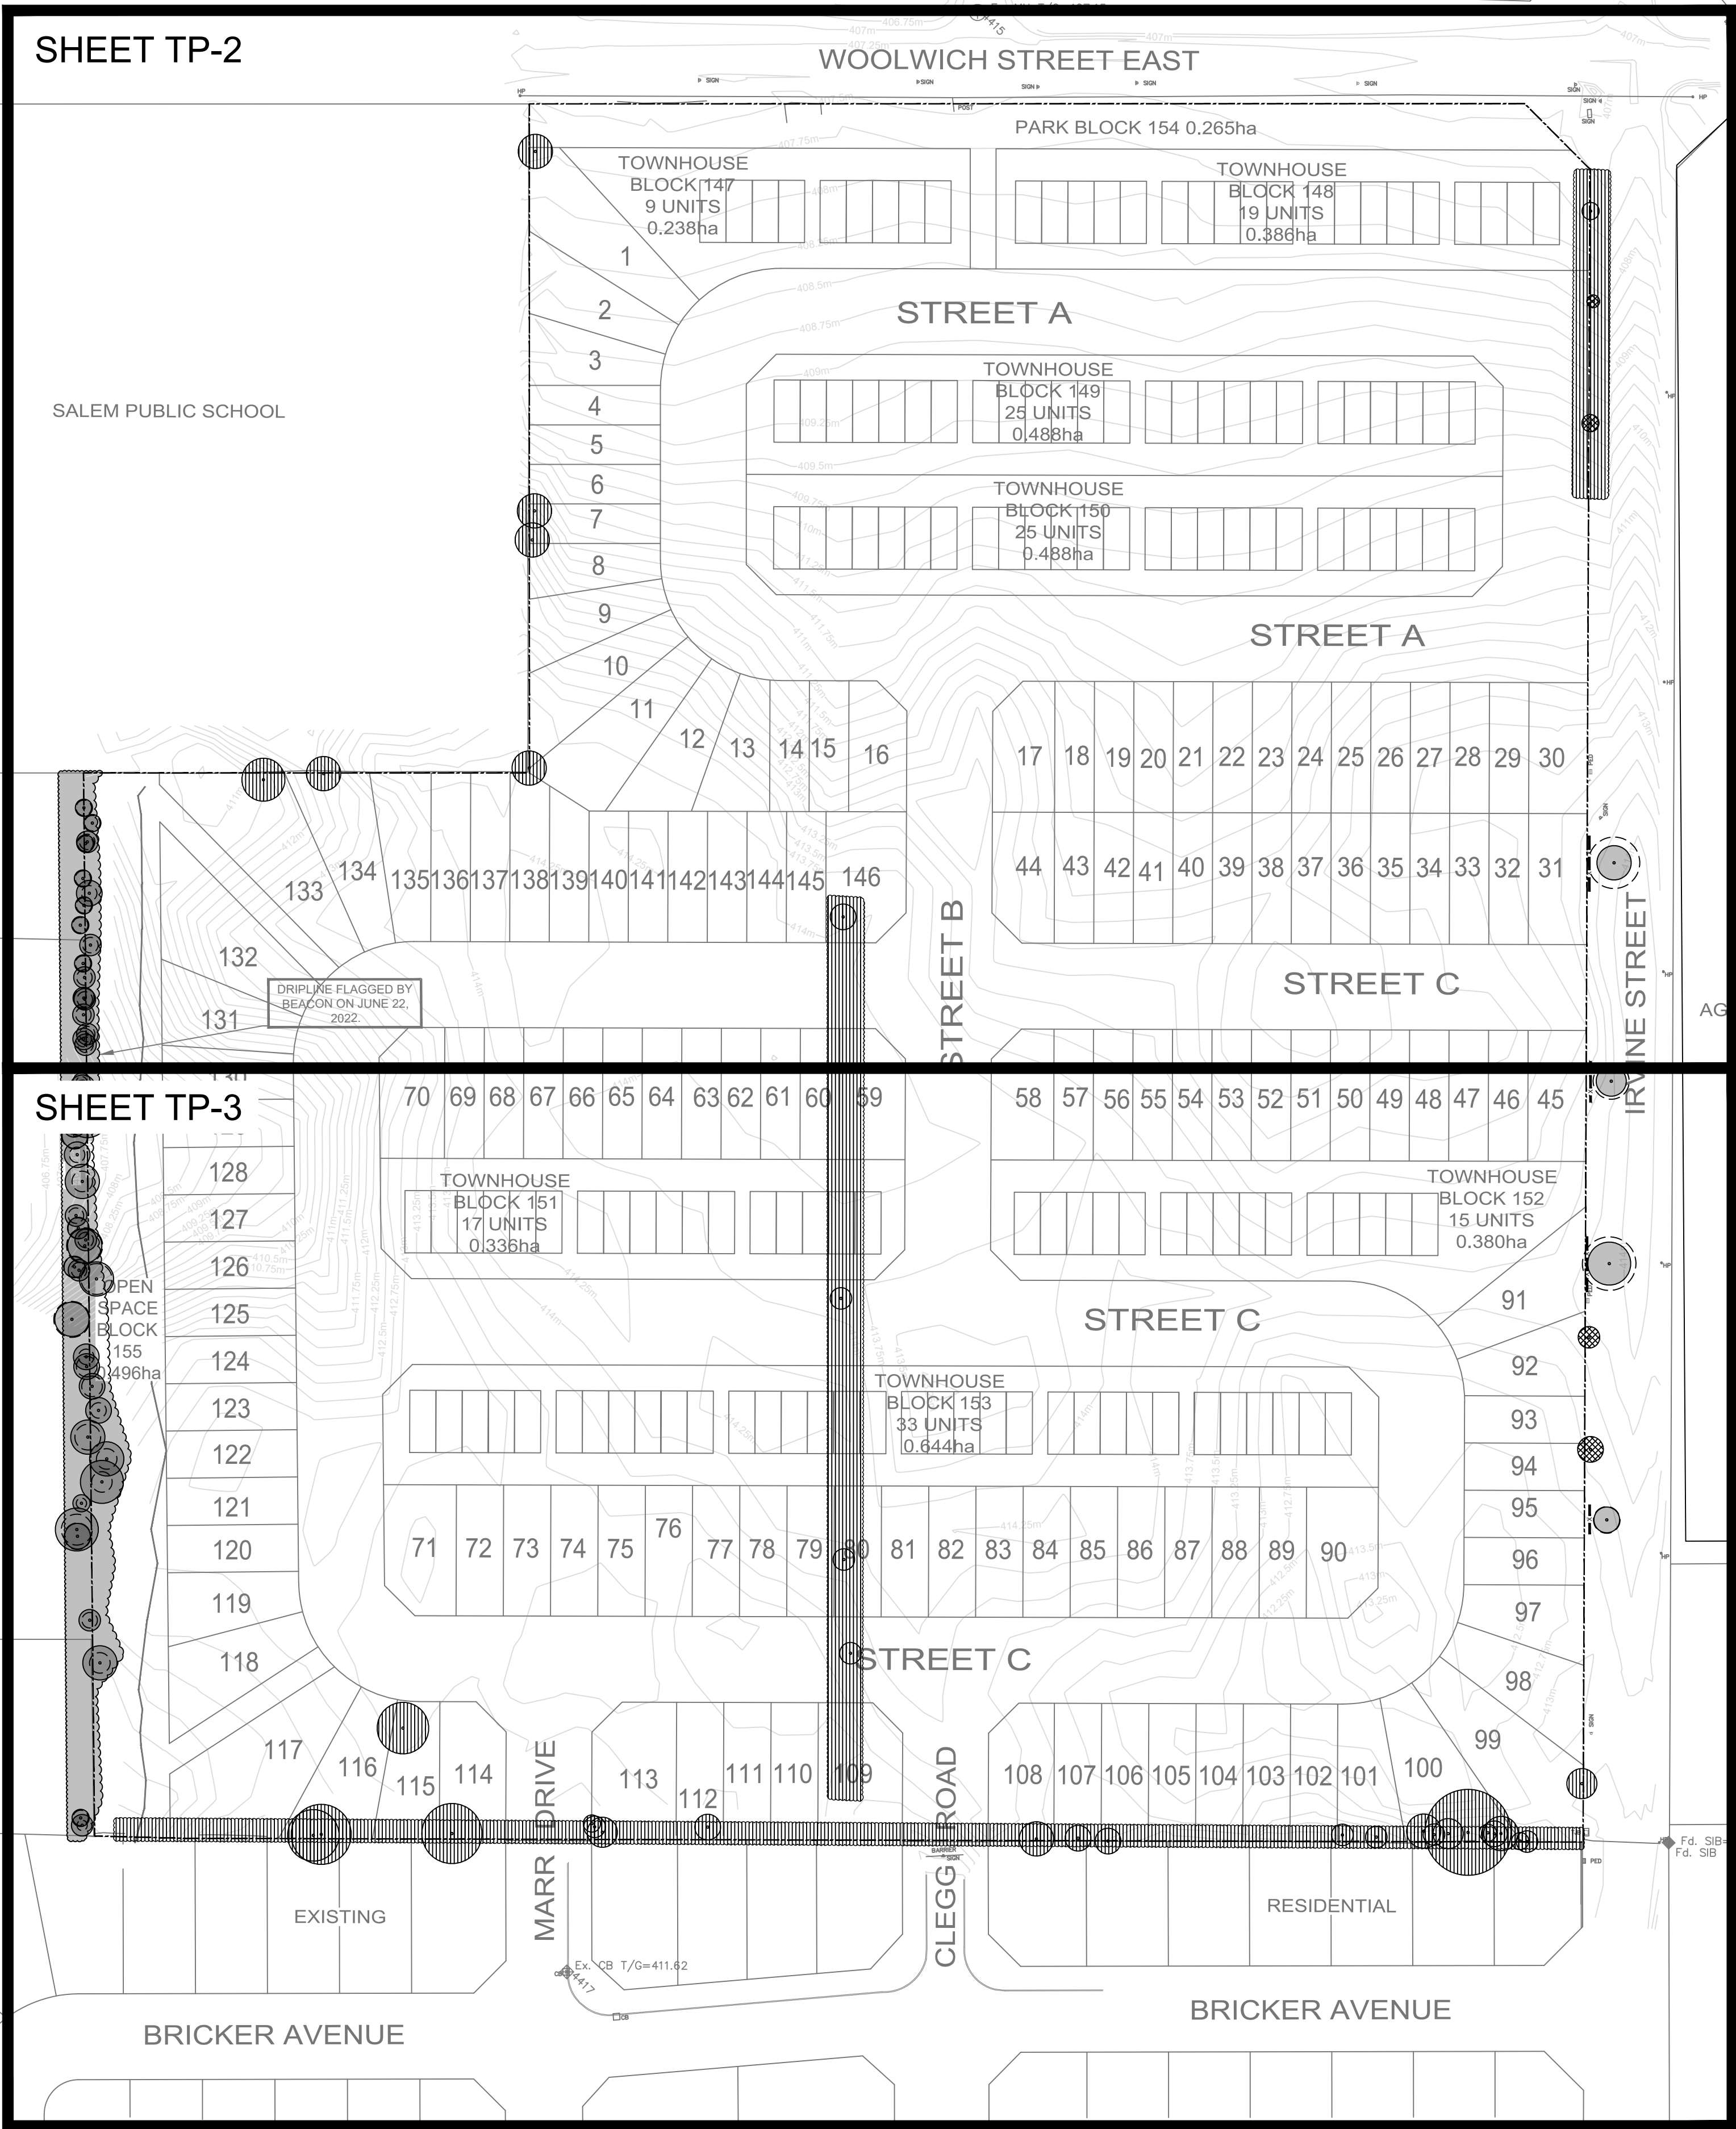
DESIGN BY: ..	PROJECT №: 221469
DRAWN BY: MB	FIGURE №: TP-1
CHECKED BY: KQ/AH	
DATE: 13 July 2022

The 31 individually-tagged trees (Tree Nos. 1210, 1212 to 1235, and 1268 to 1273) located on the subject property are listed in decreasing order of abundance below:

The two co-owned trees ((Tree Nos. NT1, and NT2)) located between the subject property and adjacent private properties include two Sugar Maple that are 80 cm and 130 cm DBH, and in fair to good, and fair condition, respectively.

Detailed tree preservation and removal recommendations are provided below and shown in the Tree Inventory Preservation Plan (**Drawings TP-1 to TP-3**).
