**THE CORPORATION
OF THE TOWNSHIP OF
CENTRE WELLINGTON**

**SCHEDULE B MUNICIPAL CLASS
ENVIRONMENTAL ASSESSMENT**

**REPLACEMENT OF
STRUCTURE 24-P**

3RD LINE WEST

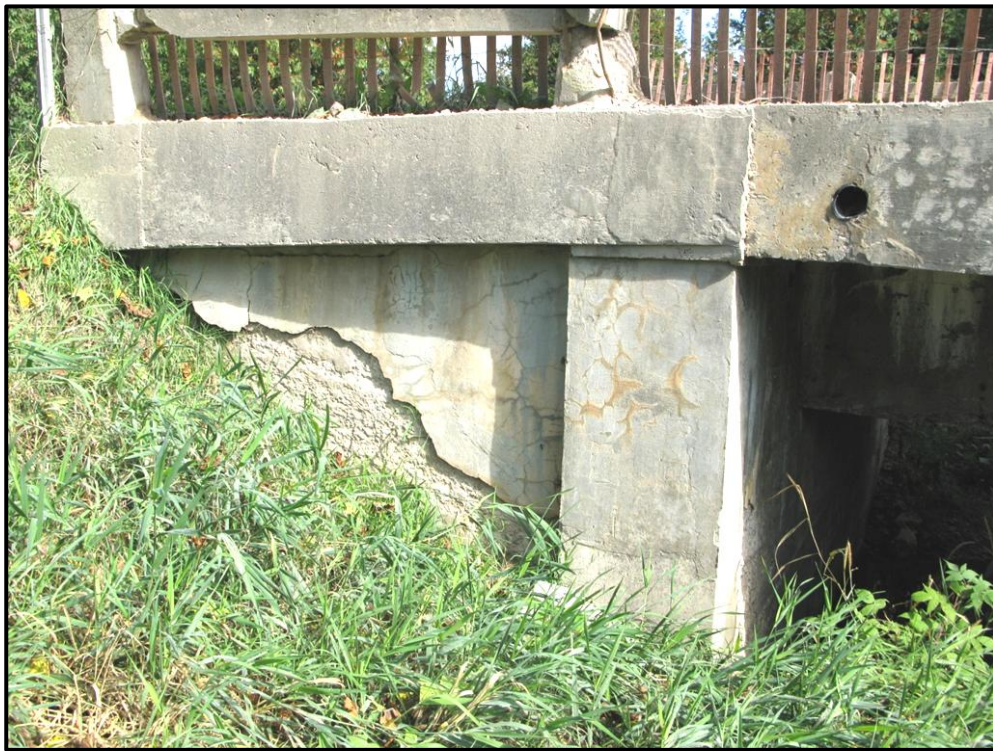
Plate 3: Detail of north abutment and west inset wing wall. Note spalling concrete resurfacing.

Both abutments on the bridge are cast concrete and appear to be simple squared structures with no ornamentation. Wing walls that are set back from the abutment ends giving the abutment the appearance of a pier when viewed from the side, although only one original wing wall is visible. The North abutment shows no indication of repairs outside of a skin coat on the west side (that may be original) but exhibits significant deterioration on the east side likely due to ice and debris impacts during floods (See Plate 3).

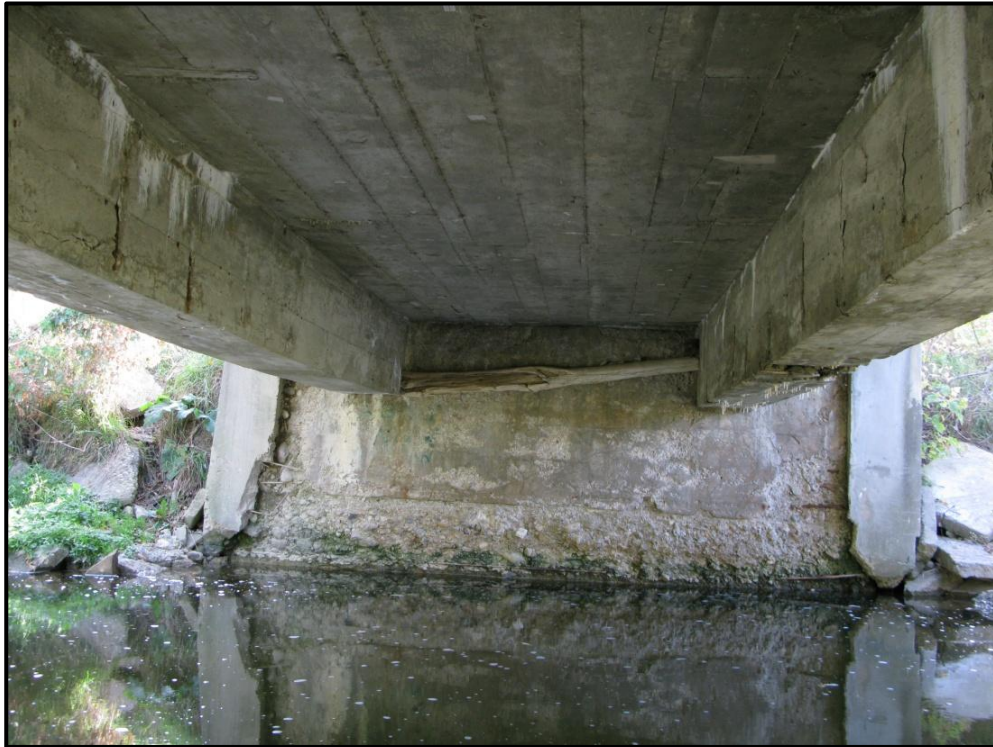
Plate 4: Carroll Creek bridge, south abutment showing "T" beams and deck bottom. Note new(er) wing wall castings separating from abutment and relatively clean edges of "T" beams.

The south abutment, however, has had new wing walls cast in place over the existing walls on both sides substantially increasing the width of the wing walls. The new concrete covers, however, are separating from the original at the abutment faces (See Plates 4 and 5). The limited pieces of visible reinforcement and large sized cobbles in the exposed section of the south abutment concrete suggest the reasons for the separation and a potentially incorrect initial concrete mixture.

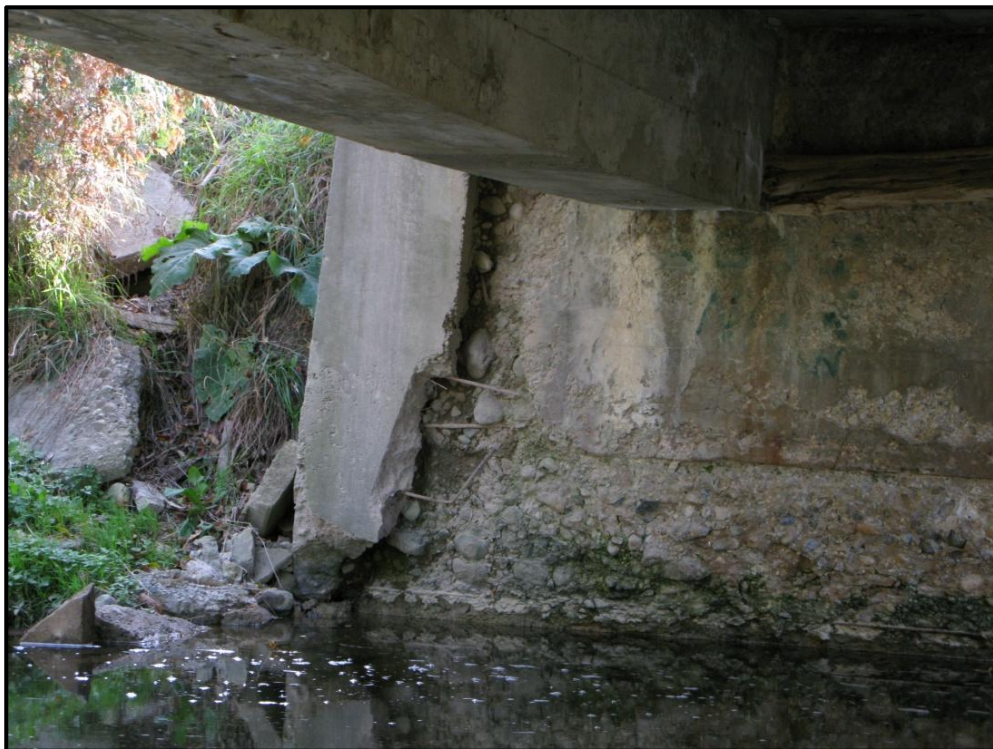
Plate 5: Detail of south east wing wall separation from south abutment. Note limited reinforcement and large cobbles.

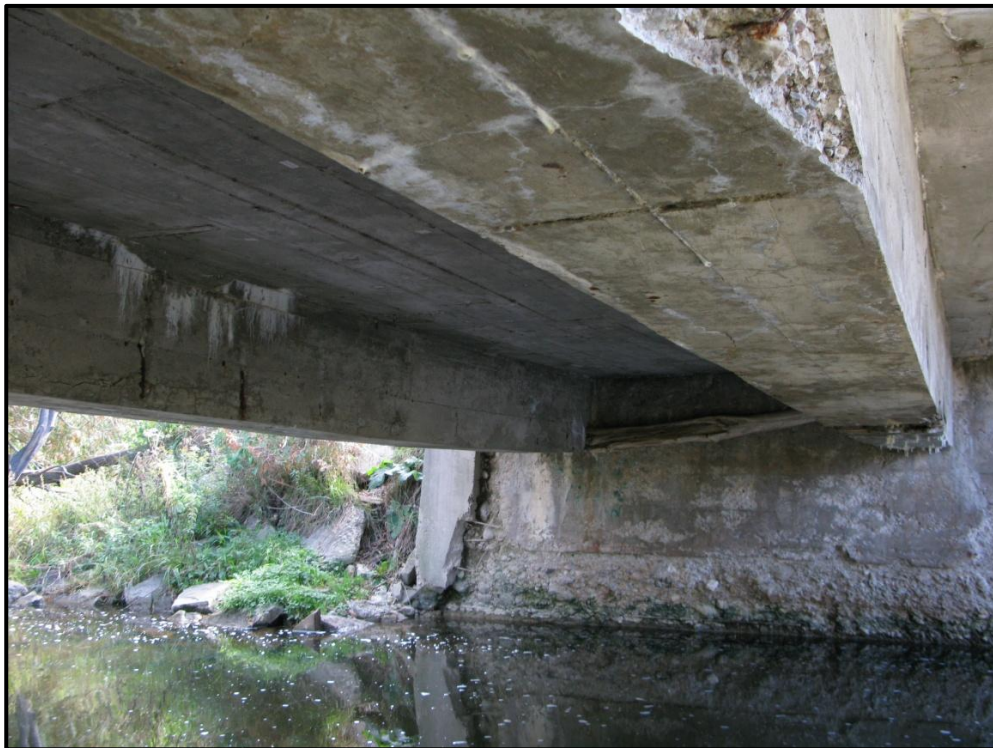
Plate 6: Two “T” beams and south abutment showing edge failures.

The two “T” beams show modest wear with several cracks and failures in the concrete surface near the lower reinforcement likely due to water encroachment, reinforcement corrosion, and freeze and thaw cycles (See Plates 6 and 7).

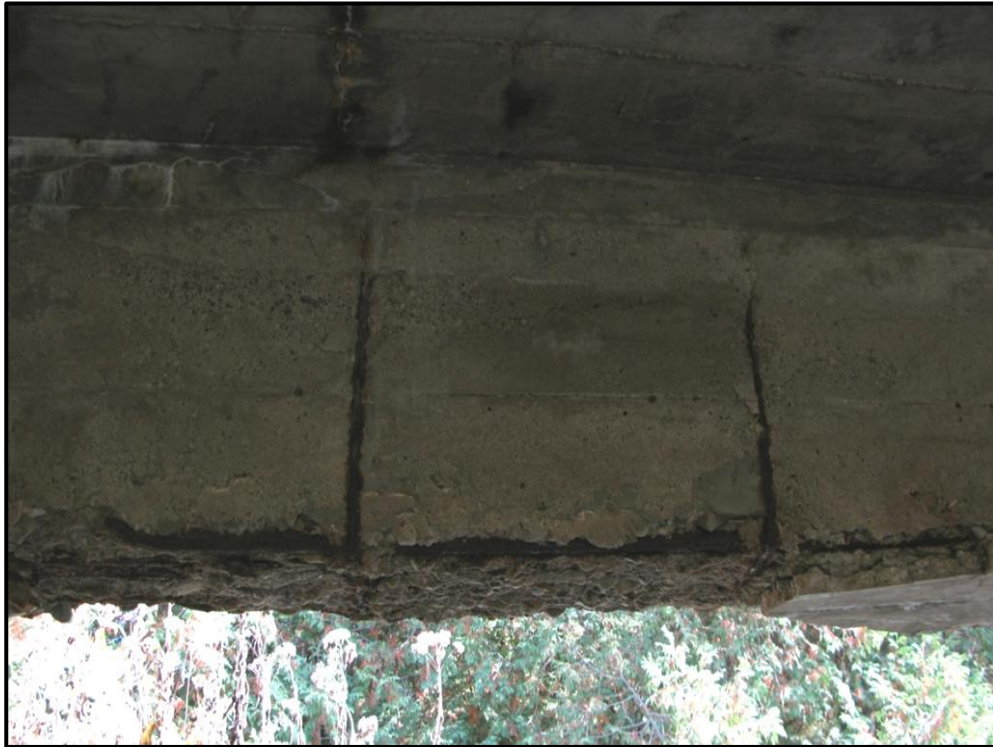
Plate 7: Detail of east "T" beam showing exposed reinforcement in lower beam half and connecting reinforcement integrating the beam into the bridge deck. Note missing concrete from beam bottom likely from corroding reinforcement and spalling concrete.

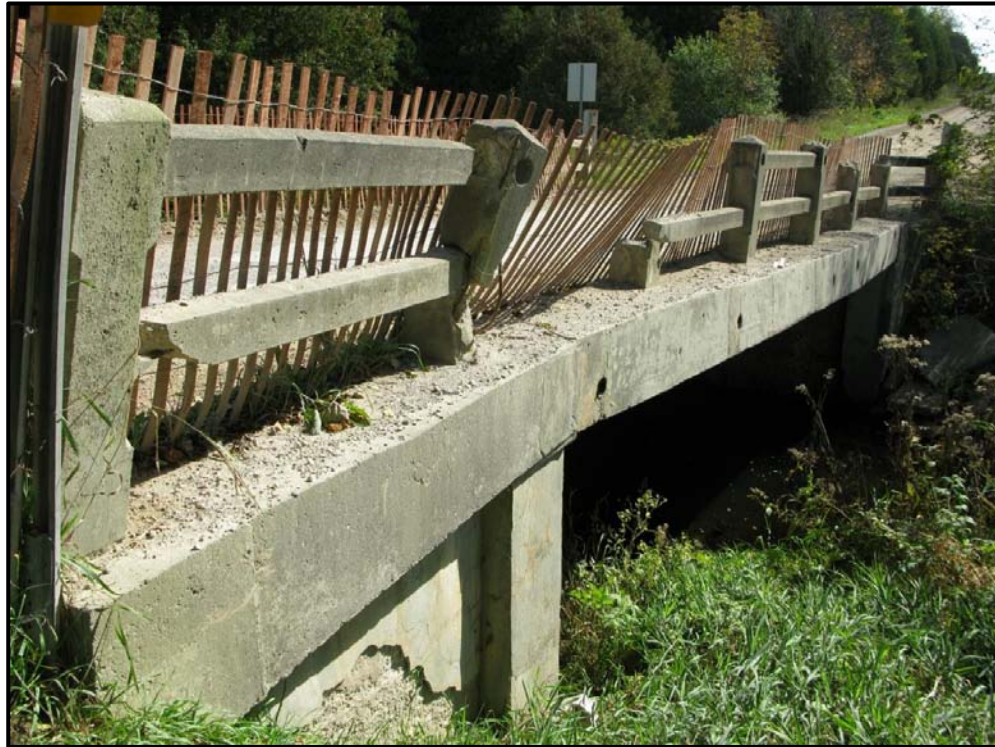
Plate 8: West deck edge showing relatively clean surface, but significant rail deterioration possibly due to collisions.

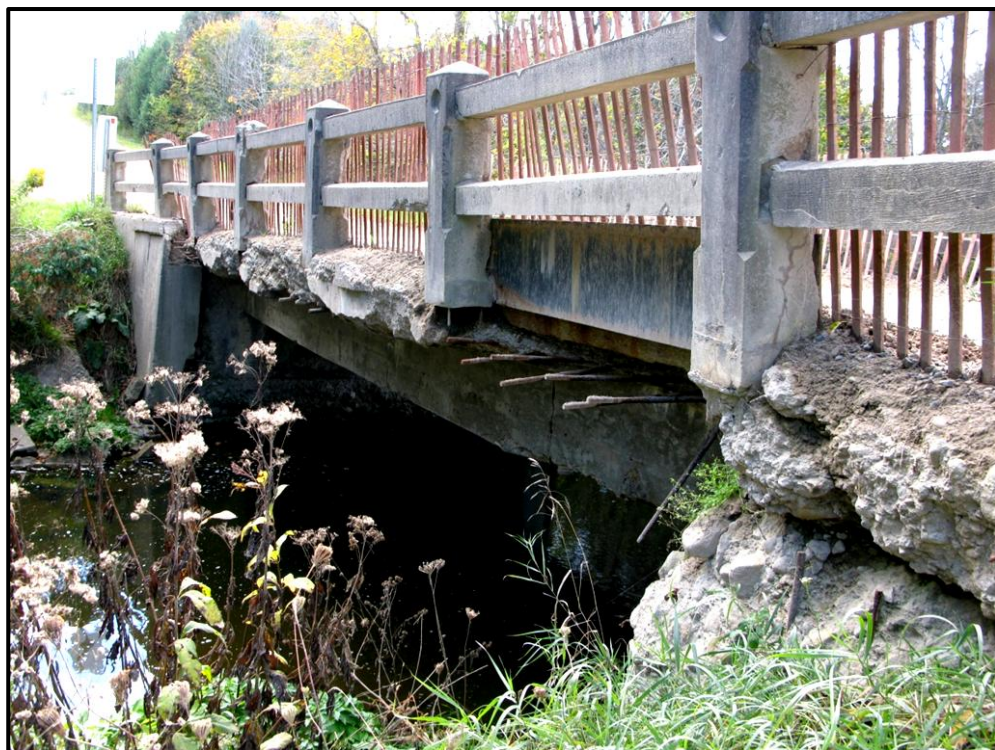
Plate 9: East deck edge showing significant deterioration likely due to ice and debris impacts during floods but relatively intact rail system.

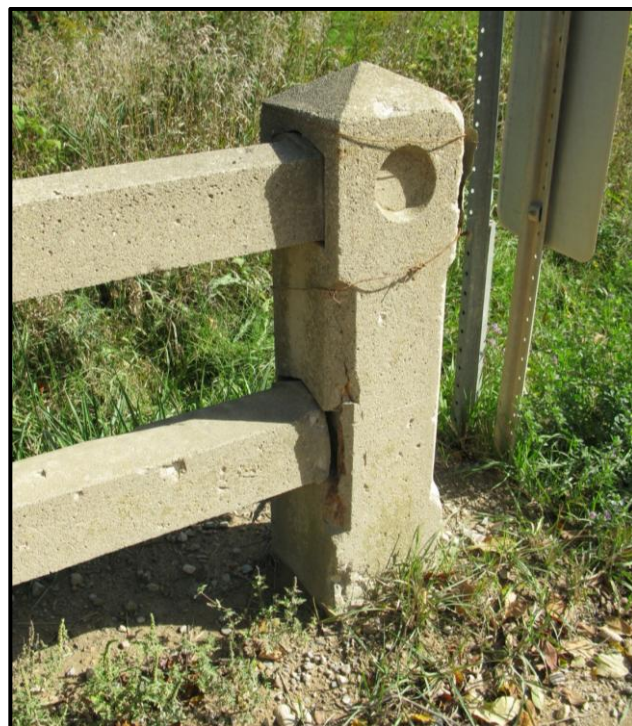
Plate 10: Balustrade detail of east rail showing pyramidal cap, chamfered edges, and decorative circular inset, and rail detail.

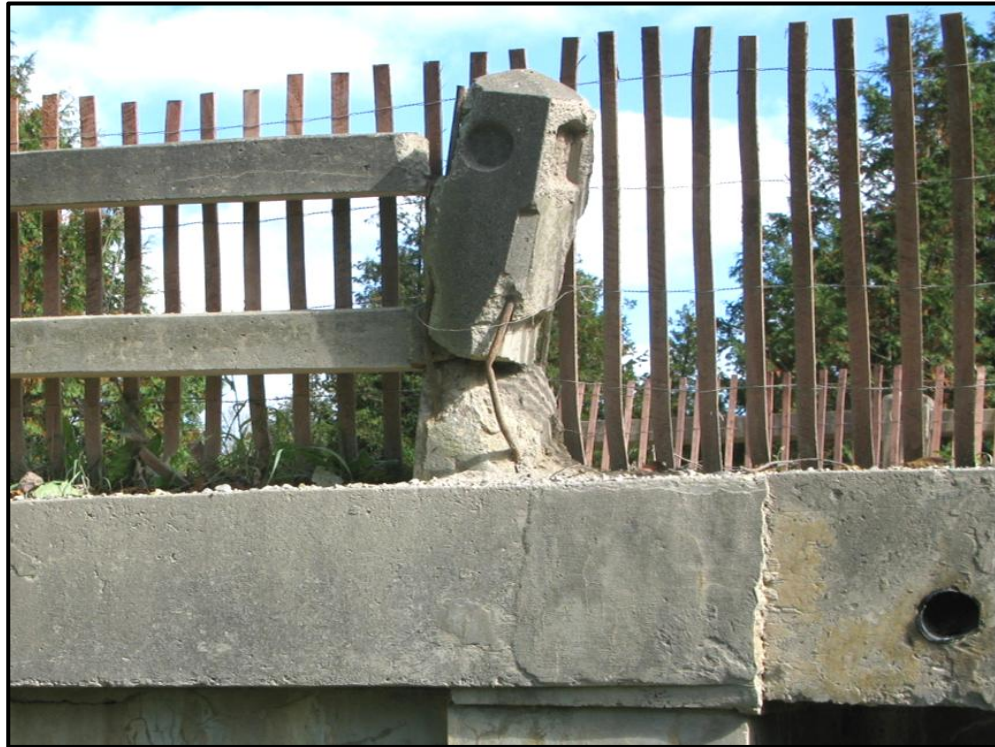
Plate 11: Failed balustrade and missing rails from west side railing.

Curiously, the west side railing, sitting on the solid west deck edge has demonstrated significant failures. Only five of the eight balustrades exist and only four of them are in good repair. While one of the balustrades is halved and only held together by reinforcement rods, three are broken off at openings for the lower railings or at the openings of the top railing opening suggesting collisions with moving vehicles (See Plate 11). The two end balustrades on the west side have flat tops opposed to the pyramidal tops of all the other balustrades whose tops still exist. On both sides of the bridge, inside the railings, the township lined the crossing with a wood-slatted snow fence likely to provide a stronger visual location of the bridge edge for moving vehicles because it would provide no resistance to impacting vehicles and only modest resistance to pedestrians who may be inclined to cross the bridge edge (See Plate 1 and 12).
