HERITAGE IMPACT ASSESSMENT

Phase II

19 East Mill Street,
Elora, Ontario

February 9, 2024

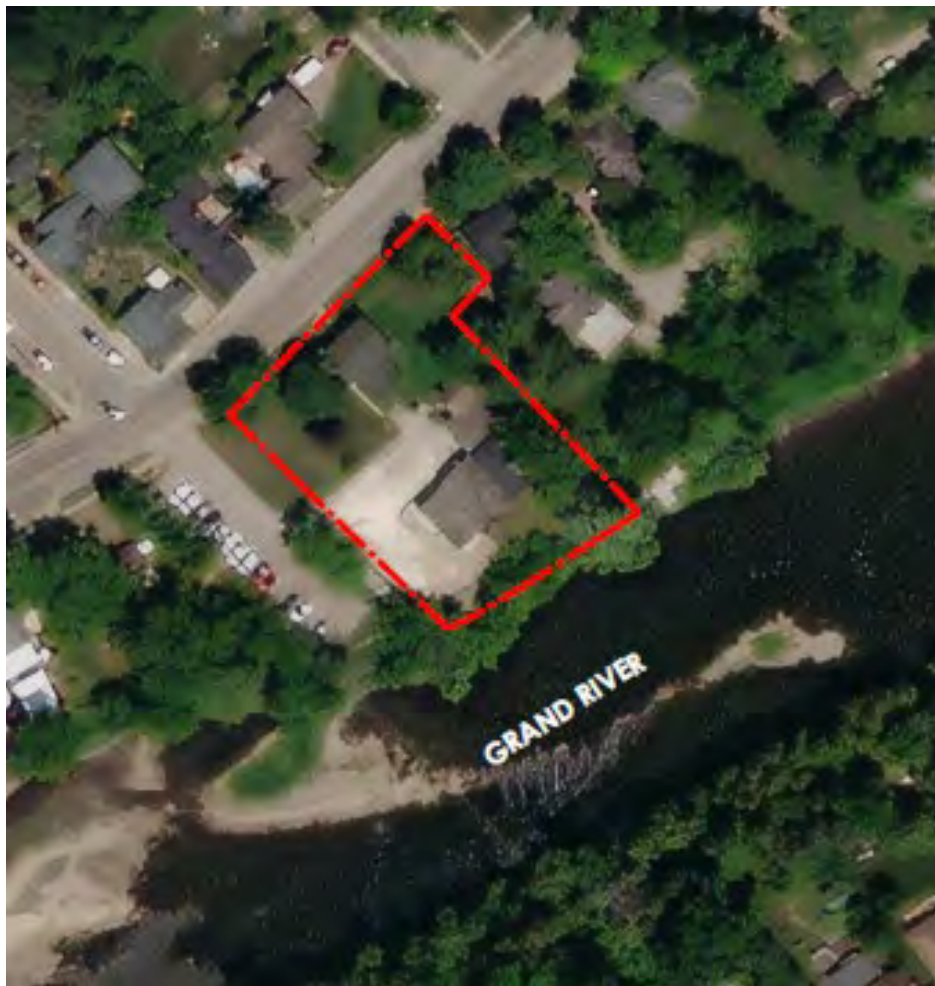
Figure 9: Aerial photograph of 19 East Mill Street (Source: MHBC, 2023)

The property includes a two storey house clad in stucco, a one and a half storey metal outbuilding, a two storey stone building with later concrete additions (see **Figures 9 & 10**). There is a driveway and open gravelled space on the south west corner of the property and the property abuts the Grand River to the south. A site visit occurred on March 19th, 2021 to document the existing buildings and structures on-site.

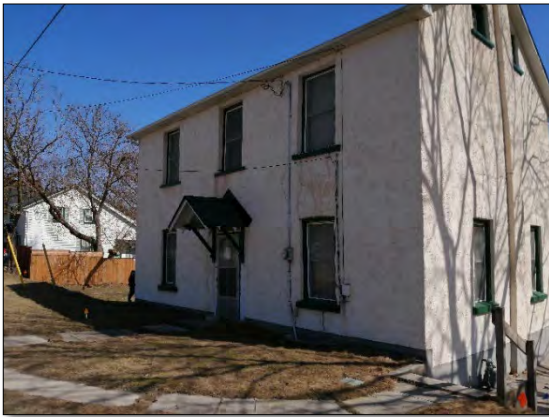
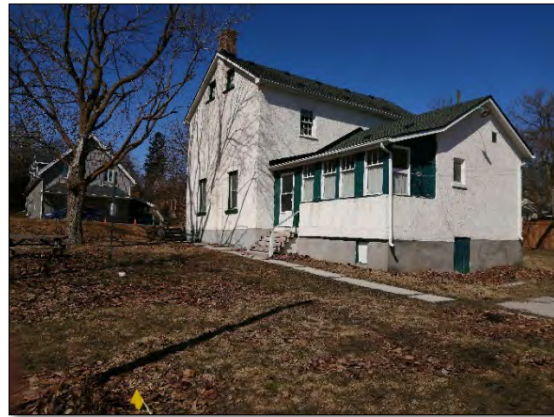
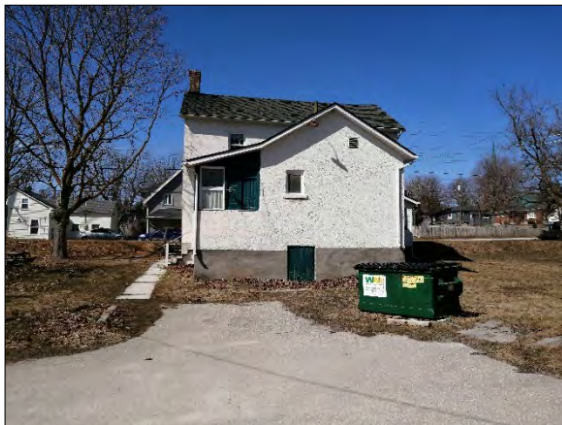
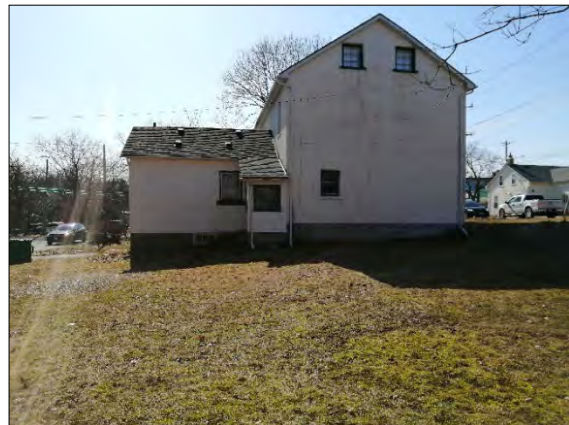
The existing dwelling is clad in stucco with an open gable roof and foundation covered with Portland cement. The front façade includes five window openings with centred entryway with gabled overhang. There are four window openings on the south elevation and three on the north elevation. There is a rear addition that includes a gallery of windows on the south elevation and entryway. The addition has an open gabled roof and concrete foundation. See **Figures 11-14** for corresponding photographs.

Figures 11, 12, 13 & 14 (above left) View of front façade of the dwelling; (above right) View of south and east elevation; (below left) View of east elevation of dwelling with view of rear addition; (below right) View of north elevation and rear addition (Source: MHBC, 2021).

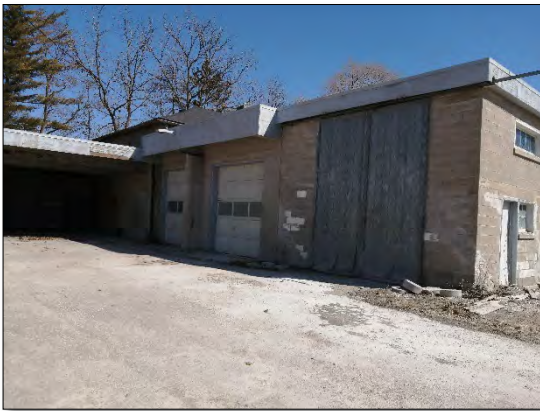
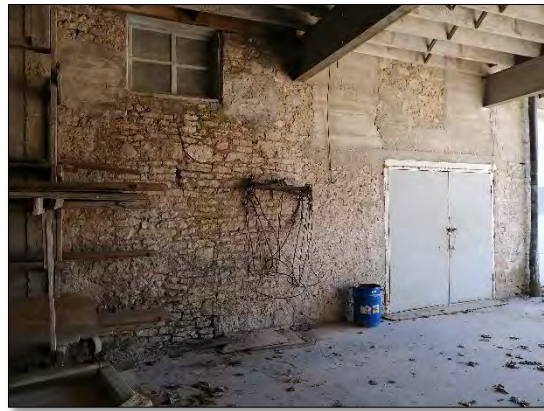
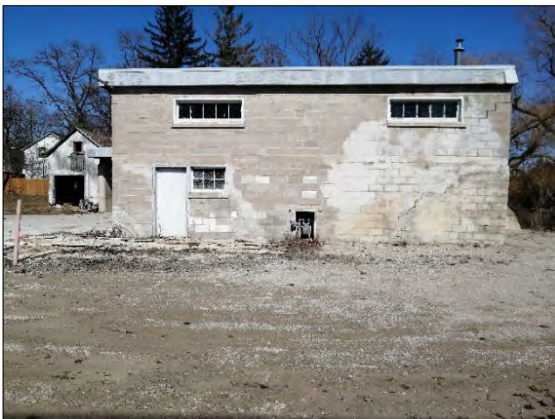
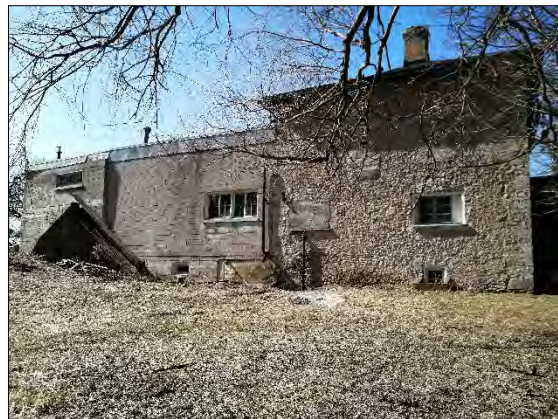
There is a two storey, rubble stone building located on the north-east corner of the property with a hipped roof with a brick chimney. Some original window openings appear on the north, east and west elevations. A two-storey, mid-century cinder block addition was made to the south of the stone building with a platform roof. Attached to the western elevation of the stone building is a cinder block shelter/ carport; it appears that this structure is affixed to the stone building by means of steel beams. See **Figures 15-18** for photographs of the exterior elevations.

Figures 15, 16, 17 & 18: (above left) View of cinder block addition to stone building looking north-east; (above right) View of shelter affixed to west elevation of stone building; (below left) View of south elevation of cinder block addition; (below right) View of east elevation including cinder block addition and stone building (Source: MHBC, 2021).

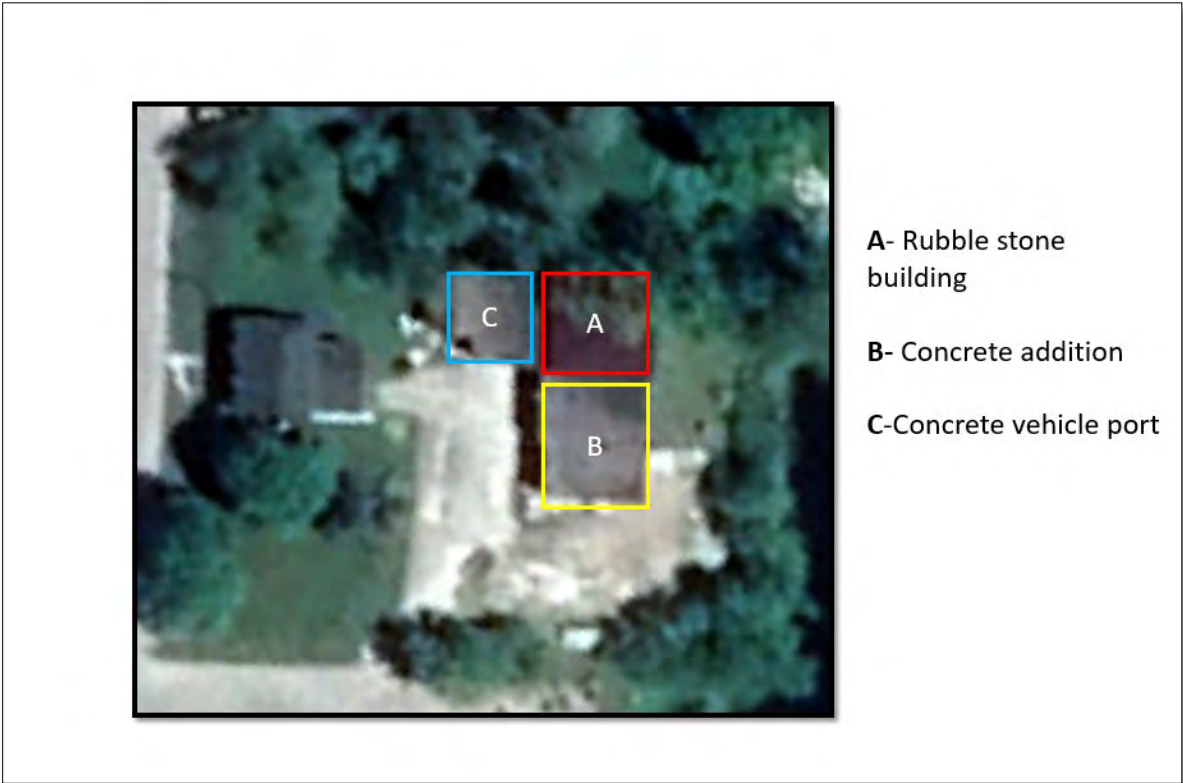
The building complex is comprised of three sections as identified in the figure below (see Figures 19-28 for photographs of the interior of the building). The section labelled 'A' includes the historic rubble stone building. Section 'B' includes a mid-century concrete addition; this addition is affixed to the south elevation of the stone building by means of steel beams. There is also a concrete overhang/ port attached to the west elevation of the stone building labelled Section 'C'. The following description will use the identified sections below for a better comprehension of the interior arrangement of the building complex.

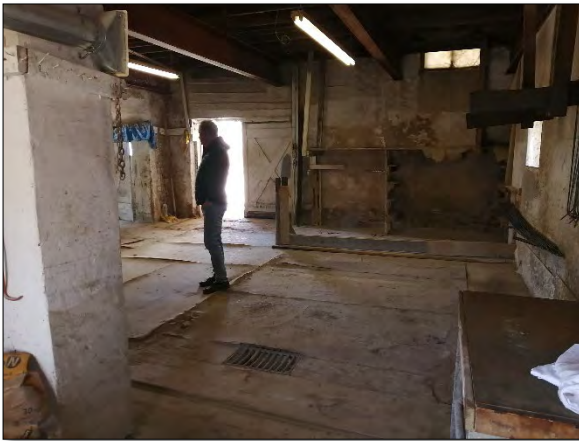
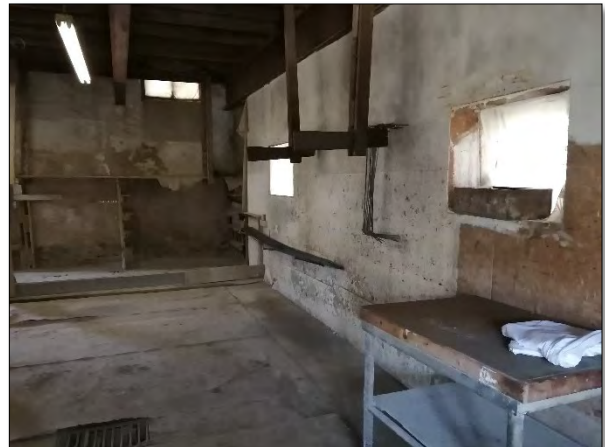
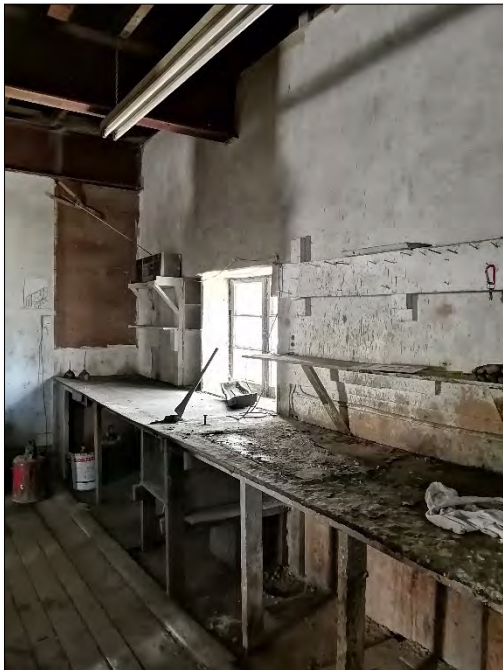
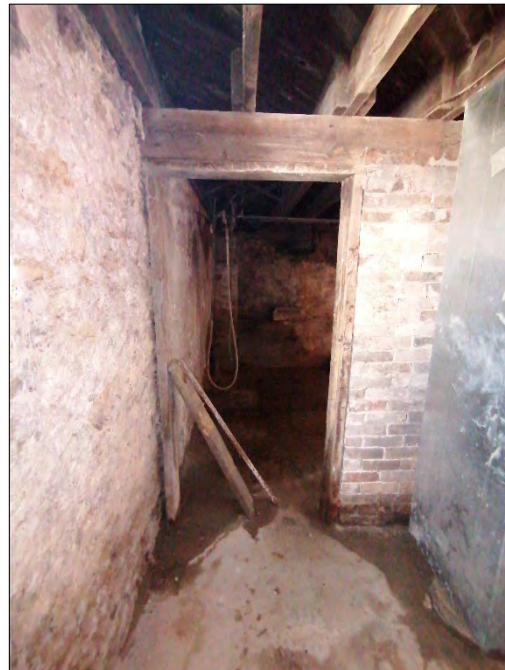
Section 'A' of the building is the original c. 1859 stone outbuilding that was formerly used as a brewery and for storage for the mill which no longer exists. The interior of the stone building located on the north-east corner of the property includes two floors and basement level. The main floor includes a workshop area including the equipment used to manufacture burial vaults (i.e. chute to direct concrete for moulds and protruding hooks presumably to hold a vault). There are brick column supports and walls on all levels of the building. The basement is includes a chute likely used for pouring concrete; the basement is connected to the basement of the addition. The second storey level is an open space; there are indications that the exterior walls were heightened over the years

and are not level leaving some significant gaps between the roof line and walls. There is some historic graffiti along the walls on this level.

Figures 19, 20, 21 & 22: (above left) View of main floor of stone building looking south-west towards building section 'C'; (above right) View of apparatus used for the manufacturing of burial vaults affixed to the north elevation of stone building on main level; (below left) View of workshop area on main floor looking north-east; (below right) View of brick partition wall in basement of stone building (Source: MHBC, 2021).

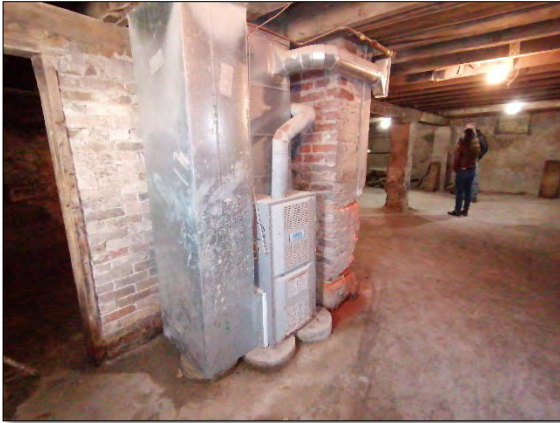
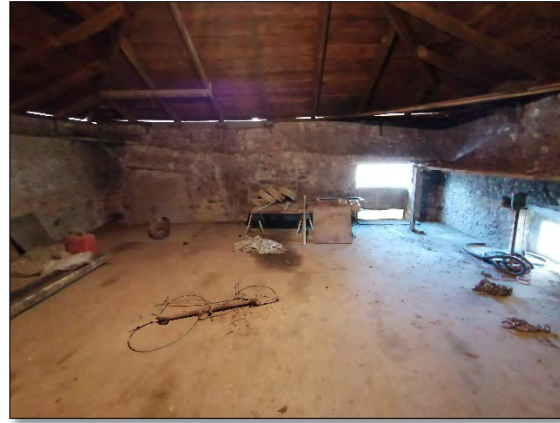
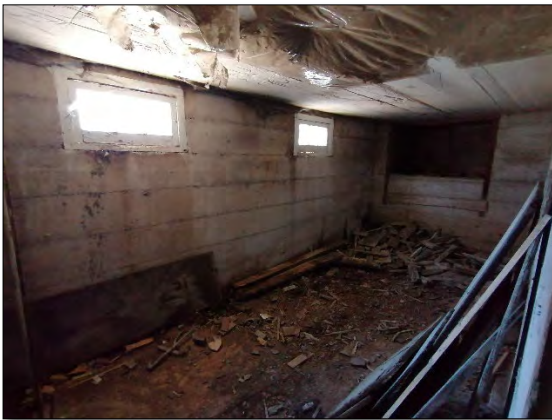
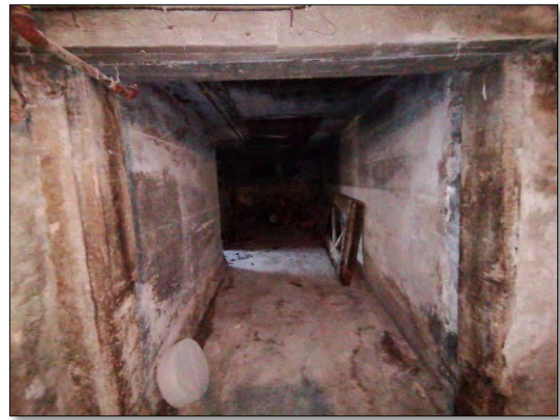
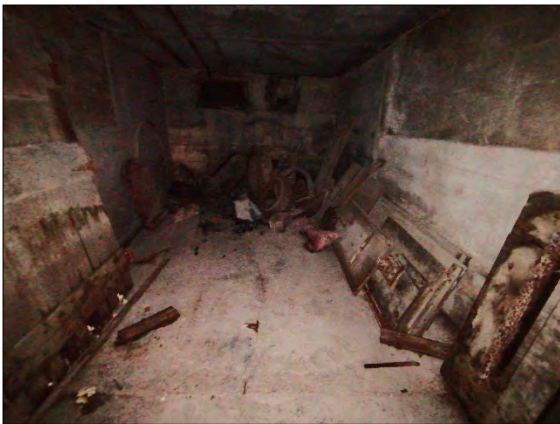
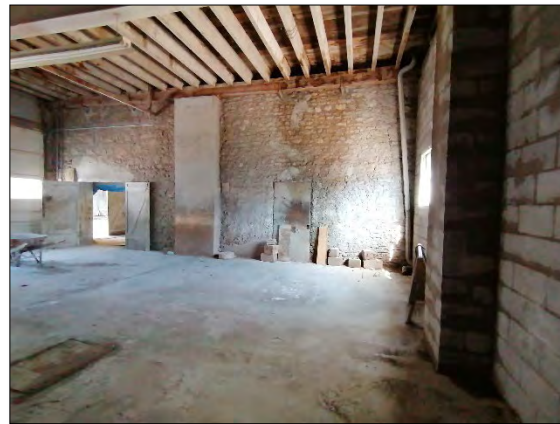
Figures 23, 24, 25, 26, 27 & 28: (above left) View of basement level; (above right) View of top floor of rubble stone building; (middle left) View of concrete basement of mid-century addition; (middle right) View of hallway in basement of building looking towards later addition; (below left) View of storage area in lower level of building to store material used for production of burial vaults; (below right) View of interior of later mid-century addition (Source: MHBC, 2021).

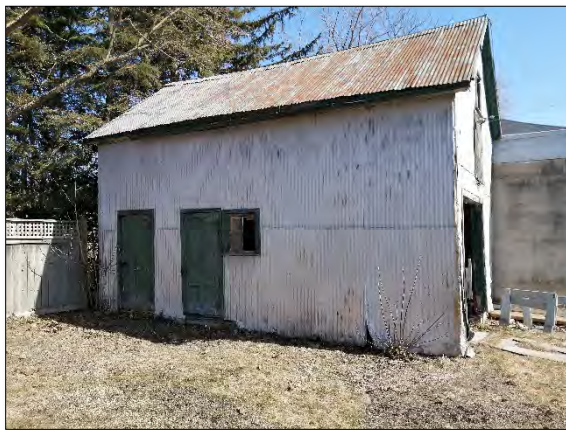
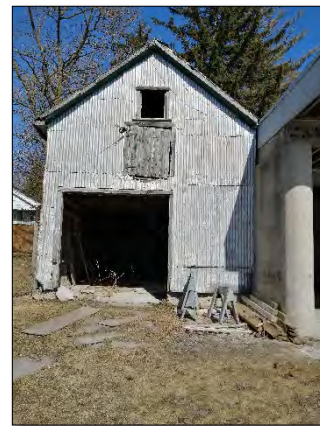
There is a one and half storey outbuilding wood frame building clad in metal sheathing with an open gabled, metal roof located on the north side of the property. There are two door entries on the west elevation, vehicular entrance on south elevation (see **Figures 29 & 30**).

Figures 29 & 30: (left) View of west elevation of outbuilding looking north-east; (right) View of south elevation of outbuilding looking north (Source: MHBC, 2021).

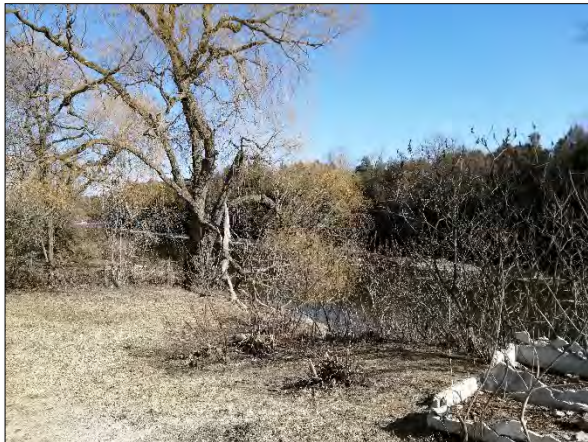
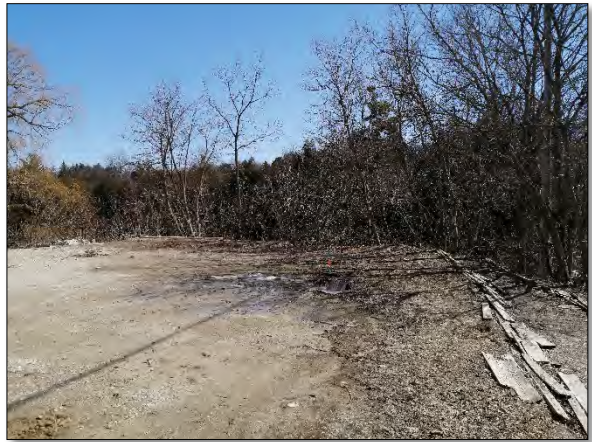
The subject property abuts the Grand River which runs along its eastern boundary. There are trees sporadically placed on the property which a concentration of trees along the south eastern corner and along the Grand River (see **Figures 31 & 32**).

Figures 31 & 32: (left) View of eastern boundary of property looking north-east towards the Grand River; (right) View of trees lining the south eastern corner of subject property looking north-east towards Grand River (Source: MHBC, 2021).

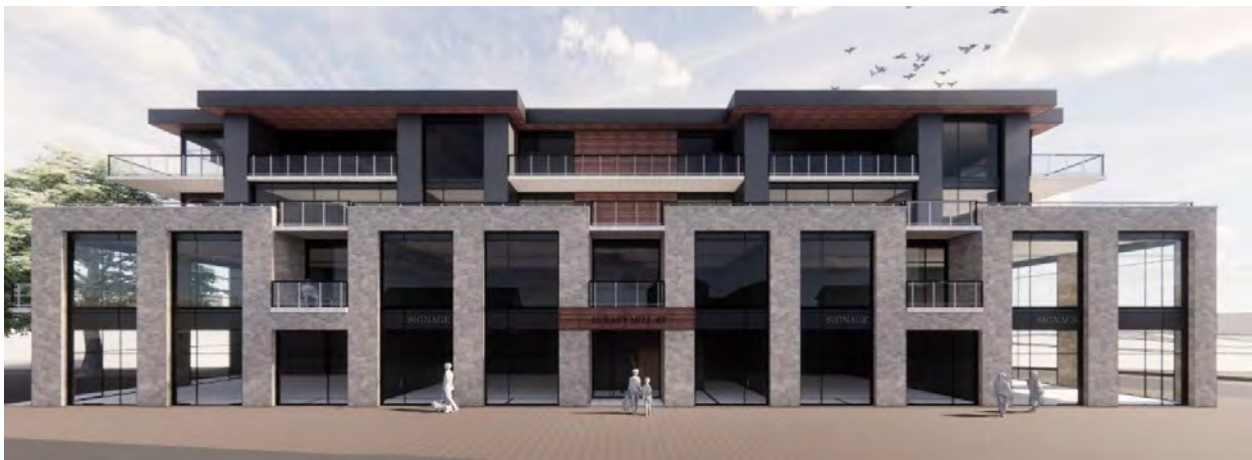
The design of the proposed four storey mixed use building is contemporary in design with some reflection of traditional elements including datum and use of some natural materials and colour palette. The building is proposed to have a platform (flat) roofline to reduce the height of the building, with a step back at the third storey to maintain the appearance of massing at street level. The front of the building along East Mill Street is proposed to have significant glazing in the form of large windows that extend upwards two storeys. Stone veneer is also proposed at the first two storeys, with a material change at the third and fourth storeys likely to be metal cladding. This material differentiation is an effort to draw the eye to the ground level and reduce the appearance of massing.

Figure 34: View of north (front) elevation of Building 'A' (Source: Fryett Turner Architects Inc., 2023).

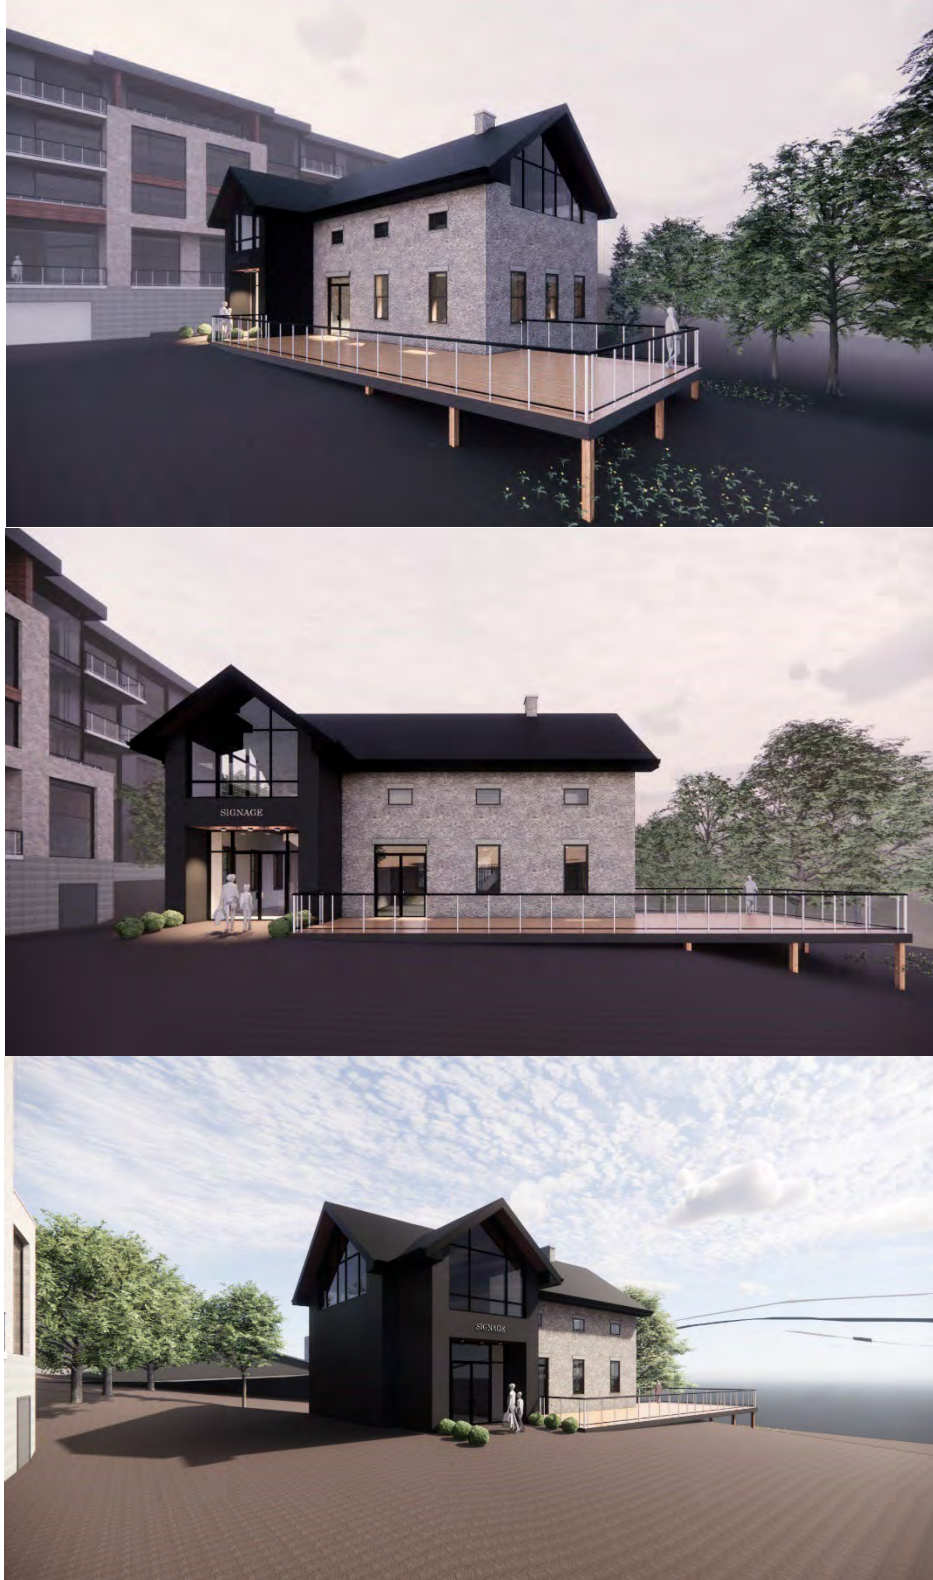
Figure 37-39: (above) Perspective view looking north-east towards Building B; (middle) View of proposed west elevation of Building B; (below) Perspective view looking south-east of proposed north and west elevations of Building B (Source: Fryett Turner Architects Inc., 2023).

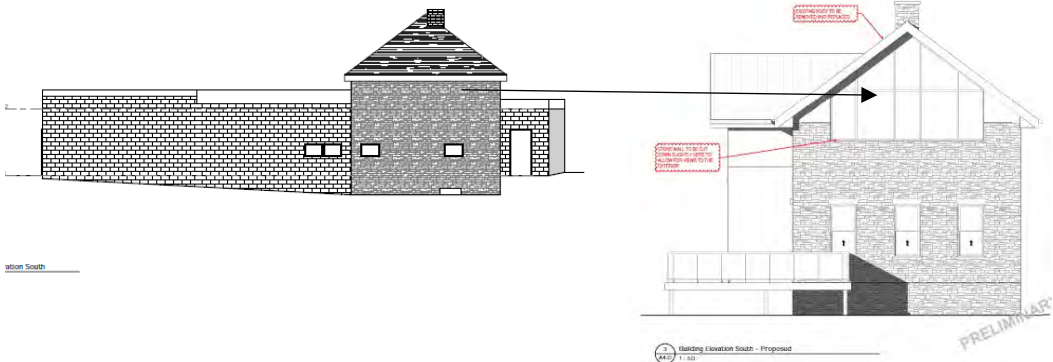
The proposed development will remove a minimal portion of the built heritage fabric of the historic stone building (Building B) to install the proposed windows on the south elevation. The glazing at the second storey extends 2' – 1" from the top of the stone wall down into the stone wall by 17' – 9" in length as seen in **Figure 40 & 41** below. The rubble stone walls are identified as heritage attributes and removal of a portion of these walls is considered a negligible impact of destruction.

Figures 40 & 41: (left) Existing view of south elevation; (right) View of proposed south elevation including alterations (Source: Fryett Turner Architects Inc., 2023).

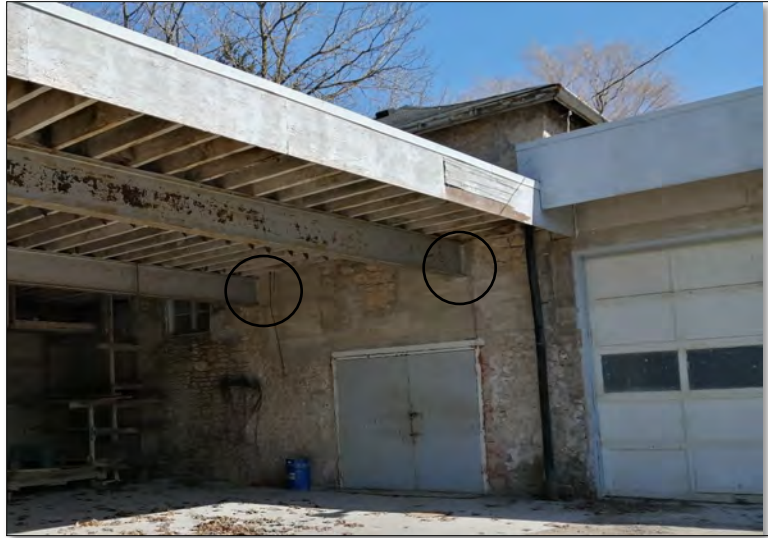
Figures 43 & 44: (above) View of north elevation of historic stone building (Building B) showing concrete carport and location of steel beams on this elevation; (below) View of attachment of western addition to historic stone building (Building B) (Source: MHBC, 2021).

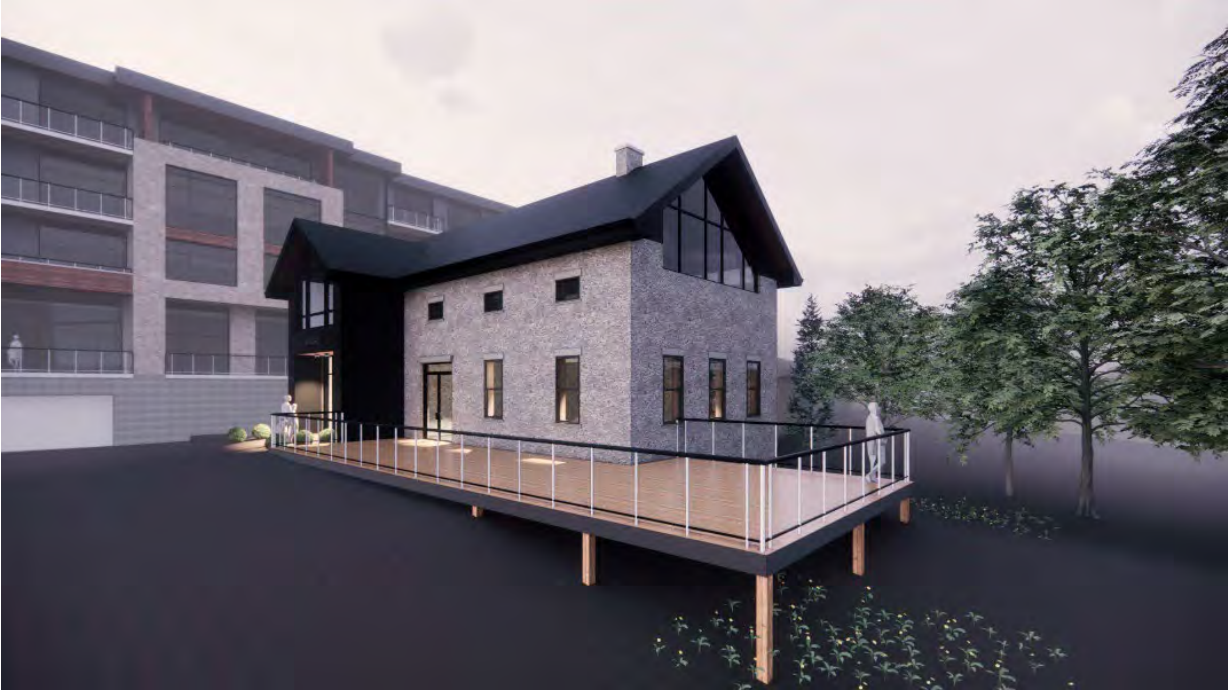
Two existing window openings will be enlarged on the east elevation which requires the removal of built heritage fabric. An existing door opening on the west elevation will be partially infilled to create a window opening (see **Figures 45 & 47**). Existing windows and door will be replaced with contemporary frames and replace the existing frames, which are currently in poor condition.

The existing roof structure will be replaced with a medium-pitched, gabled roofline. The existing chimney will be extended to be consistent with the roofline. The existing roofline is not original to the building and is in poor condition and requires replacement, however, this replacement requires integration into the existing stone building envelope.

Figure 48: View of south elevation of existing original stone building showing rendering of proposed alterations (Building B) (Source: Fryett Turner Architects Inc., 2024).

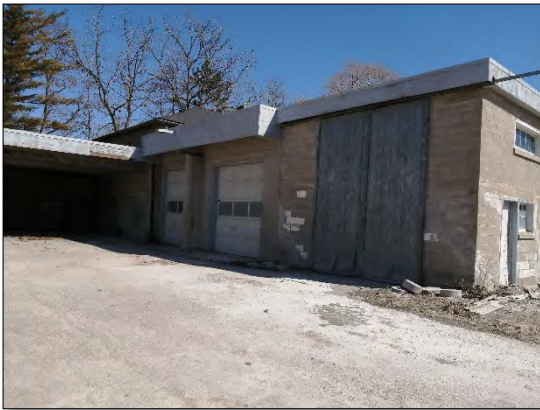
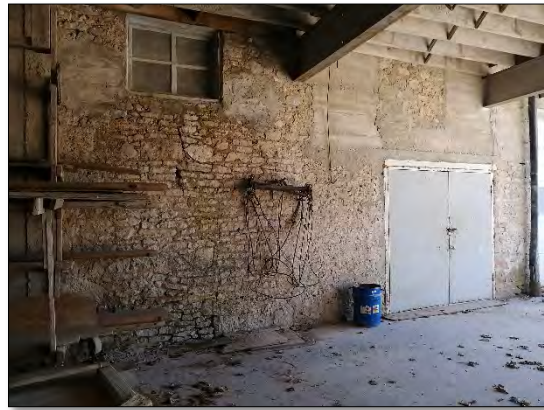
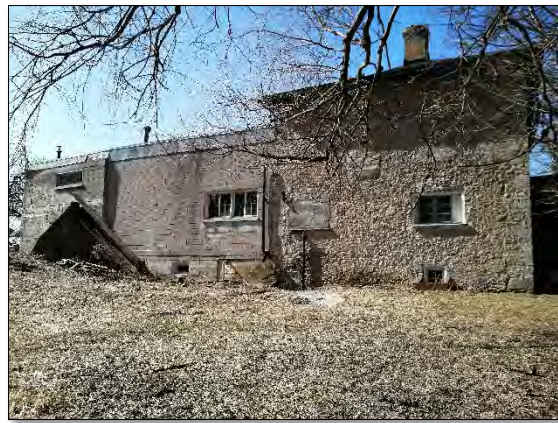
There is a two storey, rubble stone building located on the north-east corner of the property with a hipped roof with a brick chimney. Original window openings appear on the north, east and west elevations. A two-storey, mid-century cinder block addition was made to the south of the stone building with a platform roof. Attached to the western elevation of the stone building is a cinder block shelter/ carport; it appears that this structure is affixed to the stone building by means of steel beams.

Figures 32, 33, 34 & 35: (above left) View of cinder block addition to stone building looking north-east; (above right) View of shelter affixed to west elevation of stone building; (below left) View of south elevation of cinder block addition; (below right) View of east elevation including cinder block addition and stone building (Source: MHBC, 2021).

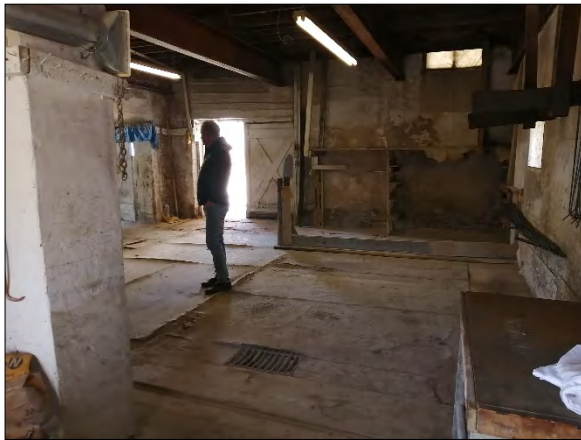
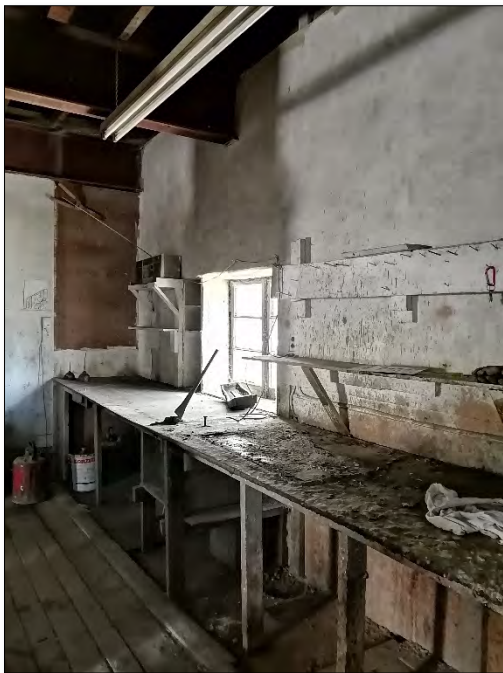
Section 'A' of the building is the original c. 1859 stone outbuilding that was formerly used as a brewery and for storage for the mill which no longer exists. The interior of the stone building located on the north-east corner of the property includes two floors and basement level. The main floor includes a workshop area including the equipment used to manufacture burial vaults (i.e. chute to direct concrete for moulds and protruding hooks presumably to hold a vault). There are brick column supports and walls on all levels of the building. The basement includes a chute likely used for pouring concrete; the basement is connected to the basement of the addition. The second storey level is an open space; there are indications that the exterior walls were

heightened over the years and are not level leaving some significant gaps between the roof line and walls. There is some historic graffiti along the walls on this level.

Figures 36, 37, 38 & 39: (above left) View of main floor of stone building looking south-west towards building section 'C'; (above right) View of apparatus used for the manufacturing of burial vaults affixed to the north elevation of stone building on main level; (below left) View of workshop area on main floor looking north-east; (below right) View of brick partition wall in basement of stone building (Source: MHBC, 2021).

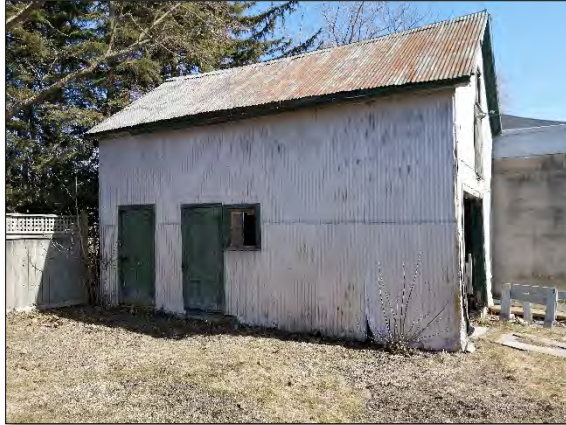
There is a one and half storey outbuilding wood frame building clad in metal sheathing located on the north side of the property. It has an open gabled, metal roof. There are two door entries on the west elevation, vehicular entrance on south elevation.

Figures 46 & 47: (left) View of west elevation of outbuilding looking north-east; (right) View of south elevation of outbuilding looking north (Source: MHBC, 2021).
