February 22, 2005
Our File: 104-185

PHASE II ESA

Re: Assessment of Environmental Impacts near
Former UST, Hill Property,
Centre Wellington, Ontario

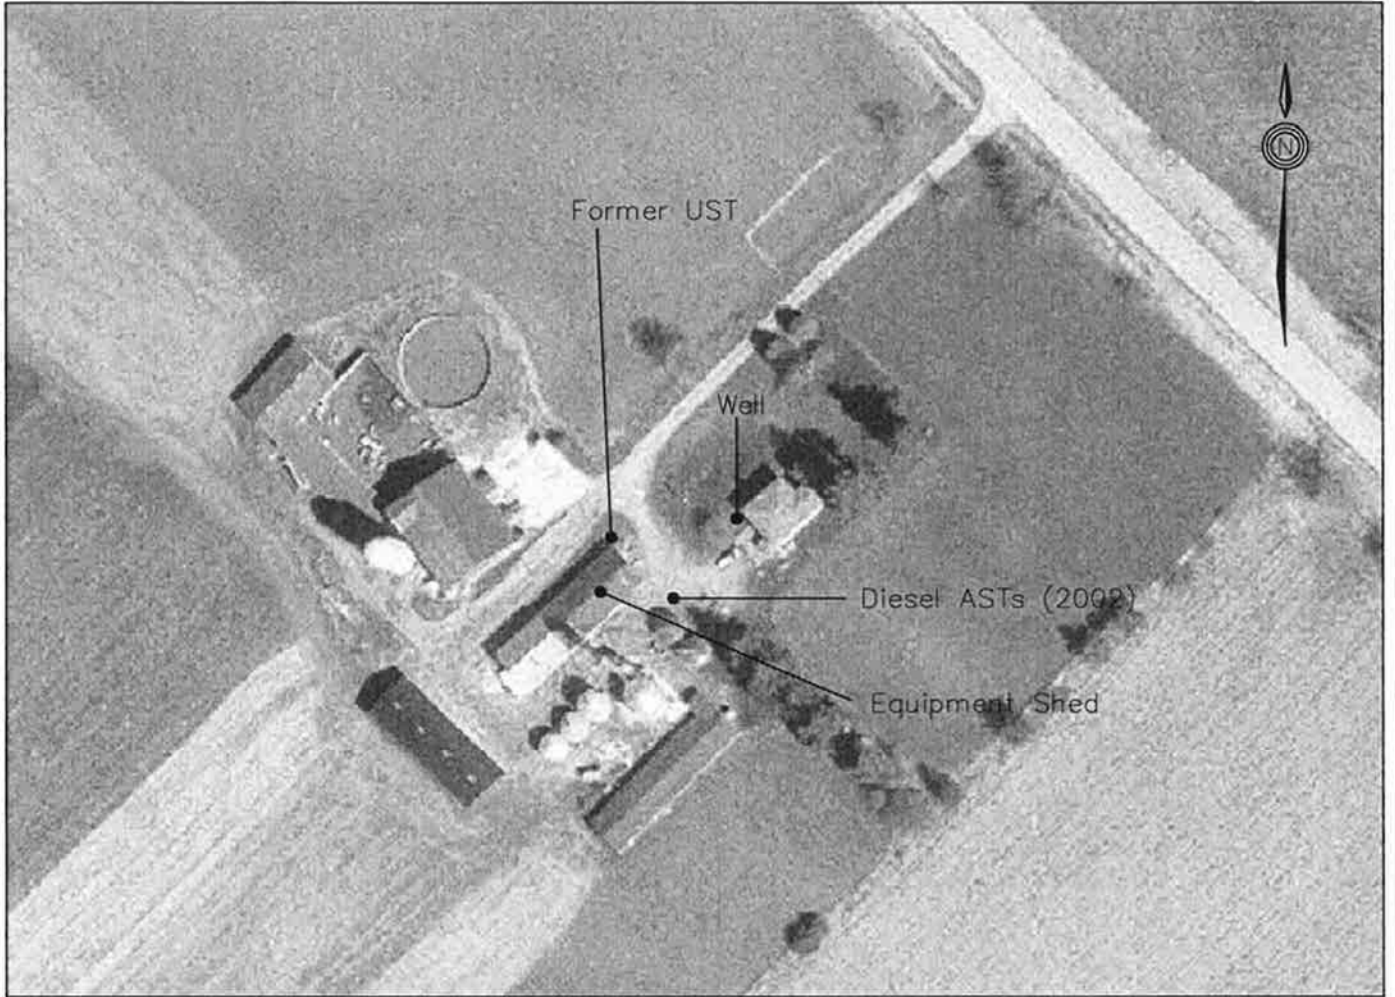
Figure 2 Detailed Site Plan Hill Property

Gamsby and Mannerow Limited (G&M) was retained by James Keating Construction Limited to document the presence or absence of environmental impact to soil and groundwater in the vicinity of a previously removed underground storage tank (UST) on the Hill Property. The general location of the property is shown on Figure 1. The estimated location of the former UST is presented on Figure 2.

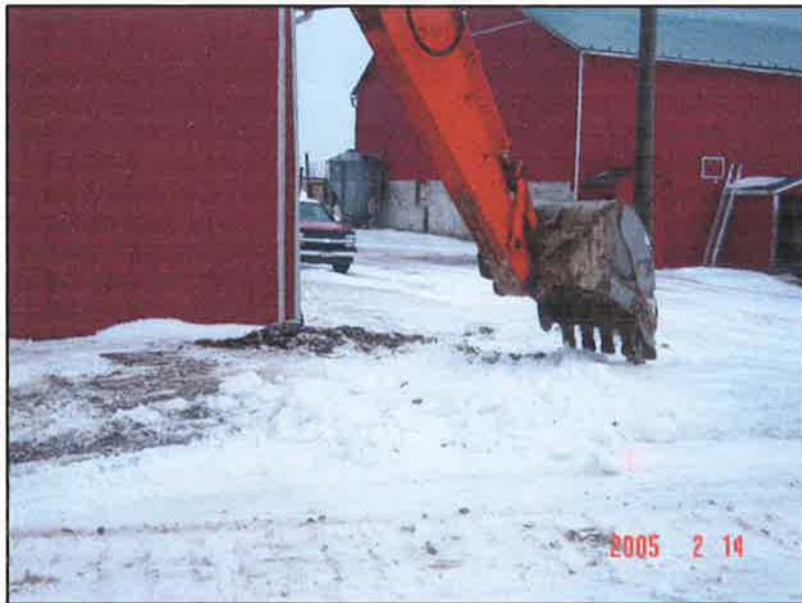
Photo 1
Location of former UST

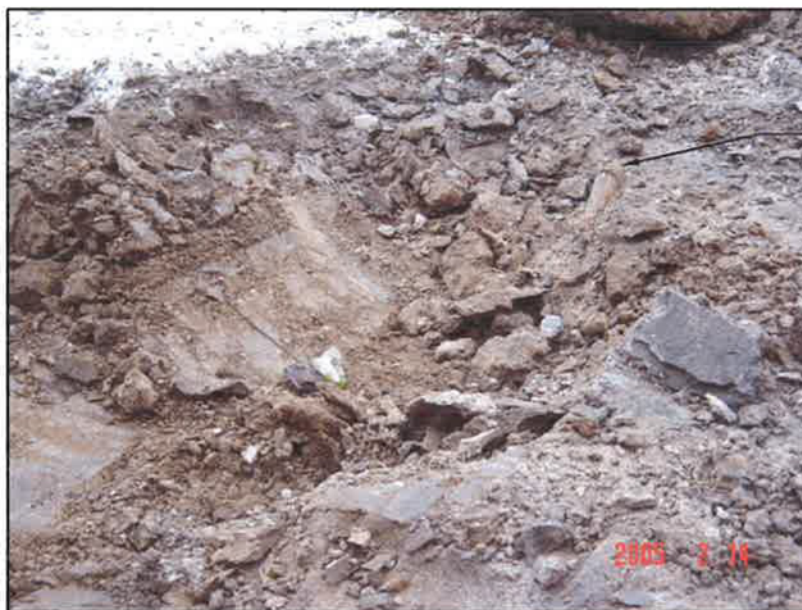
The filling pipe for the UST was found approximately 0.8 m bgs. A post and cement block presumed to be the anchoring mechanism for the UST were uncovered at approximately 1.2 m bgs. Neither the fill pipe nor the post and cement block had any hydrocarbon odour. A disused steel water line was uncovered at approximately 1 m bgs. No other pipes or connections for the UST were found.

Photo 2
Fill pipe uncovered at 0.8 mbgs

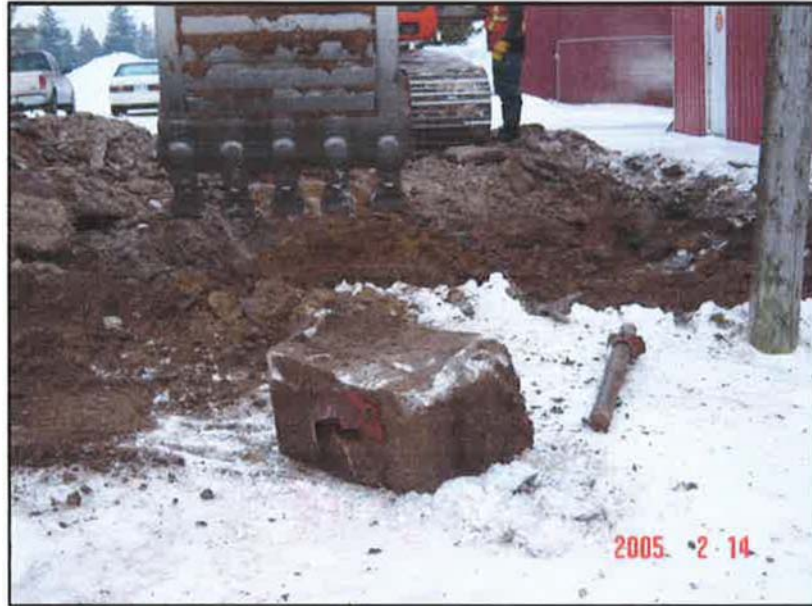
Photo 3
Concrete block and post uncovered at 1.2 mbgs

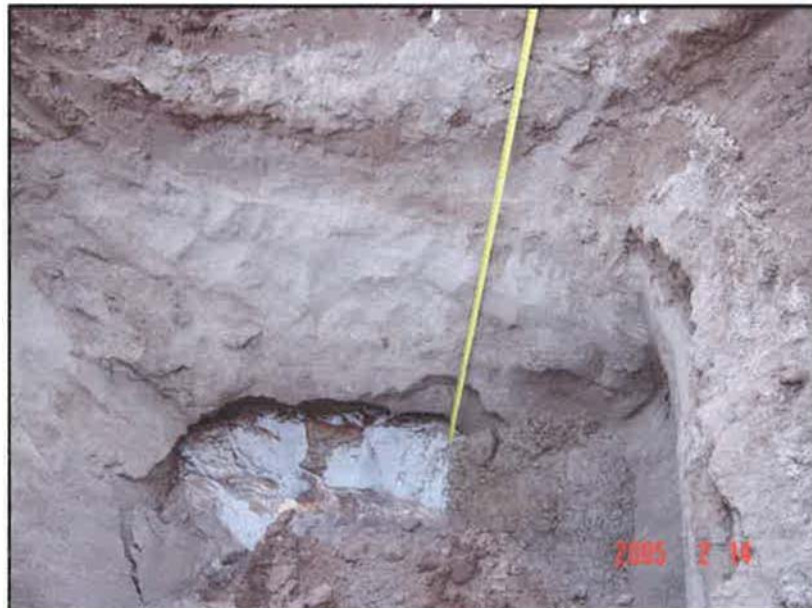
Excavation in the vicinity of the former UST on February 14, 2005 revealed a thin layer of gravel overlying clay till to a depth of 1.5 m bgs. Below this, the soil consists of medium to fine brown sand, becoming coarser with depth. At the bottom of the excavation some gravel sized stones to cobbles were observed. The final depth of the excavation was 3.2 m bgs. The excavation was approximately 2.6 m by 2.3 m in size.

Photo 4
Northeast wall of excavation

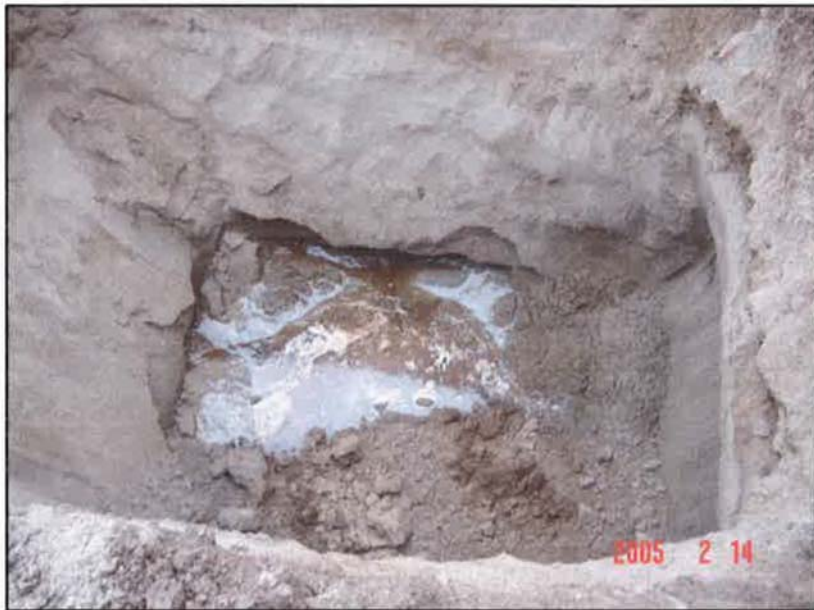
The maximum depth of the excavation was 3.2 m bgs and the water table was encountered at 2.8 mbgs. The groundwater that entered the excavation appeared to have high iron content. No oily sheen was visible on the surface of the water. No visible evidence of hydrocarbon impacts to the soil or groundwater was observed.

Photo 5
Bottom of excavation
Water table intersected at 2.8 mbgs
