HERITAGE IMPACT ASSESSMENT

Phase II

19 East Mill Street,
Elora, ON

March 21, 2023

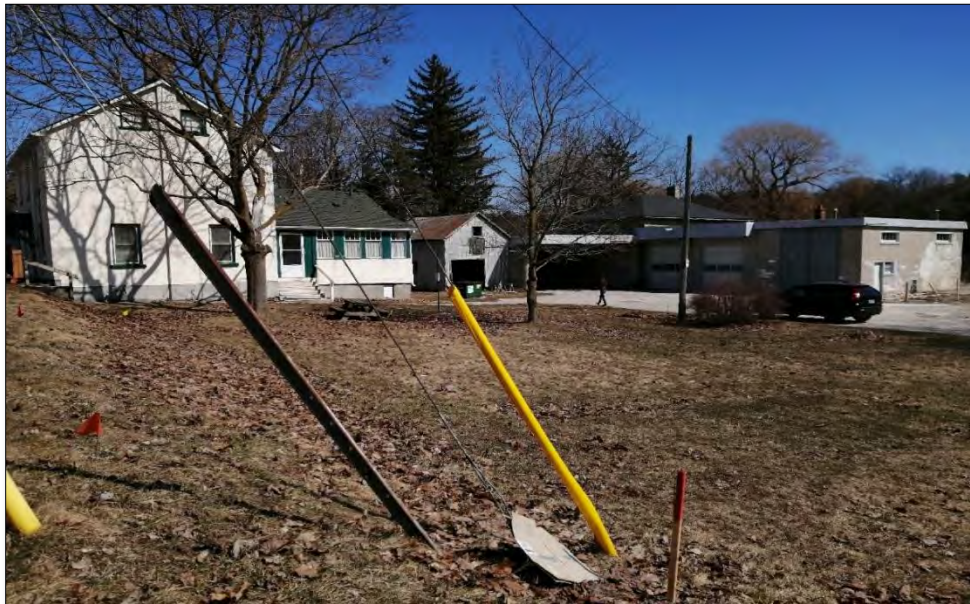
Figures 1 & 2: (above) Aerial view of subject property and surrounding properties; approximate location of subject property in red (Source: MHBC, 2021); (below) Perspective view of dwelling located on the subject property (Source: MHBC, 2021).

The existing dwelling is clad in stucco with an open gable roof and foundation covered with Portland cement. The front façade includes five window openings with centred entryway with gabled overhang. There are four window openings on the south elevation and three on the north elevation. There is a rear addition that includes a gallery of windows on the south elevation and entryway. The addition has an open gabled roof and concrete foundation. See Figures 11-14 for corresponding photographs.

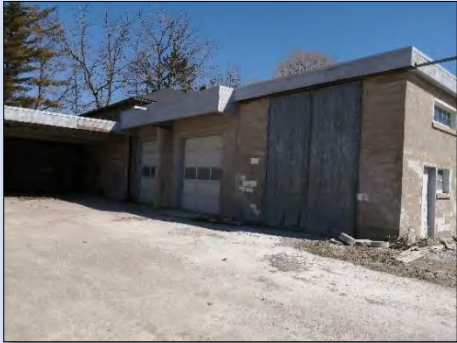
<p>Commercial building complex composed of a 2 storey limestone/ rubble stone building constructed circa 1859 with a hipped roofline. The stone building includes mid-century additions on the north (carport) and west elevations with flat/ platform rooflines.</p>
<p>Outbuilding 2</p>  	<p>1 ½ storey outbuilding built at grade with open gabled roof and clad in metal sheathing.</p>

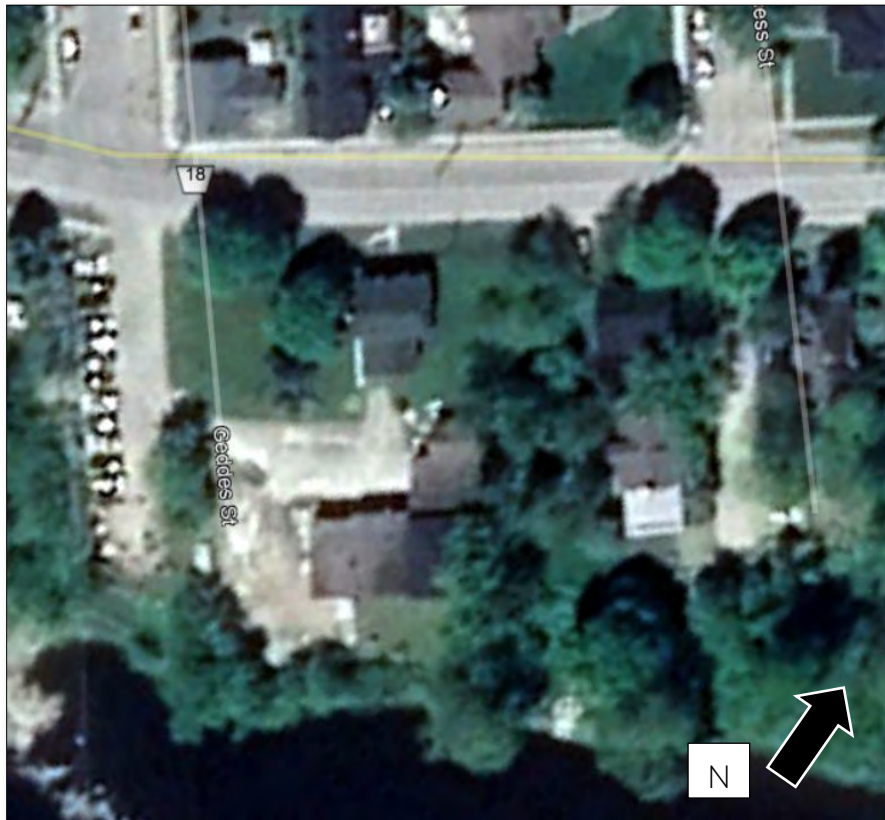
Figure 9: Aerial photograph of 19 East Mill Street (Source: Google Earth Pro, 2020)

The property includes a two storey house clad in stucco, a one and a half storey metal outbuilding, a two storey stone building with later concrete additions (see Figures 9 & 10). There is a driveway and open gravelled space on the south west corner of the property and the property abuts the Grand River to the south. A site visit occurred on March 19th, 2021 to document the existing buildings and structures on-site.

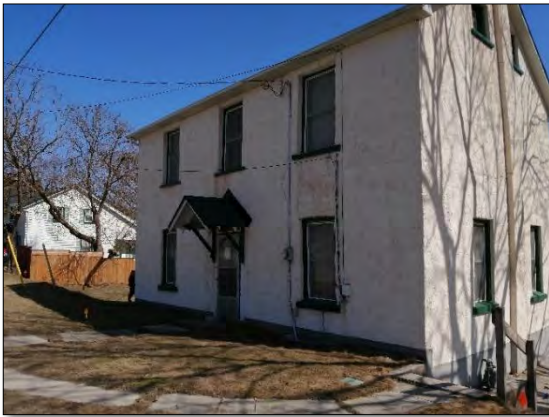
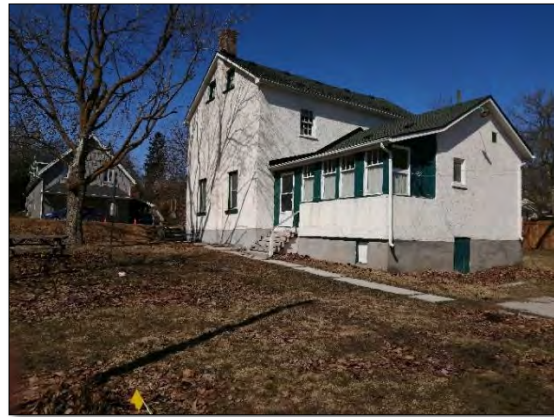
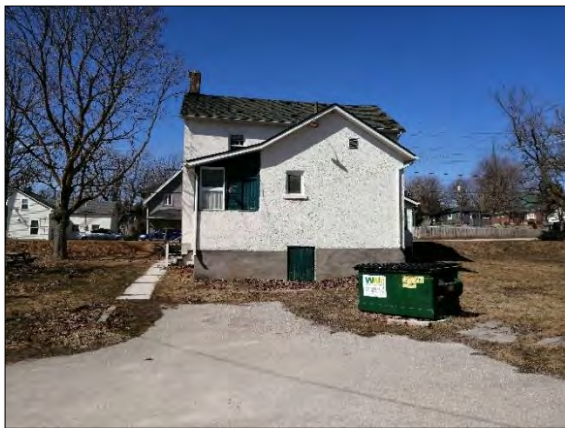
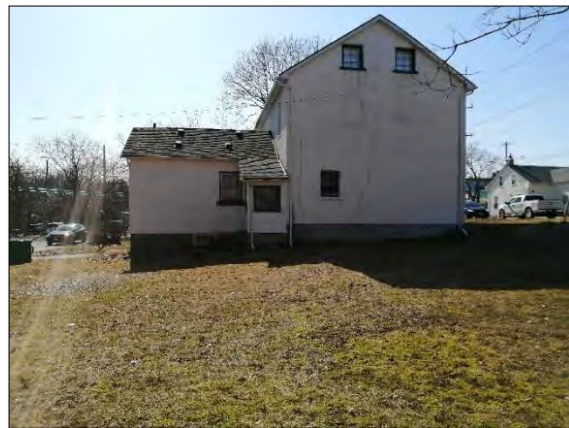
Figures 11, 12, 13 & 14 (above left) View of front façade of the dwelling; (above right) View of south and east elevation; (below left) View of east elevation of dwelling with view of rear addition; (below right) View of north elevation and rear addition (Source: MHBC, 2021).

¹ Note that the dwelling will be removed due to structural issues discussed in the Phase I HIA.

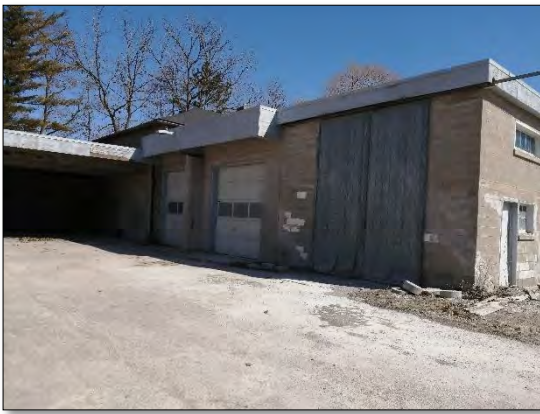
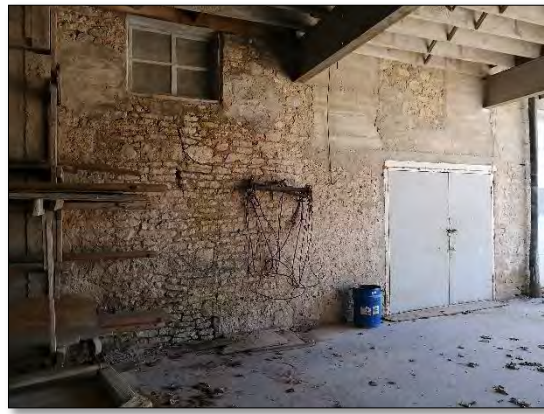
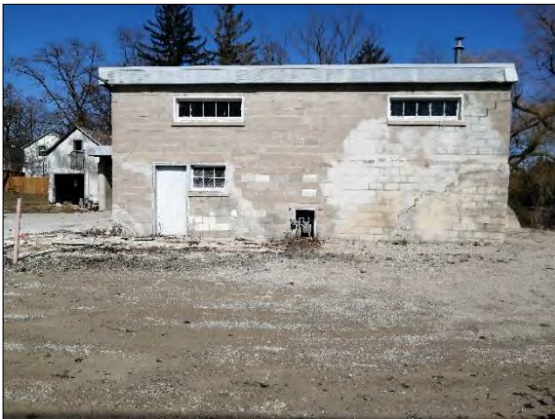
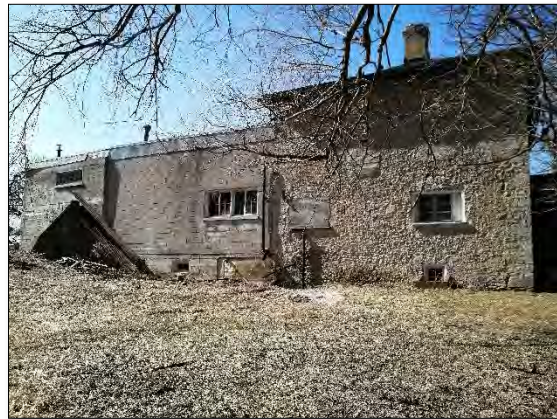
There is a two storey, rubble stone building located on the north-east corner of the property with a hipped roof with a brick chimney. Some original window openings appear on the north, east and west elevations. A two-storey, mid-century cinder block addition was made to the south of the stone building with a platform roof. Attached to the western elevation of the stone building is a cinder block shelter/ carport; it appears that this structure is affixed to the stone building by means of steel beams. See Figures 15-18 for photographs of the exterior elevations.

Figures 15, 16, 17 & 18: (above left) View of cinder block addition to stone building looking north-east; (above right) View of shelter affixed to west elevation of stone building; (below left) View of south elevation of cinder block addition; (below right) View of east elevation including cinder block addition and stone building (Source: MHBC, 2021).

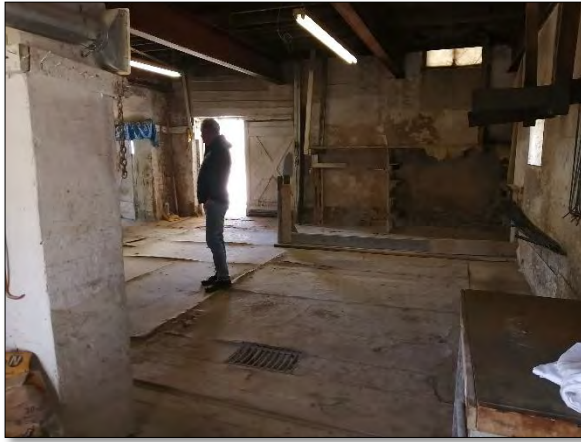
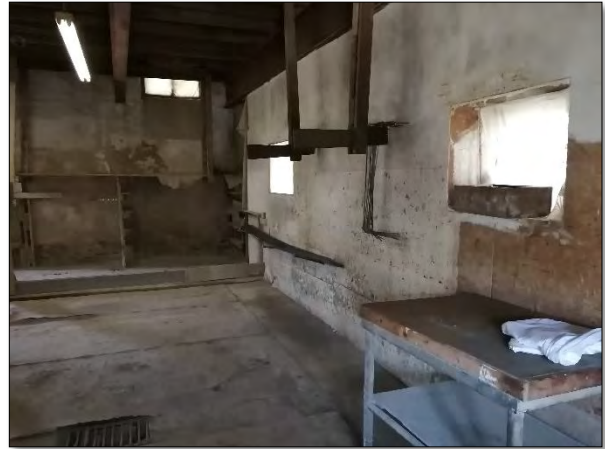
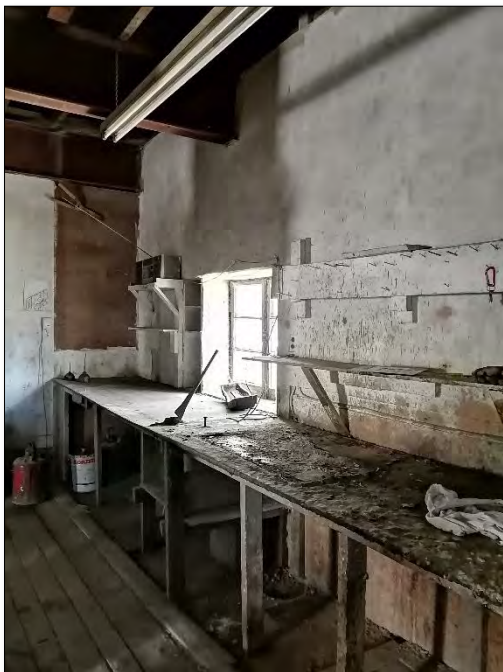
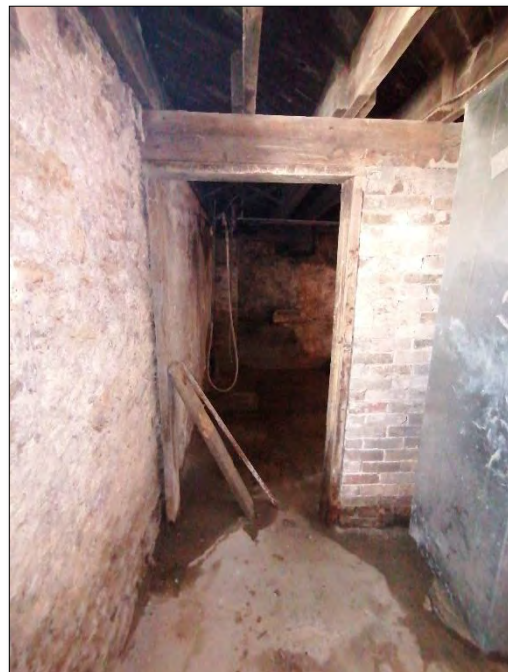
Section 'A' of the building is the original c. 1859 stone outbuilding that was formerly used as a brewery and for storage for the mill which no longer exists. The interior of the stone building located on the north-east corner of the property includes two floors and basement level. The main floor includes a workshop area including the equipment used to manufacture burial vaults (i.e. chute to direct concrete for moulds and protruding hooks presumably to hold a vault). There are brick column supports and walls on all levels of the building. The basement includes a chute likely used for pouring concrete; the basement is connected to the basement of the

addition. The second storey level is an open space; there are indications that the exterior walls were heightened over the years and are not level leaving some significant gaps between the roof line and walls. There is some historic graffiti along the walls on this level.

Figures 19, 20, 21 & 22: (above left) View of main floor of stone building looking south-west towards building section 'C'; (above right) View of apparatus used for the manufacturing of burial vaults affixed to the north elevation of stone building on main level; (below left) View of workshop area on main floor looking north-east; (below right) View of brick partition wall in basement of stone building (Source: MHBC, 2021).

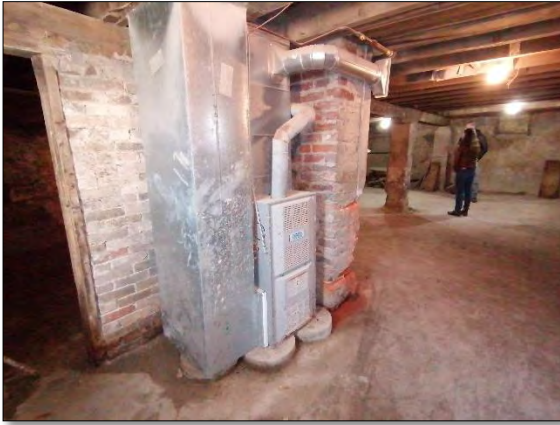
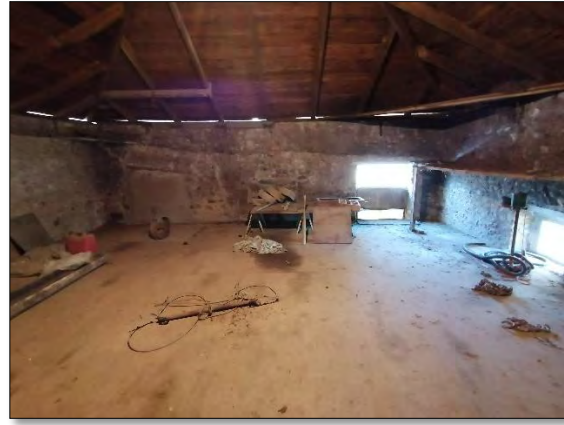
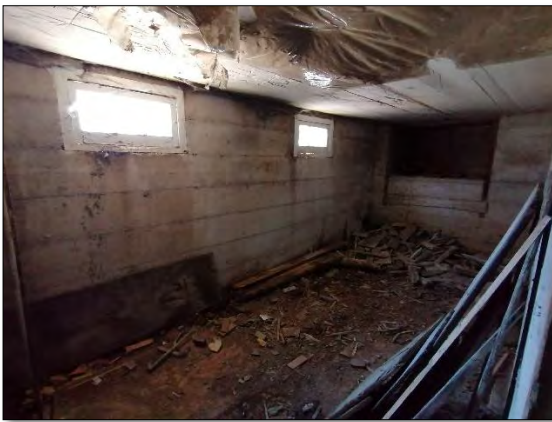
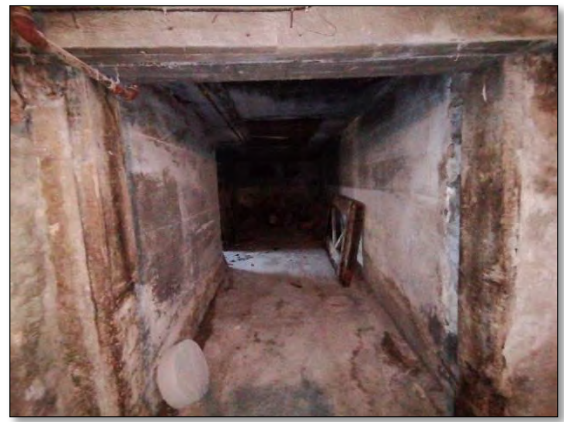
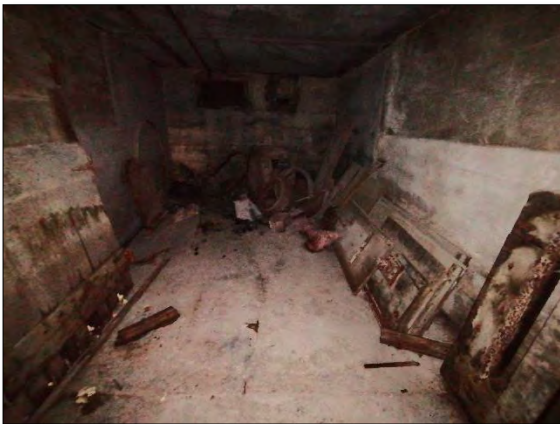
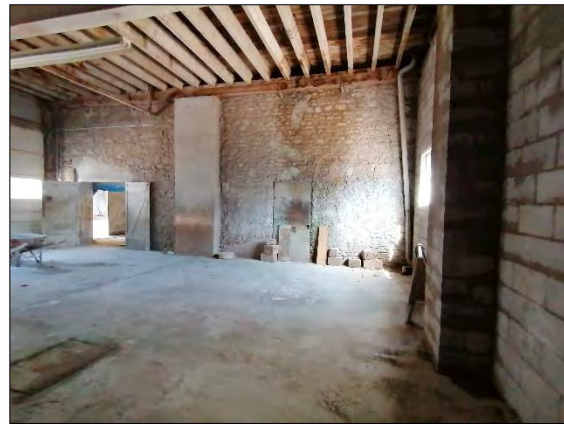
Figures 23, 24, 25, 26, 27 & 28: (above left) View of basement level; (above right) View of top floor of rubble stone building; (middle left) View of concrete basement of mid-century addition; (middle right) View of hallway in basement of building looking towards later addition; (below left) View of storage area in lower level of building to store material used for production of burial vaults; (below right) View of interior of later mid-century addition (Source: MHBC, 2021).

A Building Condition Assessment was completed by Tacoma Engineers on March 14, 2023; the assessment concluded the following:

Based on our site assessment and subsequent analysis, we are of the opinion that the stone building is in fair condition and restoration is likely practical and feasible.

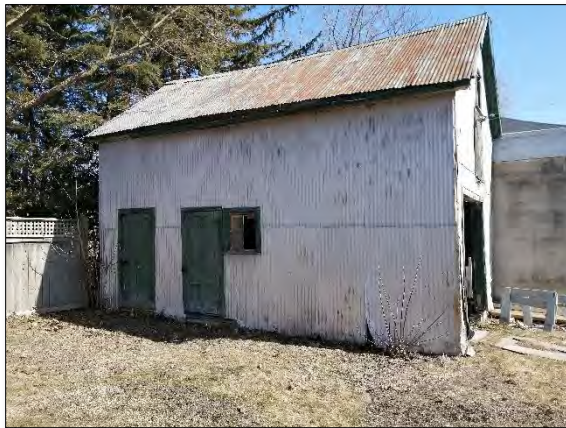
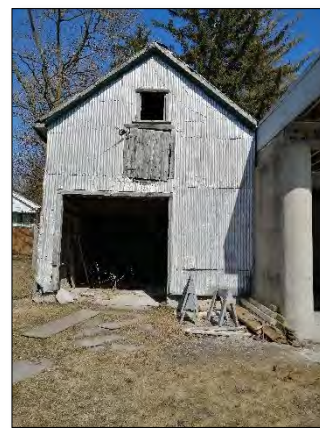
There is a one and half storey outbuilding wood frame building clad in metal sheathing with an open gabled, metal roof located on the north side of the property. There are two door entries on the west elevation, vehicular entrance on south elevation (see Figures 29 & 30).

Figures 29 & 30: (left) View of west elevation of outbuilding looking north-east; (right) View of south elevation of outbuilding looking north (Source: MHBC, 2021).

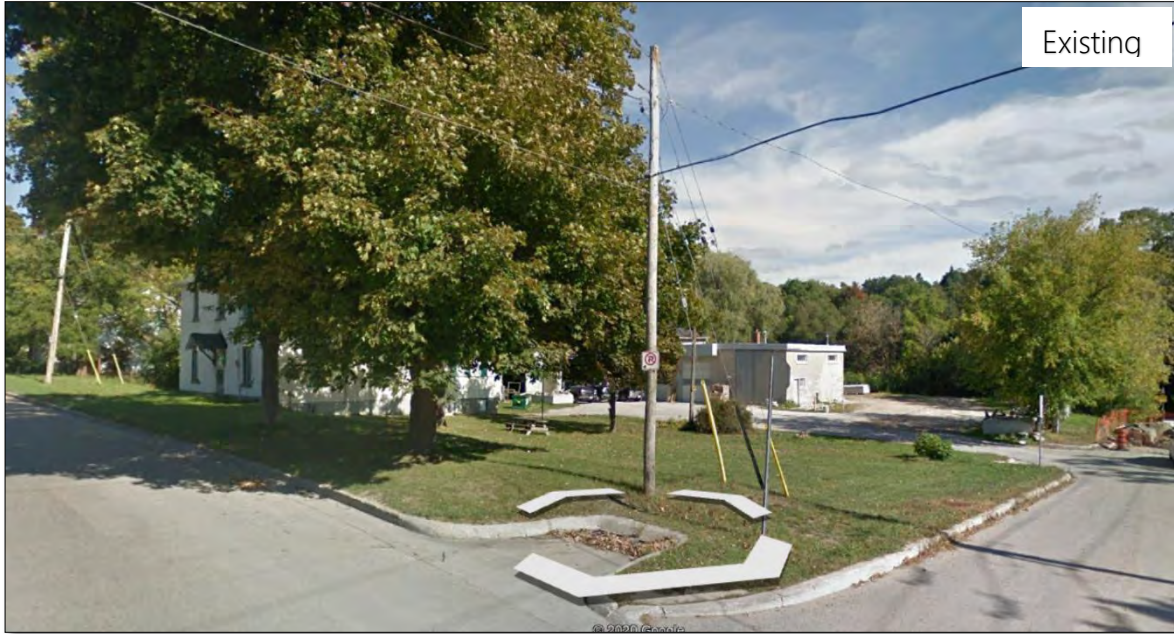
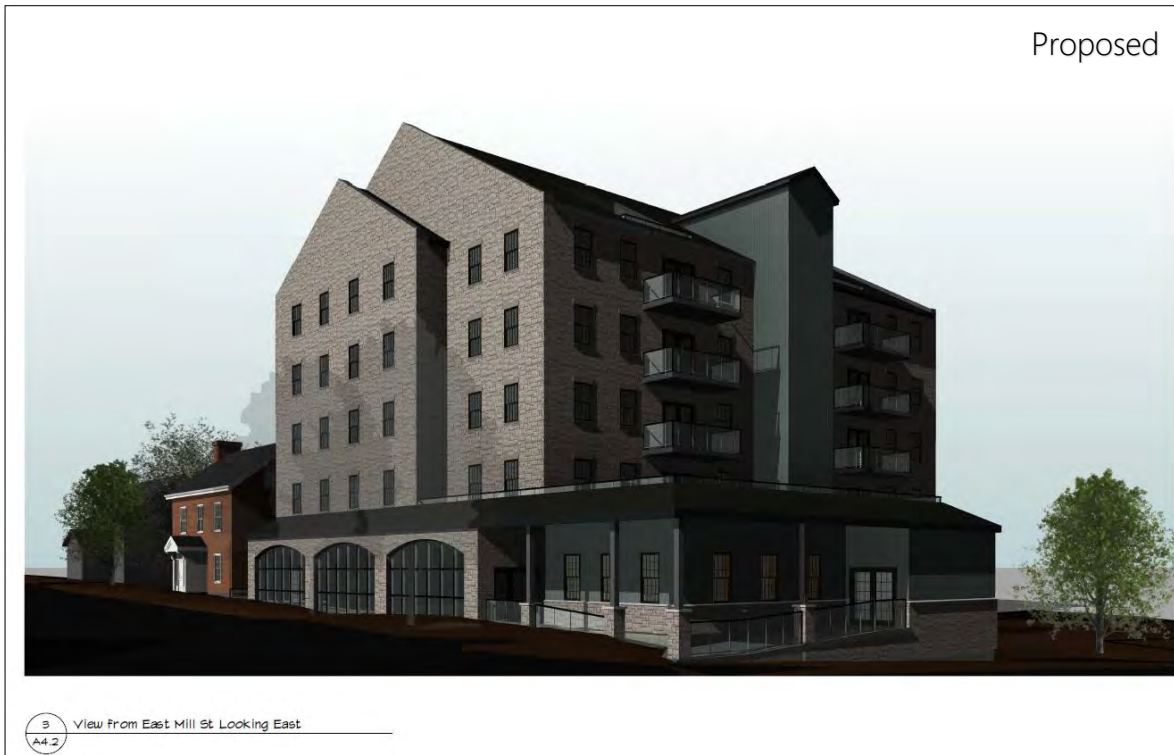
Figures 34 & 35: (above) Existing view from the intersection of East Mill Street and Geddes Street (Source: Google Earth Pro, 2020); (below) Proposed view from the intersection of East Mill Street and Geddes Street post redevelopment (Source: Fryett Turner Architects Inc., 2023).

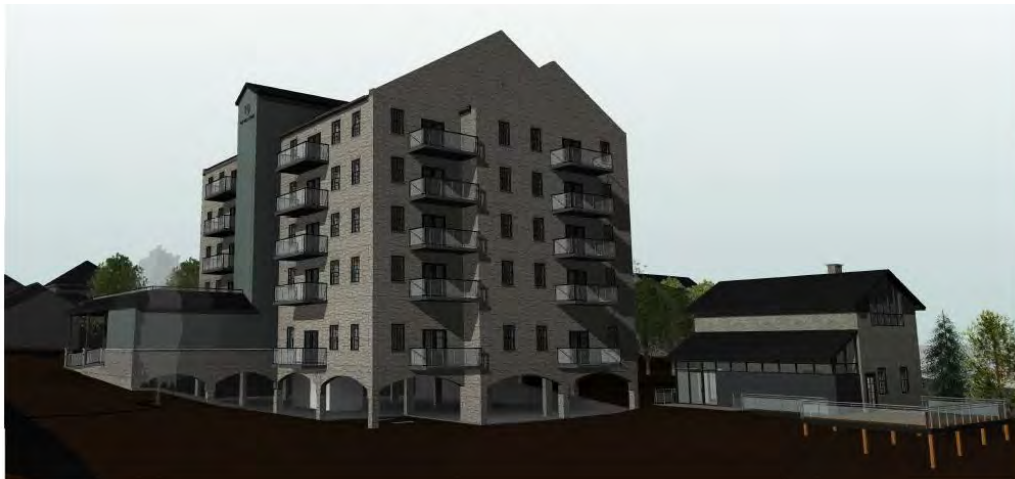
Figure 38: View looking north-east towards East Mill Street showing the rehabilitation of the historic stone building (Source: Fryett Turner Architects Inc., 2023).

- Removal of later concrete additions made to the north and west elevation;
- Removal of existing roof structure and replacement with a new roof structure which requires removal of some of the built heritage fabric to install the proposed fenestration on the south elevation;

- Patio deck added to the south and west elevation (self-supportive and does not require attachment to the original building fabric)
- Update interior structure including the construction of partition walls (for washrooms, kitchen, etc); and,

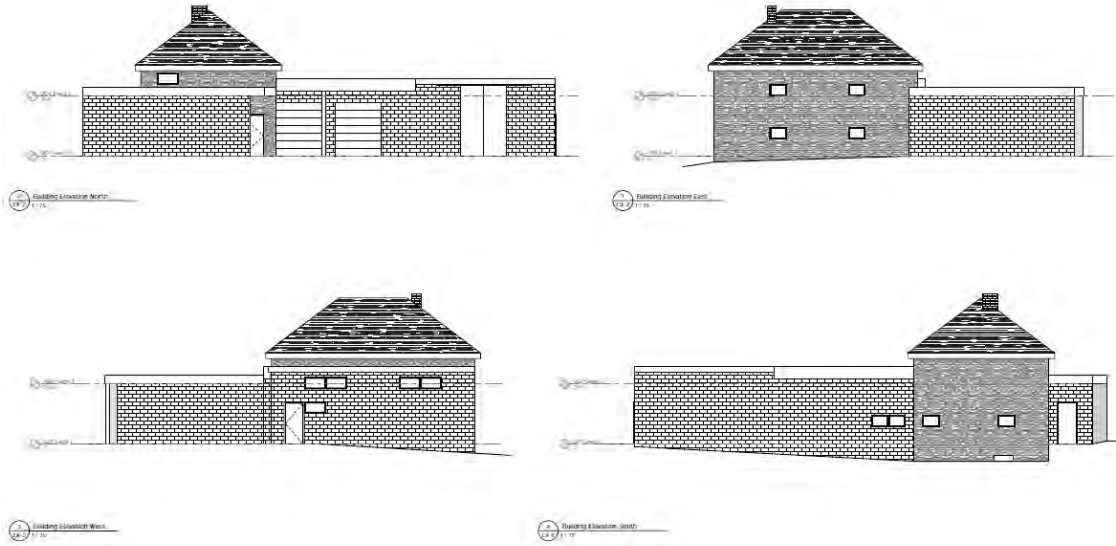
Existing Drawings

Figures 39 & 40: (above) Existing architectural drawings of historic stone building; (below) Proposed elevations of existing stone building on-site (Source: Fryett Turner Architects Inc., 2023).

Architectural drawings of the existing historic stone building are found in **Appendix 'E'** of this report for future reference to inform conservation measures.

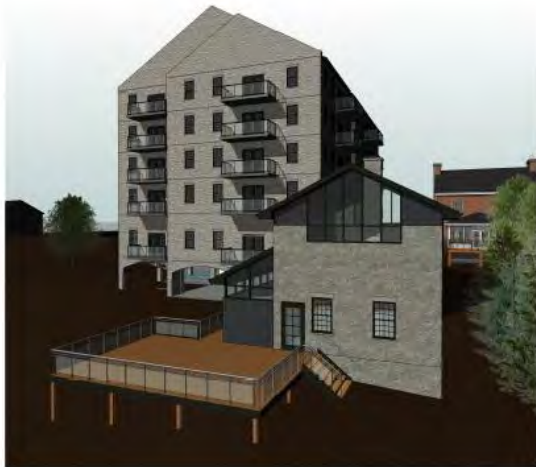
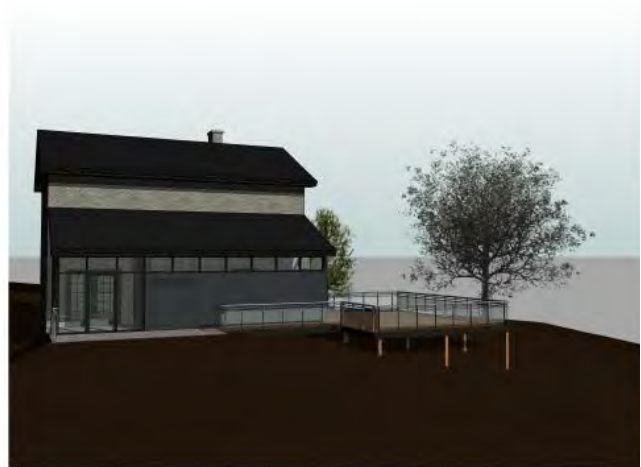
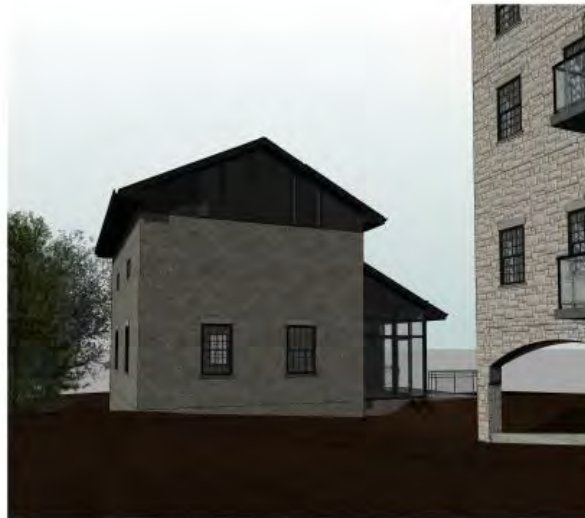
Figures 41, 42, & 43: (above left) Proposed south and part of the west elevation of the historic stone building; (above right) Proposed west elevation of the historic stone building with deck patio; (below) View of north elevation (Source: Fryett Turner Architects Inc., 2023).

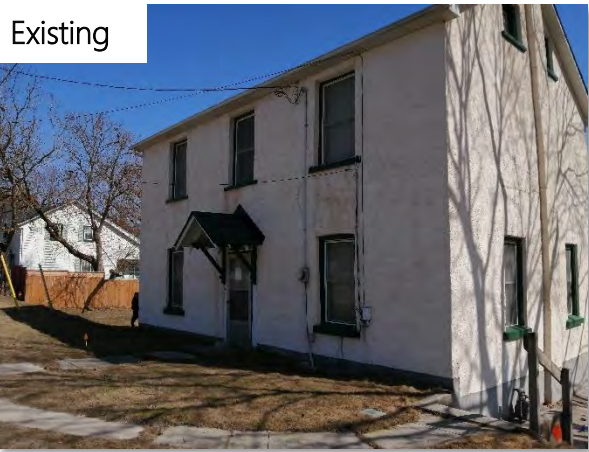
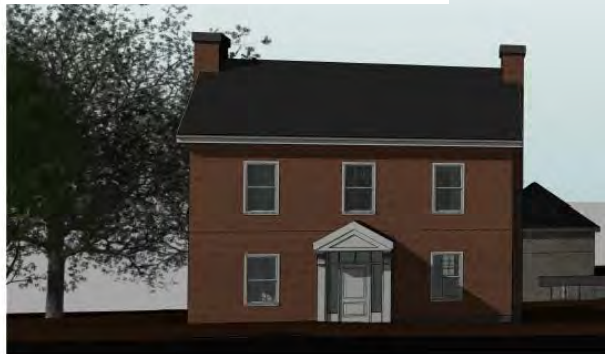
1 View from East Mill St. looking South
A.S. 2

The existing dwelling on-site will be removed and replaced with a two storey brick single detached dwelling. The new dwelling also includes a rear addition and deck patio. The new building is designed to be of a similar scale and mass of the original building on-site and mimics elements of the Georgian architectural style including the symmetrical layout of the window and door openings, the dual chimneys and neo-classical inspired portico entryway. The materials that are proposed are clay brick, wood siding and a steel roof.

Figures 44 & 45: Grayscale rendering of proposed development (Source: Fryett Turner Architects Inc., 2023).

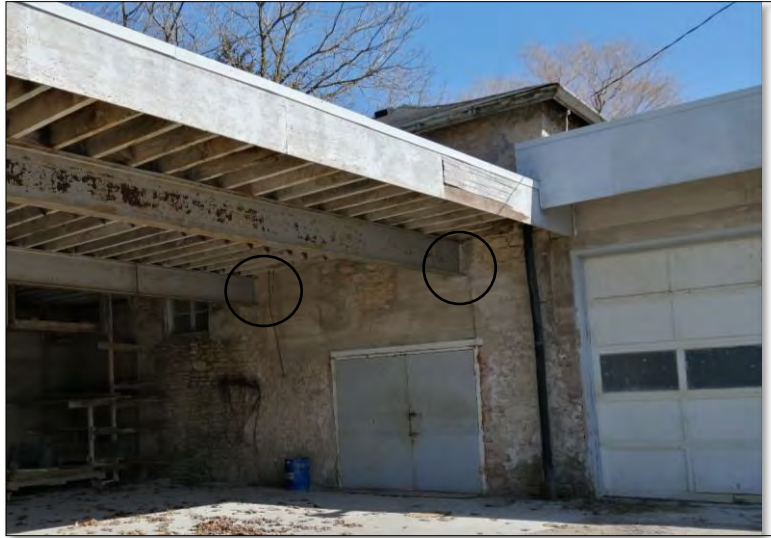
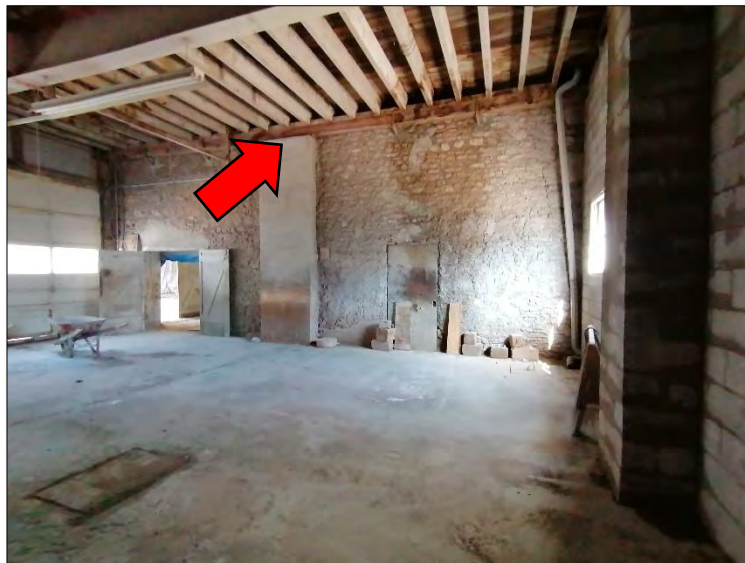
Figures 49 & 50: (above) View of north elevation of historic stone building (Building B) showing concrete carport and location of steel beams on this elevation; (below) View of attachment of western addition to historic stone building (Building B) (Source: MHBC, 2021).

The existing stone building on-site has been identified as a 'good candidate for rehabilitation' by the project's heritage engineer (Tacoma Engineers, 2023). In order to rehabilitate the building to function as a restaurant, there will be required alterations to the building including partition walls for washroom facilities and a new addition along the west elevation to include the proposed kitchen and associated equipment. The building also requires a new roof as the current roof is in poor condition. There is a deck/ patio proposed for the south elevation, however, this is intended to be self-supportive and not require physical attachment to the historic building fabric.

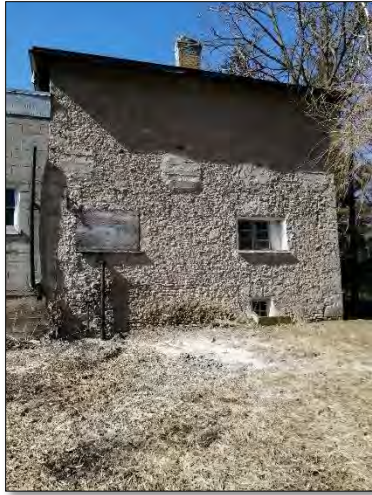
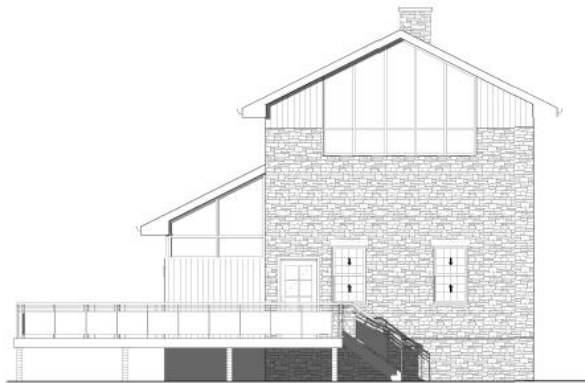
Figures 51 & 52: View of south elevation of existing original stone building (Building B) (Source: MHBC, 2021).

Existing window and door openings on the north and south elevation will be enclosed and two (2) new window openings will be inserted on the north elevation and two (2) new window openings will be inserted on the south elevation with the addition of door entry opening (see Figures 51 & 52). These window openings and windows are intended to be double hung, 6 x 4 windows with stone lintels and sills to be sympathetic to the architecture of the building.

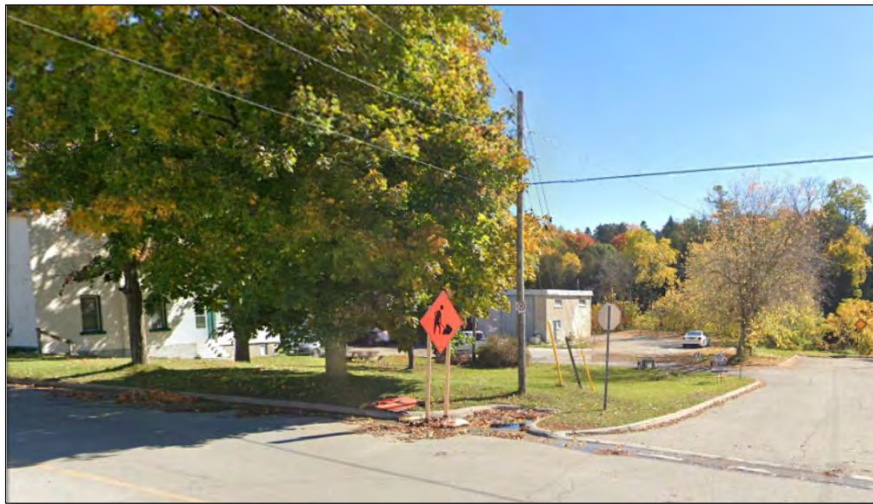
Figures 53 & 54: (above) Rendering of proposed development (Source: ABA Architects, 2022); (below) Streetscape view at the intersection of East Mill Street and Geddes Street (Google Earth Pro, 2021).

The proposed new five storey building will indirectly obstruct some existing views of the historic stone building (Building B), however, the building has historically been obstructed from view, particularly from the East Mill Street streetscape due to its location, vegetation and the existing dwelling on-site (see Figures 53 & 54). The proposed development maintains views of the Grand River. A landscape plan should incorporate pedestrian circulation that is cognisant of the views of the Heritage River.

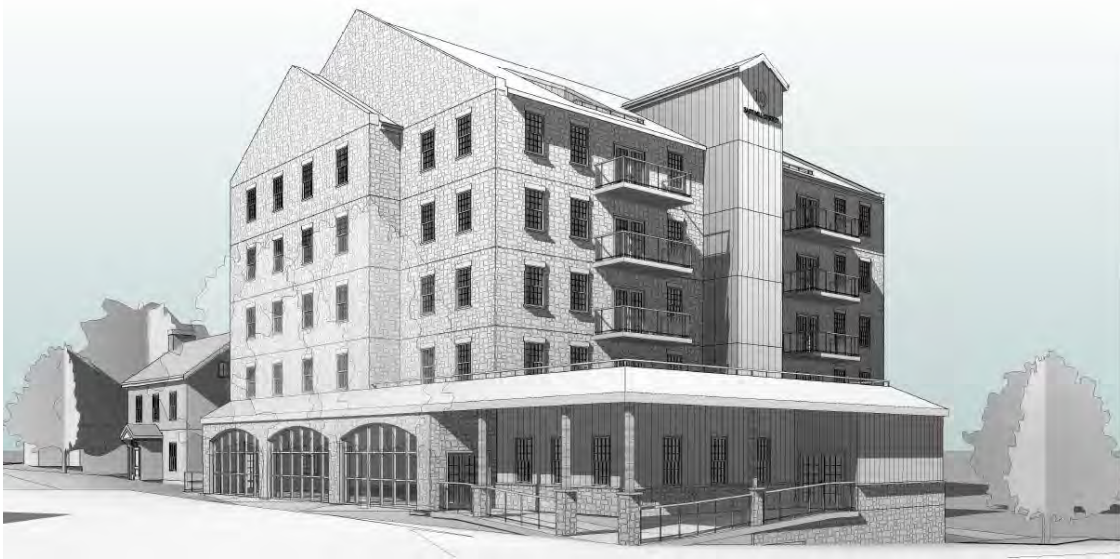
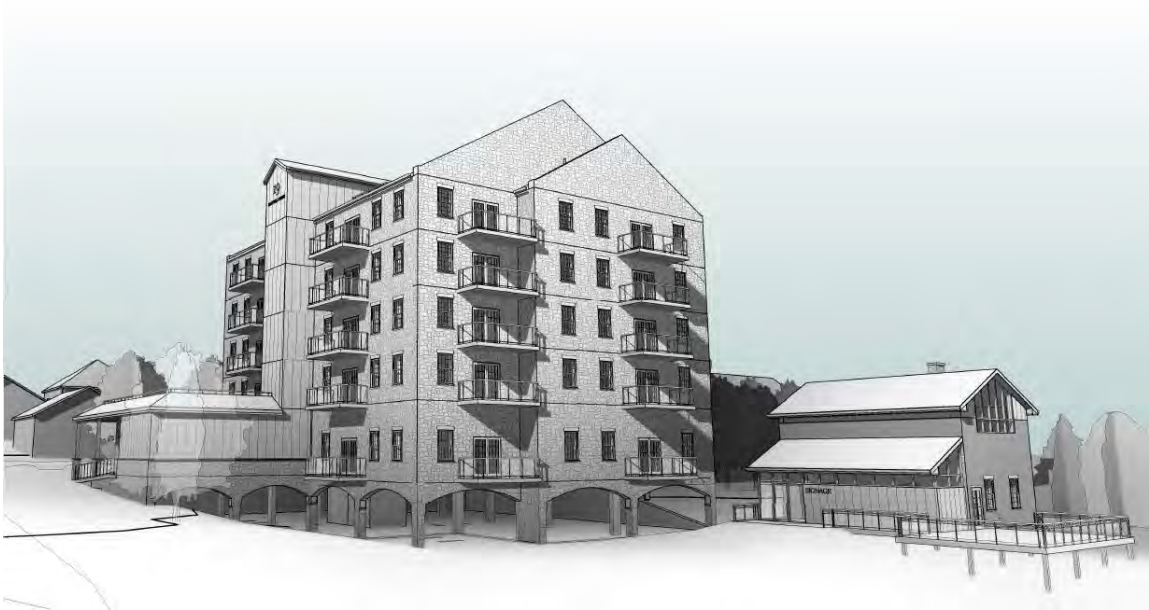
Figures 60 & 61: (above) Greyscale rendering of proposed development looking south-east along East Mill Street; (below) Greyscale rendering of proposed development looking north-east at the intersection of East Mill Street and Geddes Street (Source: Fryett Turner Architects, March 2023).

Table 6.0 Elements of Successful Infill	
<p>Setback and Orientation</p>	<p>The proposed mixed use building (Building 'A') has a 0 metre setback, however, this is consistent with the downtown commercial buildings in the historical core. The building is oriented to both East Mill Street and Geddes Street. The proposed dwelling (Building 'C') retains the same setback and orientation as the house that historically was situated on the property.</p> <p>See Table 7.0 for proposed setbacks and Figure 58.</p>
<p>Scale, Proportion, Rhythm</p>	<p>The proposed mixed use building (Building 'A') is of a greater scale than the residential area, however, is more consistent with historic commercial and uses its scale to capitalize the corner of Geddes and East Mill Street. The proportions and rhythm of the building is inspired by the local, historic industrial buildings. Window openings are consistent with rhythm of local buildings as well as their proportion (see Figures 60 & 61).</p> <p>The proposed dwelling (Building 'C') is representative of the former heritage dwelling in scale, proportion and rhythm.</p> <p>See Figures 60 and 61 for streetscape renderings.</p>

<p>Massing and Height</p>	<p>The proposed mixed use building (Building 'A') is of a larger mass and height of the surrounding area, however, minimally. Commercial buildings in Elora range from 1 to 3 storeys in height and the building is proposed to be 5 storeys. There is the use of stepbacks after the first storey which allows the building to be read at a lesser height along the streetscape. There is a variety of building projections to 'break up' the massing of the building which is emphasized by the use of a variety of materials.</p> <p>The proposed dwelling (Building 'C') is of the same massing and height as the former heritage house.</p>
<p>Materials, Colour, Roof Shape, Detail and Ornamentation</p>	<p>The materials, colour, roof shape, details and ornamentation of the mixed use building (Building 'A') is inspired by the local industrial architecture, particularly that of the mill industry. Materials include: stone veneer, board and batten, and metal (see Figure 59). The first floor includes emblematic large, industrial windows and the window openings for the remainder of the building are consistent</p>

<p>with what is observed in the local area, particularly, those of stone buildings. There is a lean-to roof on the first level fronting the intersection of Geddes and East Mill Street which transitions to the other building sections which both have medium-pitched gabled rooflines with coping along the stone building portions and an extended open gabled roofline for the board and batten building projection. The overall development uses a neutral colour palate and includes details, particularly fenestrations that are sympathetic to the 19th and early 20th century properties that are noted as attributes of the CHL.</p> <p>It is encouraged that there be more design consideration for the north elevation of the historic stone building as it faces East Mill Street and the public realm. The proposed new dwelling also requires more design articulation to ensure that it is legible from historic buildings and avoids pseudo-heritage construction.</p>

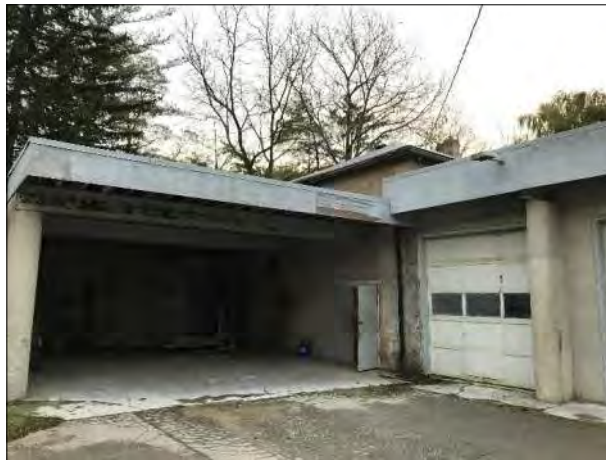
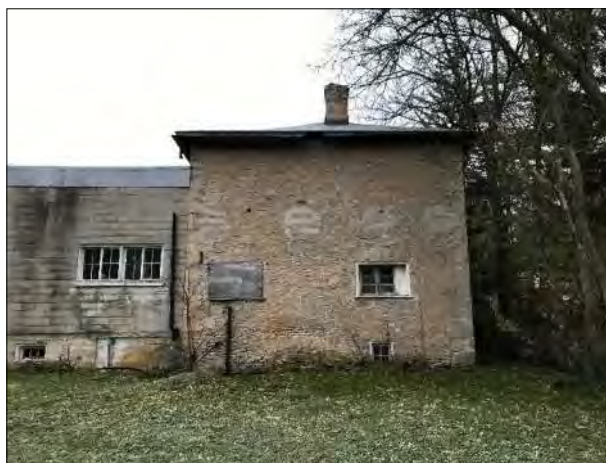
Tacoma Engineers has been retained by Oxford Green Developments to complete a building condition assessment of the existing stone buildings and attached additions located at 19 Mill Street East, Elora. Front and rear elevations illustrated below. The purpose of this assessment was to determine the existing conditions and determine the feasibility of restoring, renovating or relocating the building as part of a large property development project. This report is based on site visits carried out by Will Teron, P.Eng. through the period of September 2012 to March 2023.

- Careful demolition of the existing concrete additions. This will include reinstatement of the original masonry walls where they were impacted by the now demolished portion of the building.
- Comprehensive masonry reinforcing including repointing and crack stitching with pure lime-based mortars. Replacement of previous concrete wall infill with stone construction is recommended.
- Replacement of the existing roof to satisfy modern code specified loads as well as insulation/ventilation requirements is recommended.
- General reinforcing of the main level floor framing to provide sufficient capacity to support restaurant or other assembly occupancies.
- Localized reinforcing of the upper level floor framing to address isolated deficiencies due to previous interventions.

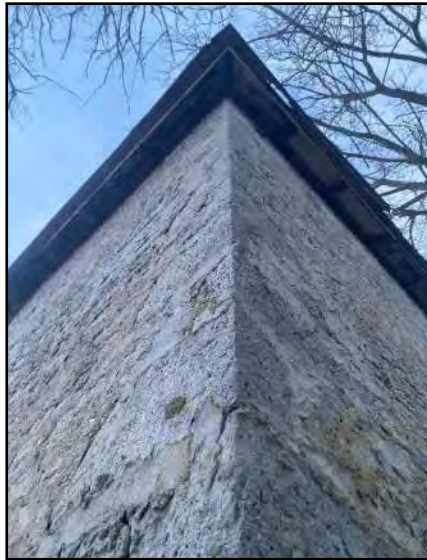
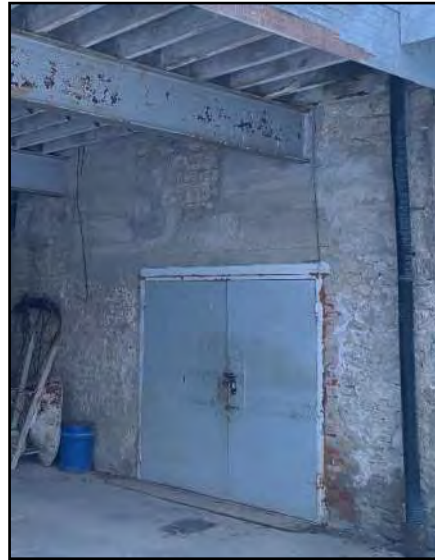
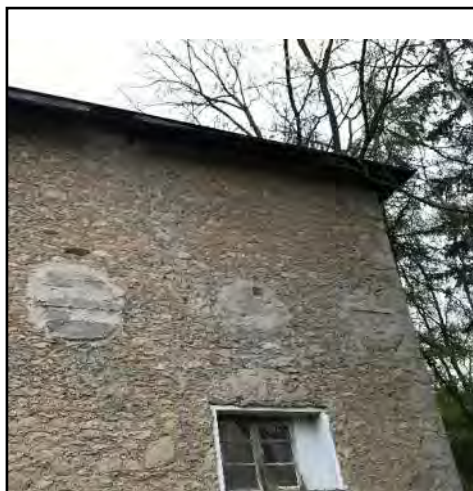
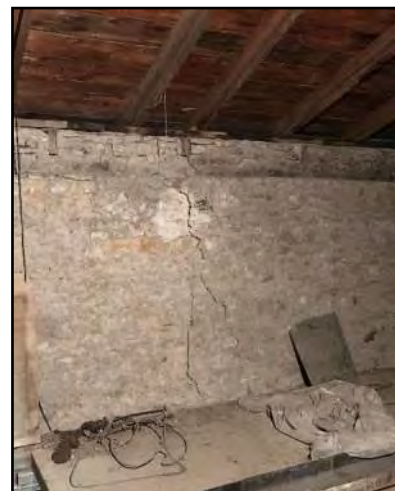
2. Exterior Walls: Overall, the exterior masonry walls are sound and structurally adequate to support future occupancies. As part of the redevelopment, we recommend a comprehensive repointing of the wall (interior and exterior) to address localized voids, mortar joint cracks and previous interventions. These interventions include numerous areas where previous windows/doors have been infilled with cast-in-place concrete – we assume that this concrete will be removed, and the openings infilled with mass masonry to match the original construction. All work to be completed with material compatible with the original historic fabric including lime mortars.

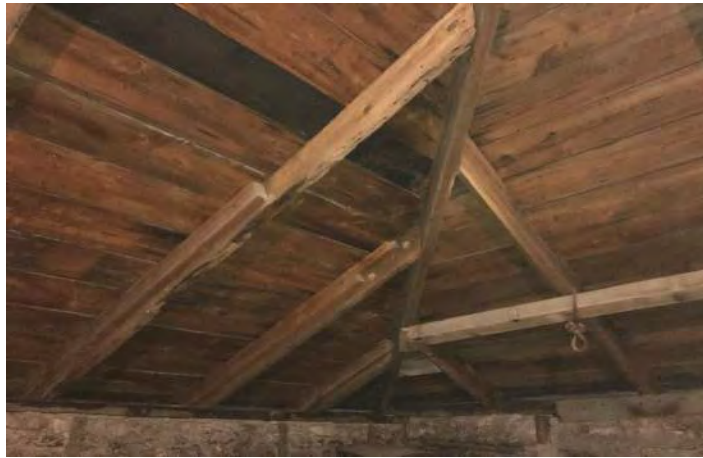
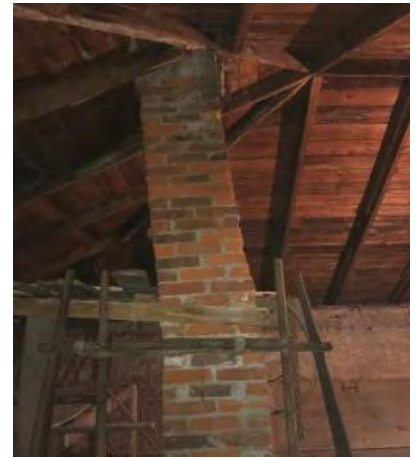
3. **Roof:** The existing roof structure, consisting of widely spaced 2x6 rafters and hips, is not structurally adequate to support the code specified loads. While the roof has not collapsed, our review identified deflection of the rafters, weakened joints and localized areas of wood decay. Concerns are amplified with the likely desire to insulate the roof structure. We recommend that the roof structure be replaced with a roof designed to resist the code specified snow loads for commercial occupancies and accommodate modern approaches to insulation and ventilation.

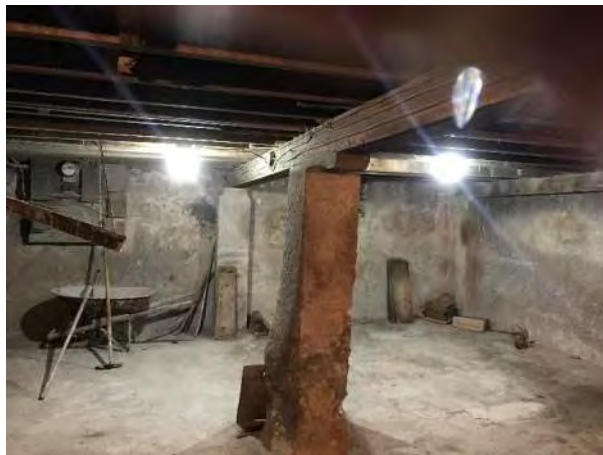
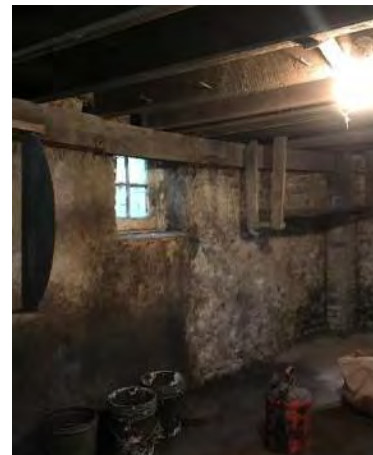
4. **Main Floor Level:** The main level floor framing (as seen from the basement) is in fair to good condition. While the joists appear to be performing adequately, the bearing conditions have excessive deflection. Given the building will be subject to a change of use to assembly occupancy, a detailed engineering analysis is required. Our preliminary analysis indicates that the joists have a capacity marginally less than required and the beam and bearing have capacity significantly less than required to support the proposed restaurant occupancy. Reinforcing of the joists, beams and bearing is likely required.

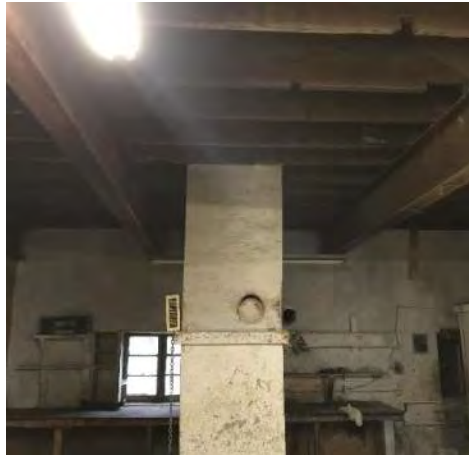
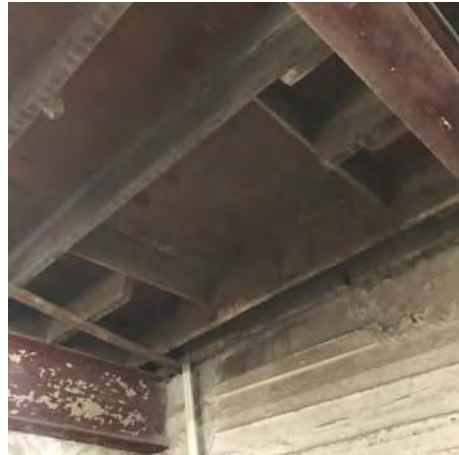
5. Upper Floor Level: The upper-level floor framing is similarly in fair to good conditions. The original 2x12 floor joists, where not subject to previous interventions, are sound and robust. Unfortunately, many floor joists have been cut, notched or otherwise modified to the point where they no longer have sufficient capacity to support specified loads. We recommend that those joists impacted be reinforced including adding extra members, adding headers and infill members. The wood floor joists are supported by 18" deep steel beams that span the full depth of the building (approximately 33'). Our preliminary analysis indicates that the beams are structurally adequate to support loads specified for restaurant occupancies. Based on this assessment, no significant structural remediation is required for the upper-level floor framing.

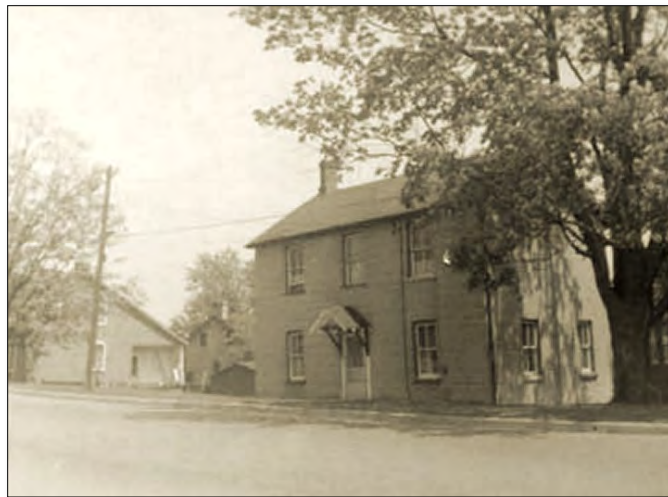
Figure 10: Photograph of house on subject property prior to stucco application c. 1963 (Source: Roberta Allan, Courtesy of the Wellington County Archives and Museum).

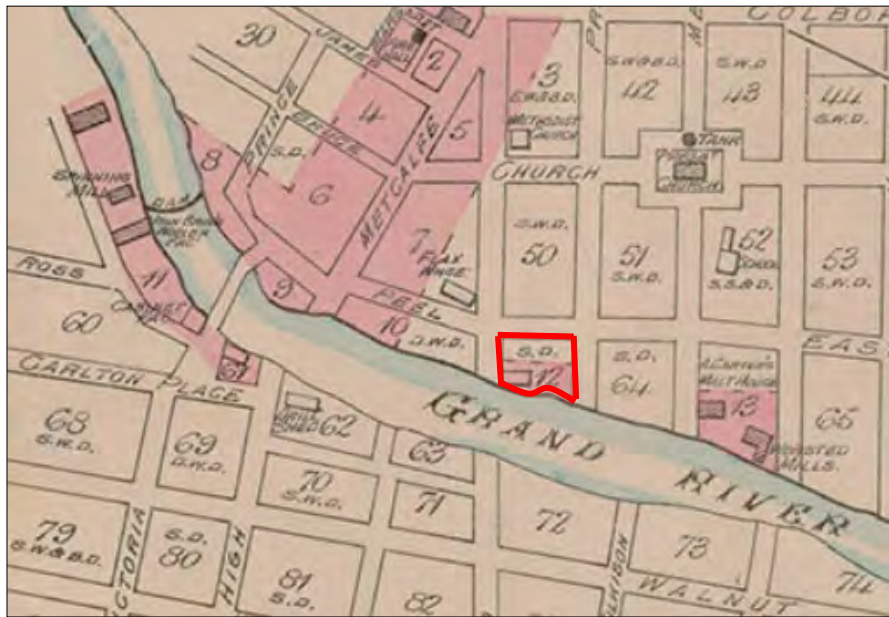
Figure 13: Excerpt of the 1890 Fire Insurance Plan of the Village of Elora; red boundary indicates block within which the subject property is located (Courtesy of the Wellington County Archives and Museum).

The 1890 revised 1894 Fire Insurance Plan indicates that the former flour and oatmeal mill was constructed mainly of stone as the existing stone building, which is identified as "Old and dilapidated" in the Plan.

The subject property is labelled 'S.D" in the 1890 Fire Insurance Plan which means 'Scattered Dwellings". Scattered dwellings that would have existed at the time of the Plan would include the house fronting East Mill Street on the subject property, and adjacent 23 East Mill Street and 14 Princess Street which continue to exist. The northern portion of the block is separated from that of the rear which includes the chopping mill and existing two storey stone building to the rear of the property.
