HERITAGE IMPACT ASSESSMENT

Phase II

19 East Mill Street,
Elora, ON

March 21, 2023

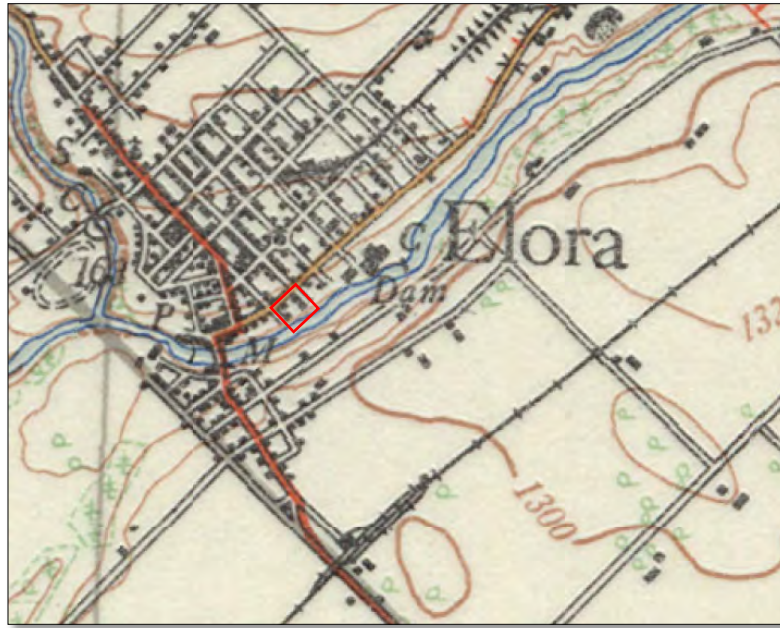
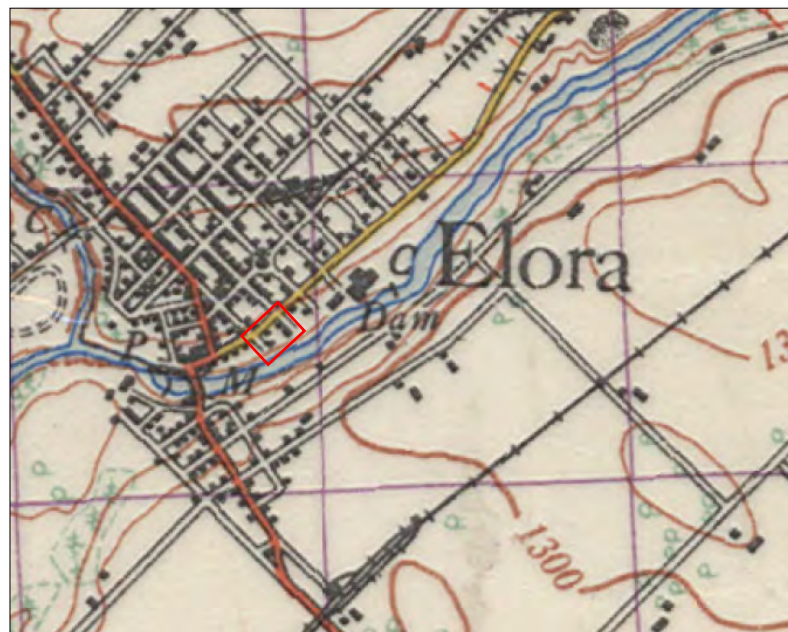
Topographic maps in the 1930s demonstrate that the chopping mill was still in existence and identified as a building on the subject property (see Figures 17 & 18). The existing dwelling on-site and adjacent houses are also represented on these maps. By 1944, five years after the latest topographic map shown on the following page, the former mill was identified as 'ruins' (Figure 19).

Figure 17 & 18: (above) Topographic map from 1935; red box identifying subject property and adjacent properties; (below) Topographic map from 1939; red box identifying subject property and adjacent properties (Source: Ontario Council of University Libraries Historical Topographic Map Digitization Project).

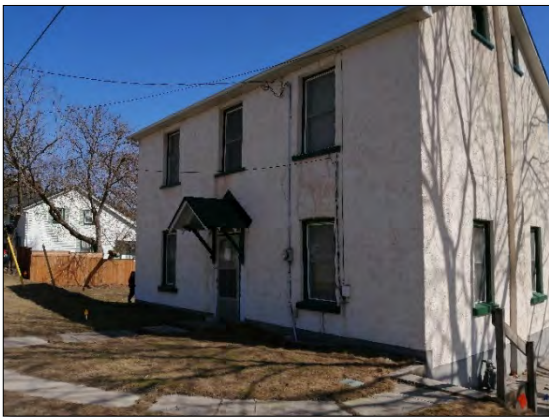
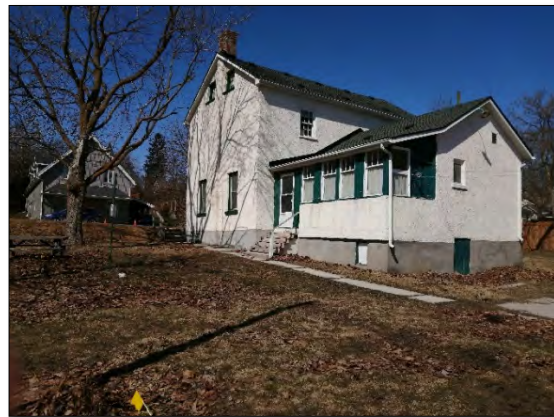
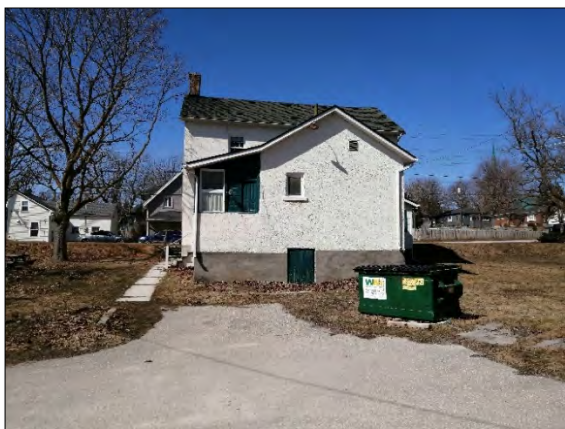
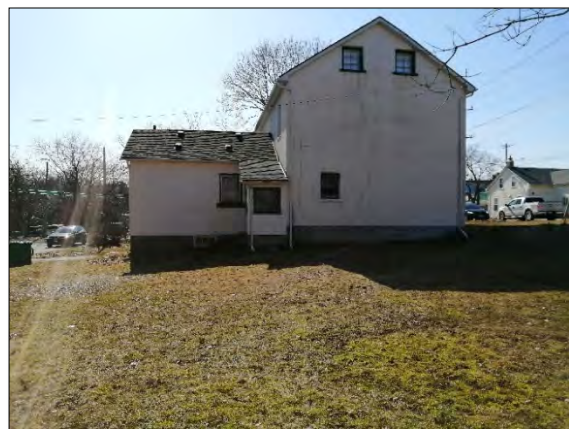
The house is clad in stucco with an open gable roof and foundation covered with Portland cement. The front façade includes five window openings with centred entryway with gabled overhang. There are four window openings on the south elevation and three on the north elevation. There is a rear addition that includes a gallery of windows on the south elevation and entryway. The addition has an open gabled roof and concrete foundation.

Figures 22, 23, 24 & 25: (above left) View of front façade of the house; (above right) View of south and east elevation; (below left) View of east elevation of house with view of rear addition; (below right) View of north elevation and rear addition (Source: MHBC, 2021).

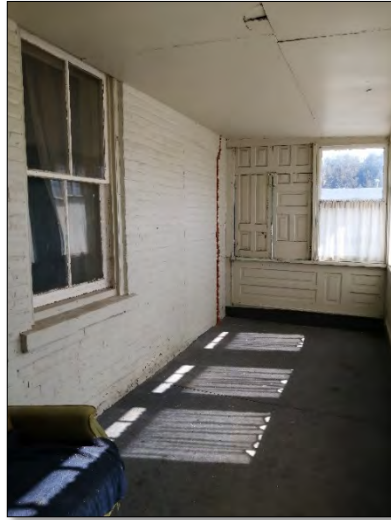
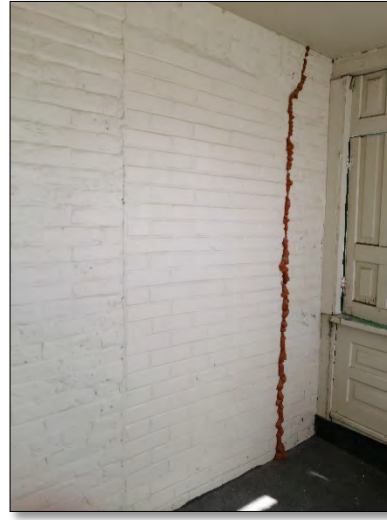
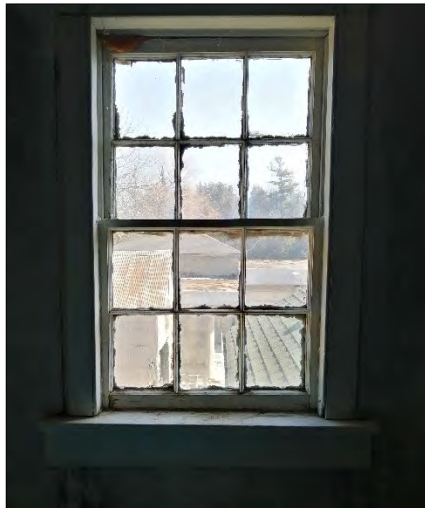
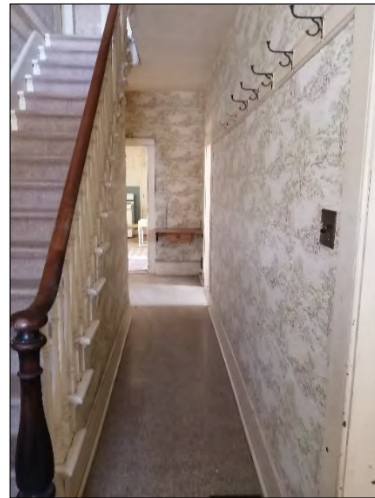
There is wood trim throughout the house including baseboards, door and window trim. The rear addition exposes the original exterior of the house which appears to have been red brick with common brick bonding (see Figure 27). From the interior of the rear addition, it is observed that construction of this addition is comprised of large stone blocks which originally appeared on the exterior in a photograph c. 1963. It is highly likely that the original brick exterior was clad in stone blocks during the construction of the addition.

Figures 26, 27, 28 & 29: (above left) View of brick wall in addition; (above right) View of filled in door opening in addition; (below left) View of original window frame on second storey; (below right) View of stairway from front entrance along East Mill Street (Source: MHBC, 2021).

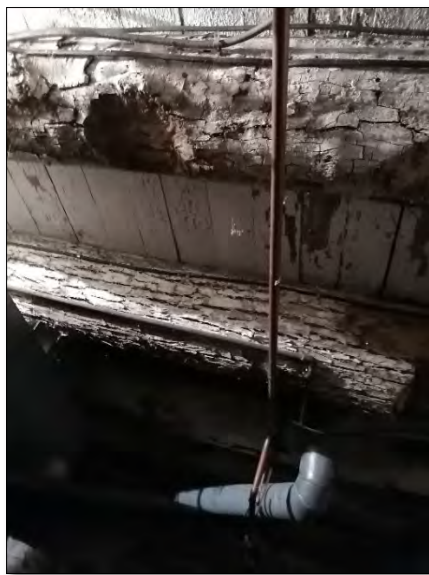
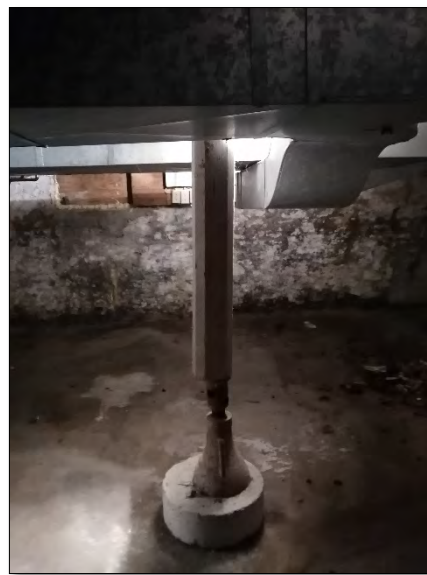
An original door opening appears to have been filled on the south elevation, however, an original window opening remains with a 2 x 2, double-hung window (see Figure 28). Most of the original wood flooring exists throughout the house, however, some floors have been covered with carpet or replaced with vinyl/ laminate flooring. The original staircase with bannister and newel post remains. The upstairs includes large floor boards (approximately 11/2 feet in width). Some of this flooring has been covered in Victorian oil cloths that mimic textiles. There is sloping apparent in most of the flooring on the upper floor. There is only one original window frame, however, most of the original doors, including transoms, remain. The basement includes large (approximately 1 ft 3/4), unhewn timber beams (includes exterior bark). The foundation walls are construction of rubble stone.

Figures 30 & 31: (left) View of large, un-hewn, lumber beams (above right) View of rubble stone foundation wall (Source: MHBC, 2021).

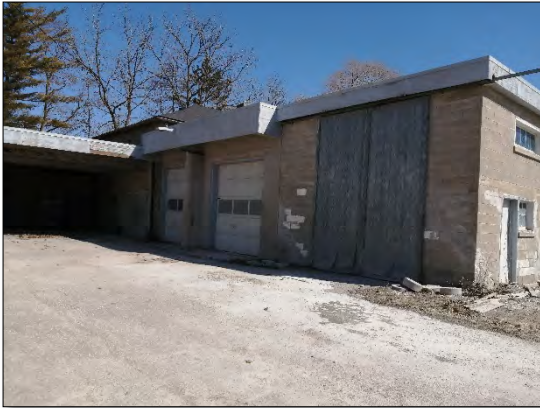
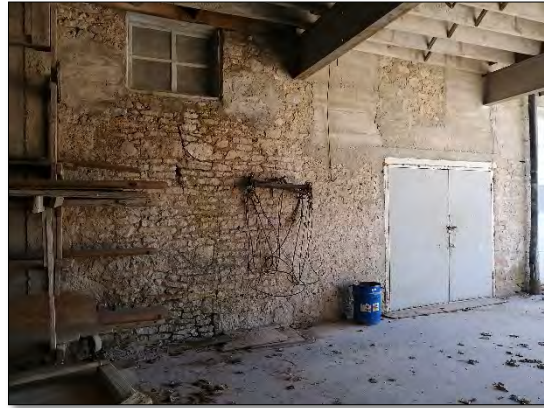
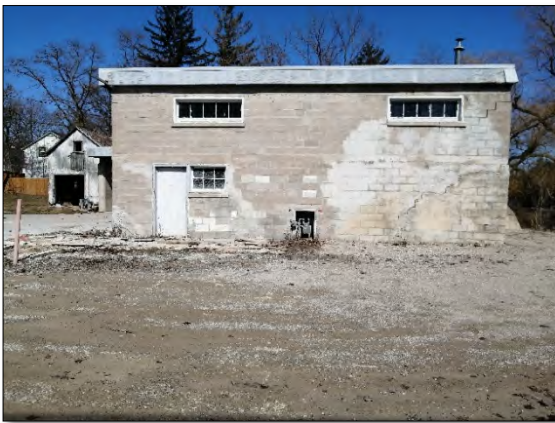
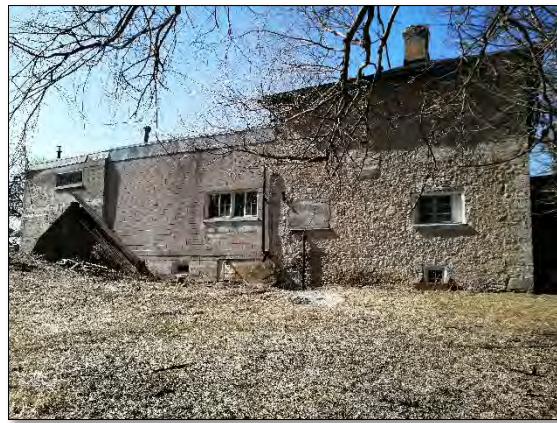
There is a two storey, rubble stone building located on the north-east corner of the property with a hipped roof with a brick chimney. Original window openings appear on the north, east and west elevations. A two-storey, mid-century cinder block addition was made to the south of the stone building with a platform roof. Attached to the western elevation of the stone building is a cinder block shelter/ carport; it appears that this structure is affixed to the stone building by means of steel beams.

Figures 32, 33, 34 & 35: (above left) View of cinder block addition to stone building looking north-east; (above right) View of shelter affixed to west elevation of stone building; (below left) View of south elevation of cinder block addition; (below right) View of east elevation including cinder block addition and stone building (Source: MHBC, 2021).

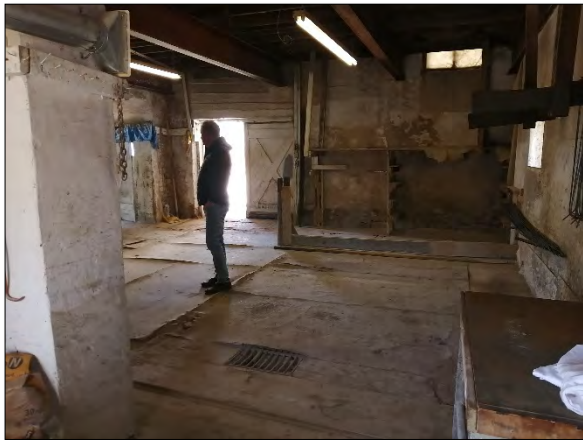
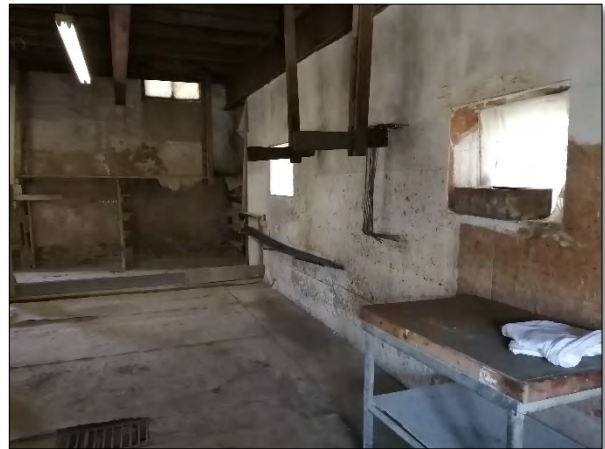
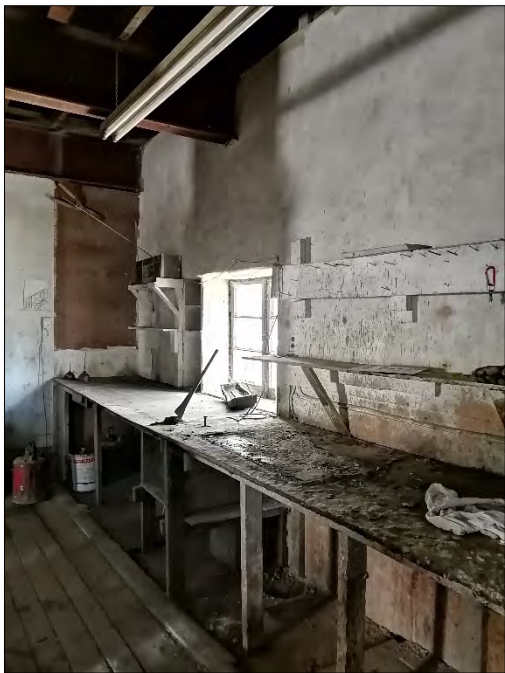
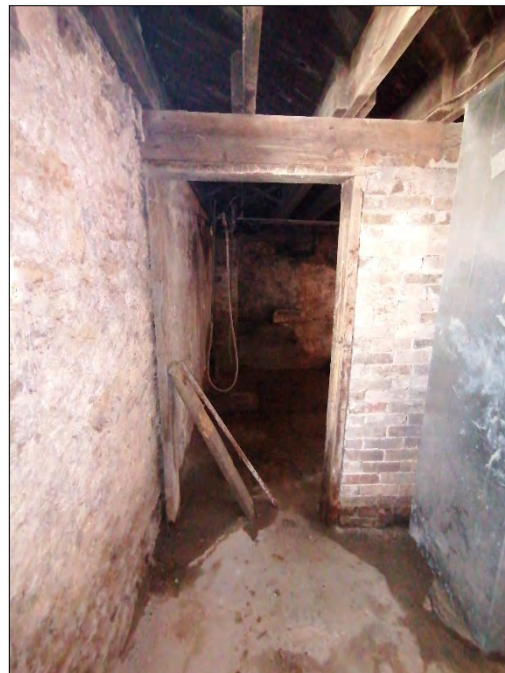
Section 'A' of the building is the original c. 1859 stone outbuilding that was formerly used as a brewery and for storage for the mill which no longer exists. The interior of the stone building located on the north-east corner of the property includes two floors and basement level. The main floor includes a workshop area including the equipment used to manufacture burial vaults (i.e. chute to direct concrete for moulds and protruding hooks presumably to hold a vault). There are brick column supports and walls on all levels of the building. The basement includes a chute likely used for pouring concrete; the basement is connected to the basement of the addition. The second storey level is an open space; there are indications that the exterior walls were

heightened over the years and are not level leaving some significant gaps between the roof line and walls. There is some historic graffiti along the walls on this level.

Figures 36, 37, 38 & 39: (above left) View of main floor of stone building looking south-west towards building section 'C'; (above right) View of apparatus used for the manufacturing of burial vaults affixed to the north elevation of stone building on main level; (below left) View of workshop area on main floor looking north-east; (below right) View of brick partition wall in basement of stone building (Source: MHBC, 2021).

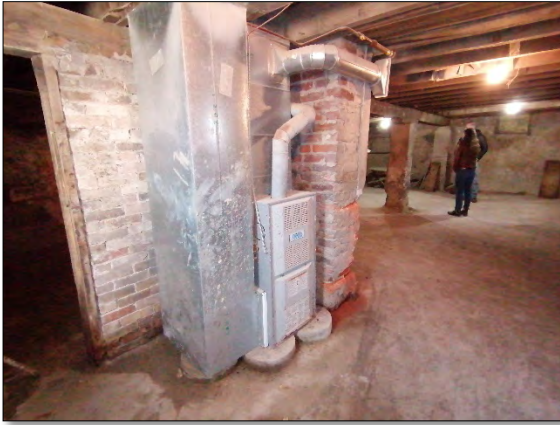
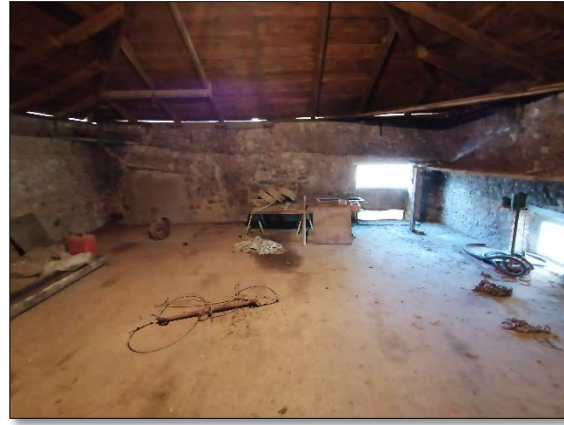
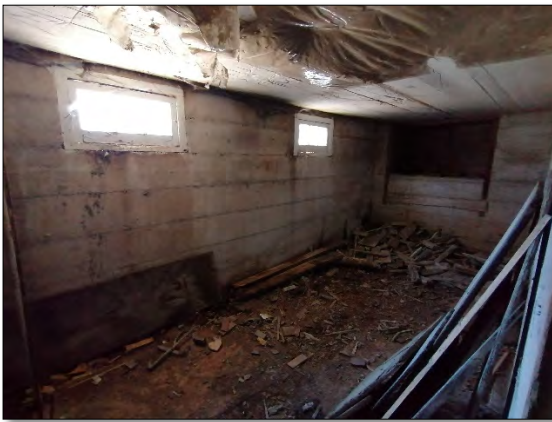
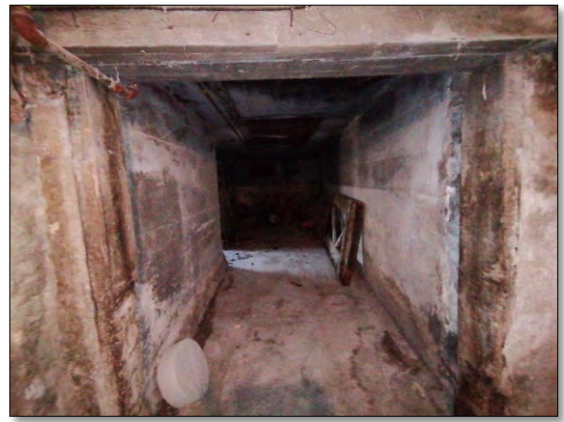
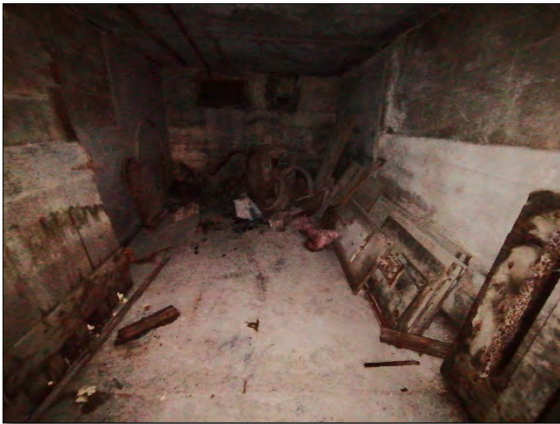
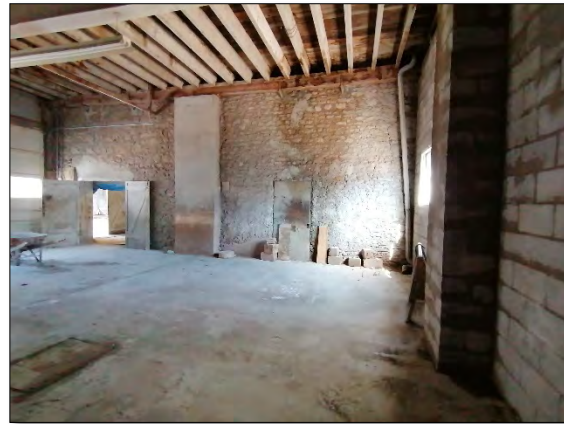
Figures 40, 41, 42, 43, 44 & 45: (above left) View of basement level; (above right) View of top floor of rubble stone building; (middle left) View of concrete basement of mid-century addition; (middle right) View of hallway in basement of building looking towards later addition; (below left) View of storage area in lower level of building to store material used for production of burial vaults; (below right) View of interior of later mid-century addition (Source: MHBC, 2021).

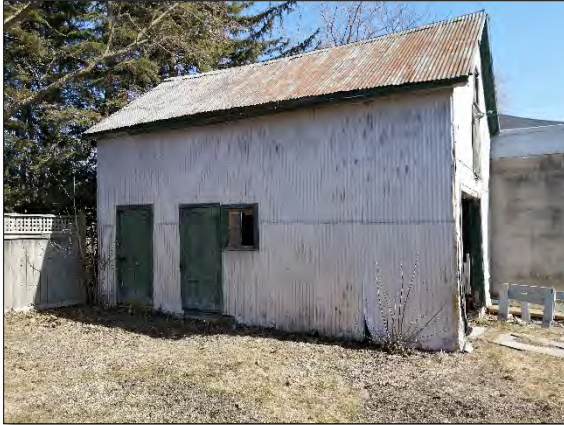
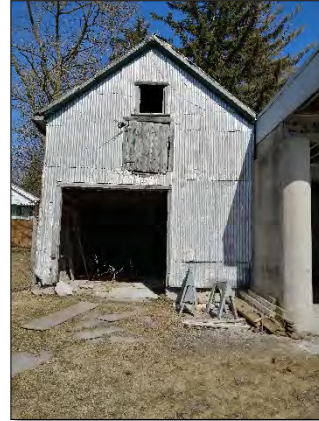
There is a one and half storey outbuilding wood frame building clad in metal sheathing located on the north side of the property. It has an open gabled, metal roof. There are two door entries on the west elevation, vehicular entrance on south elevation.

Figures 46 & 47: (left) View of west elevation of outbuilding looking north-east; (right) View of south elevation of outbuilding looking north (Source: MHBC, 2021).

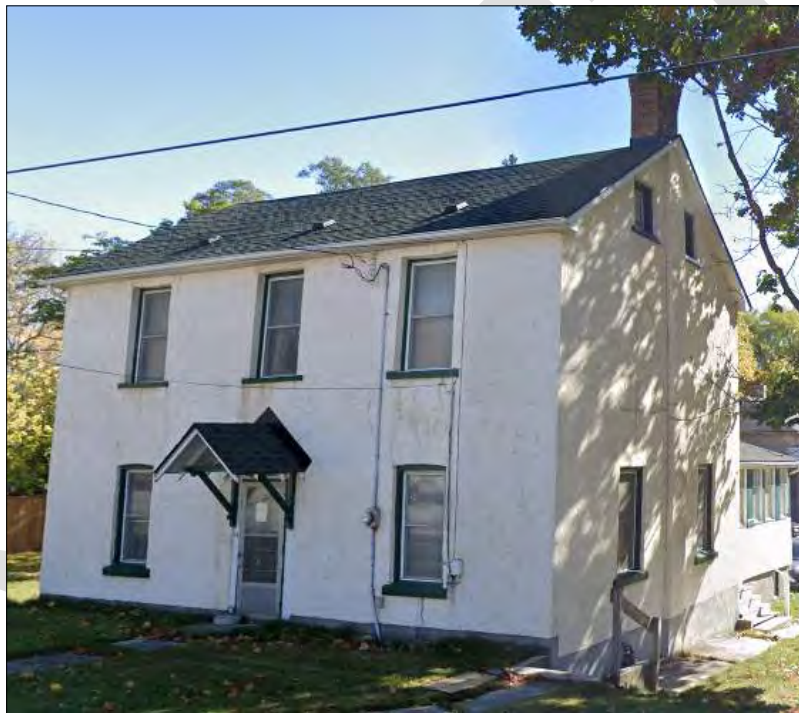
Tacoma Engineers has been retained by Oxford Green Developments to complete a building condition assessment of the existing residence located at 19 Mill Street East, Elora. An overall image of the subject building is included below. The purpose of this assessment was to determine the existing conditions and determine the feasibility of restoring, renovating or relocating the building as part of a large property development project. This report is based on a site visit carried out by Will Teron, P.Eng. on September 1, 2021.

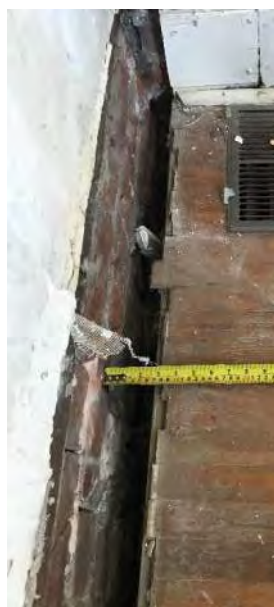
1. Exterior Walls: The east elevation wall (adjacent to the chimney) was found to be at least 3" out of plumb with an identifiable hinge (break point) at mid-height. On the interior, we identified a significant gap between the floor framing and the inside face of the wall and identified numerous floor joists that are no longer bearing on the wall. Further, a significant crack between the exterior wall and perpendicular interior wall was identified.

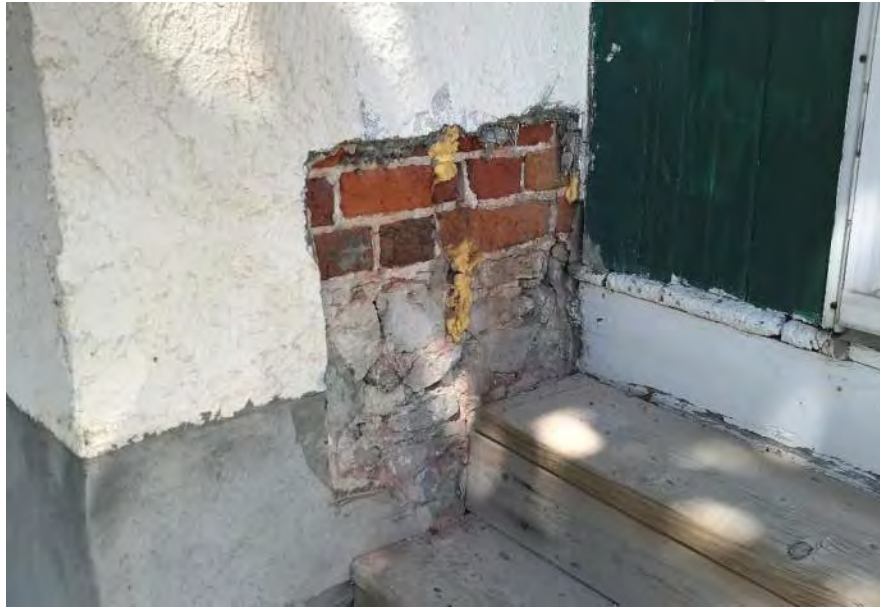
2. Exterior Walls: Numerous reports suggested that the walls were stone construction with a stucco overlay. Our review indicates that the walls are built with a relatively soft pressed brick. Where exposed, a marginally friable surface was exposed as was medium mortar decay. The stucco or more accurately called a render is a Portland cement based material on expanded metal lathe with assumed mechanical fasteners into the masonry. Based on our experience, these renders were only applied as a means to conceal deteriorated brick that is generally deemed to be beyond restoration through repointing. Unfortunately, these renders also tend to trap moisture and results in further and accelerating masonry decay. Photo below illustrates the brick walls above the stone

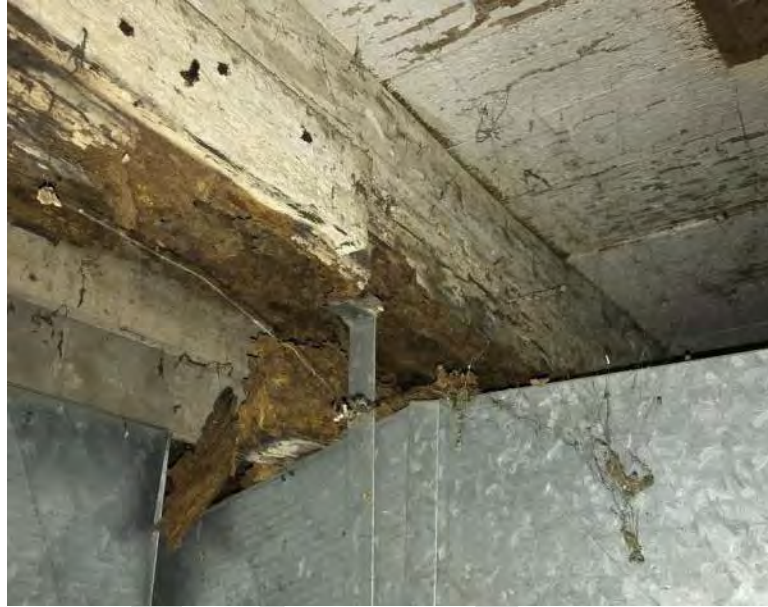
3. Lower Level Floor Framing: The lower level floor framing within the principal building consists of 10" round logs as beams installed at 24" o.c.. These logs have small flat bearing surface for the flooring above and are supported by the stone foundation walls and random interior posts. These posts may not be original but more modern interventions. Our review of the beams identified significant moisture related decay (wood rot) and extensive insect damage. Within the crawlspace, we were able to see evidence of splits and cracks in many joists.

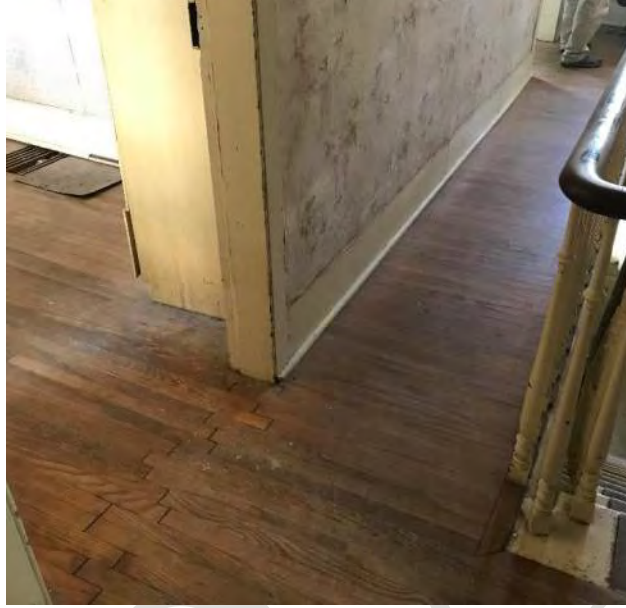
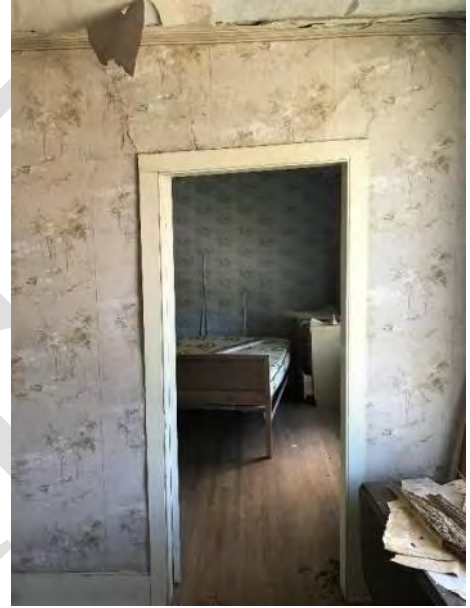
4. Upper Level Floor Framing: The upper level floor is framed with 3"x8" joists bearing between the exterior walls and the centre hall design interior bearing walls. Our review indicated: a large section along the east elevation where the joists are no longer bearing (see above regarding bowed wall) and significant deflection of the floor joists towards the middle of the building. In addition to the floor deflection, the doorway is significantly out of square indicative of

differential settlement.

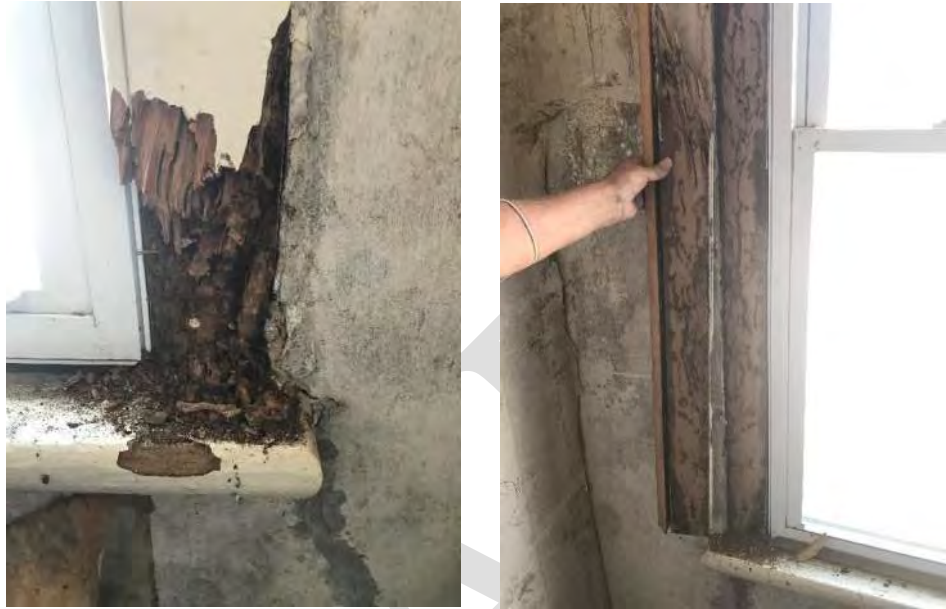
5. Interior Finishes: On the upper level, significant wood decay was identified at the north elevation window. On closer inspection, an active termite infestation was revealed. After the interior casing was removed, the extent of wood decay was evident.

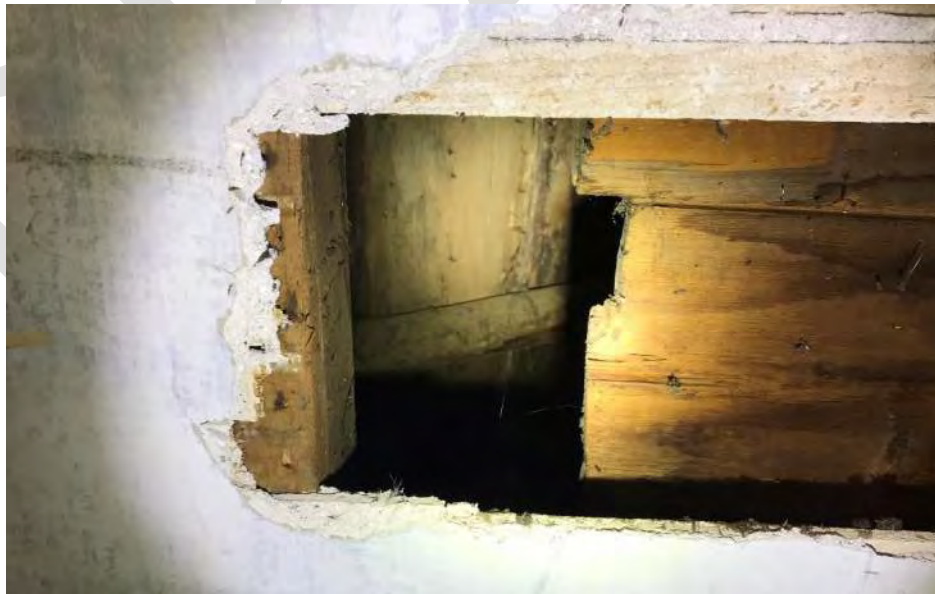
6. Roof: The roof framing over the principal portion of the house consists of 4" round logs as roof rafters. Deflection and damaged interior finishes was evident in the limited areas with access.
