**Building Condition Assessment
965 Gartshore Street, Fergus**

Township of Centre Wellington

**November 17, 2022
300055234.0000**

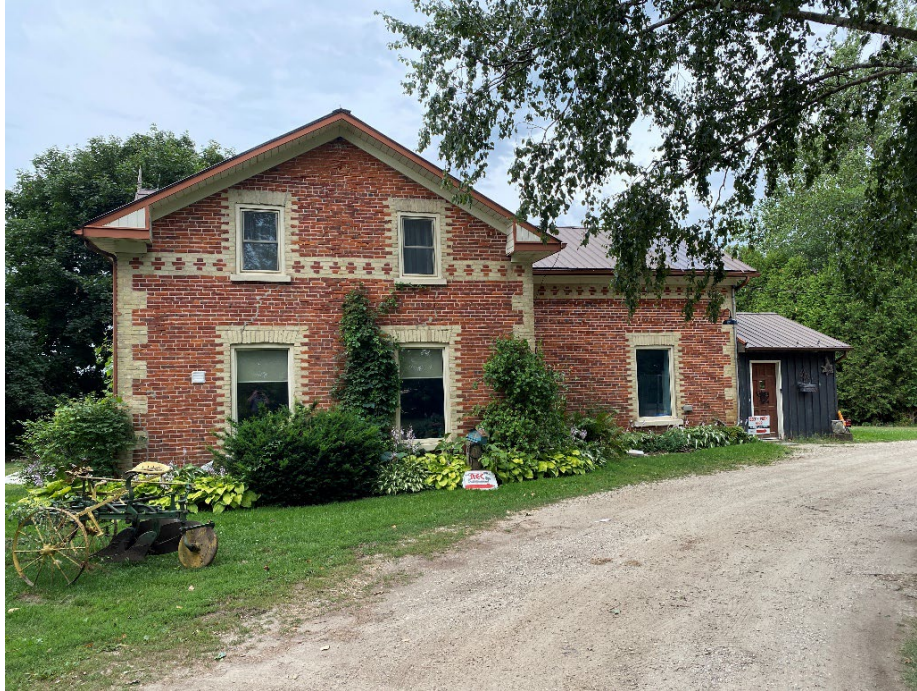
Photo 1: View of north east elevation.

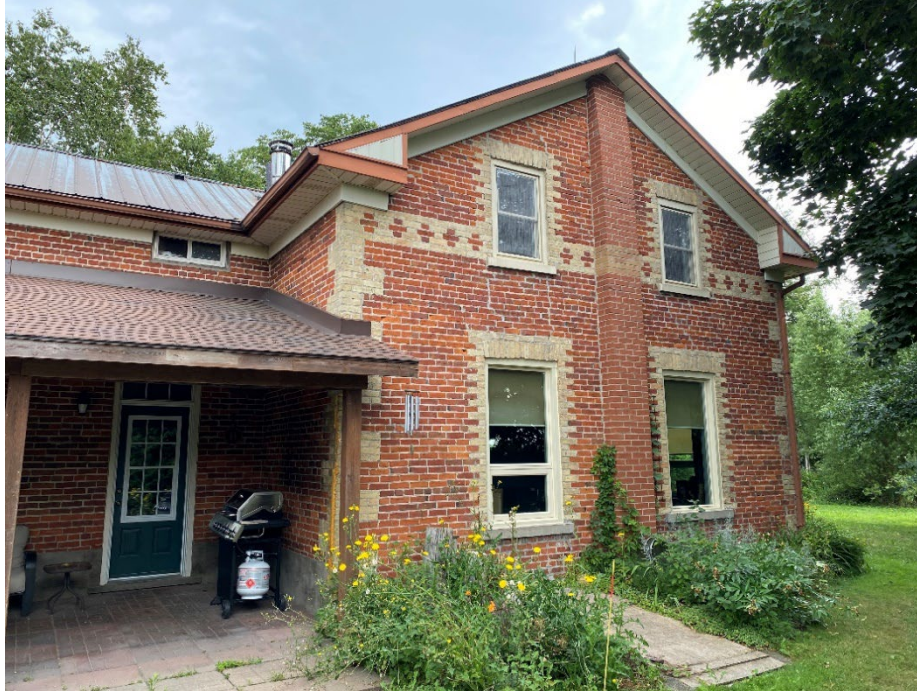
Photo 3: View of south west elevation.

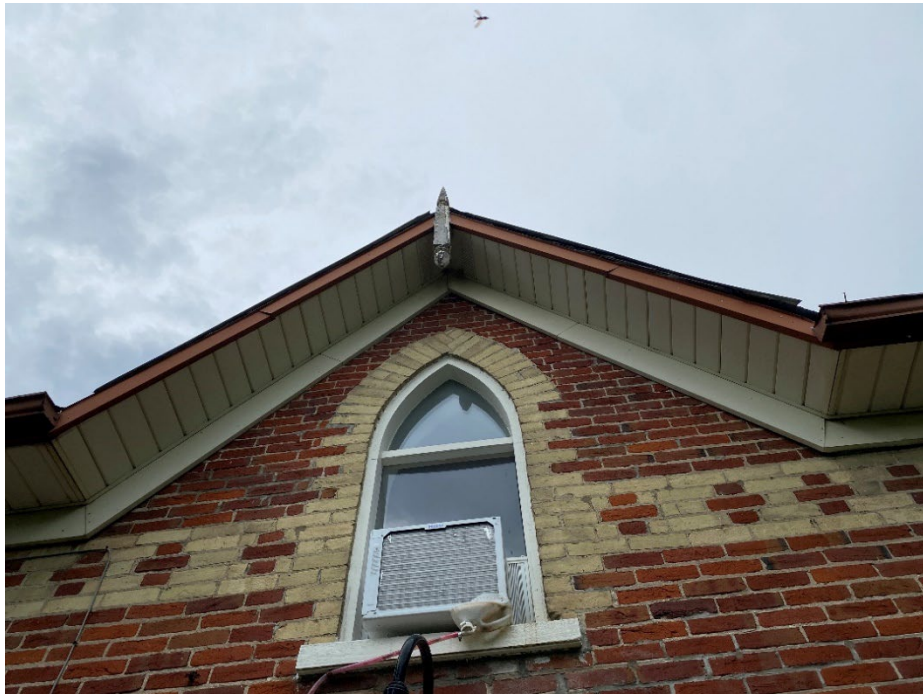
Photo 12: View of wood framed gothic arch window.

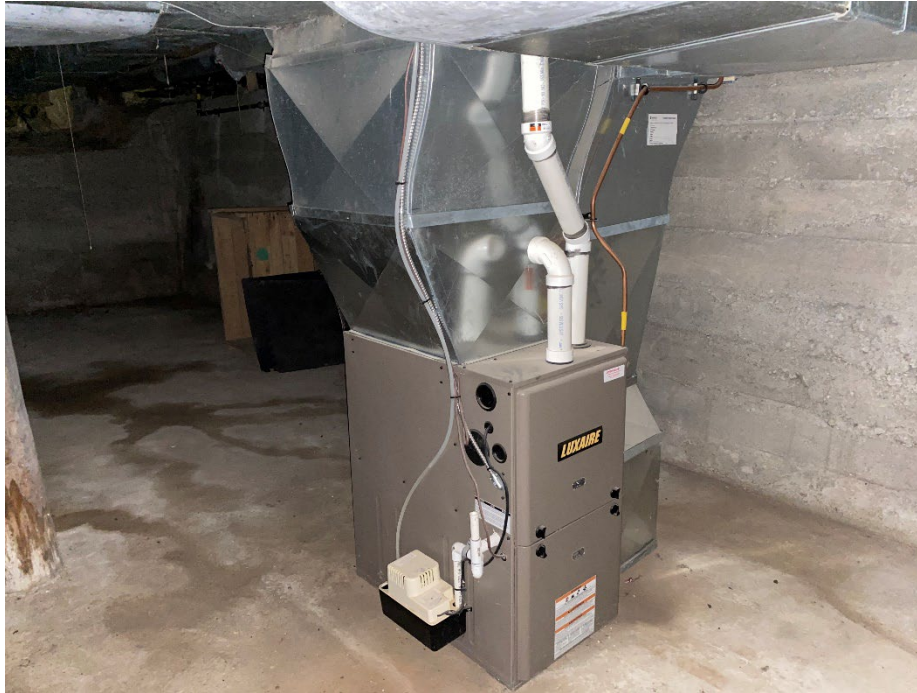
Photo 15: View of typical

The gas fired furnace (Photo 15) is manufactured by Luxaire and has a model #TG9S080B12MP11B, serial # W1H6953550, with an input heating capacity of 80,000 BTU/hr and was manufactured in 2016.

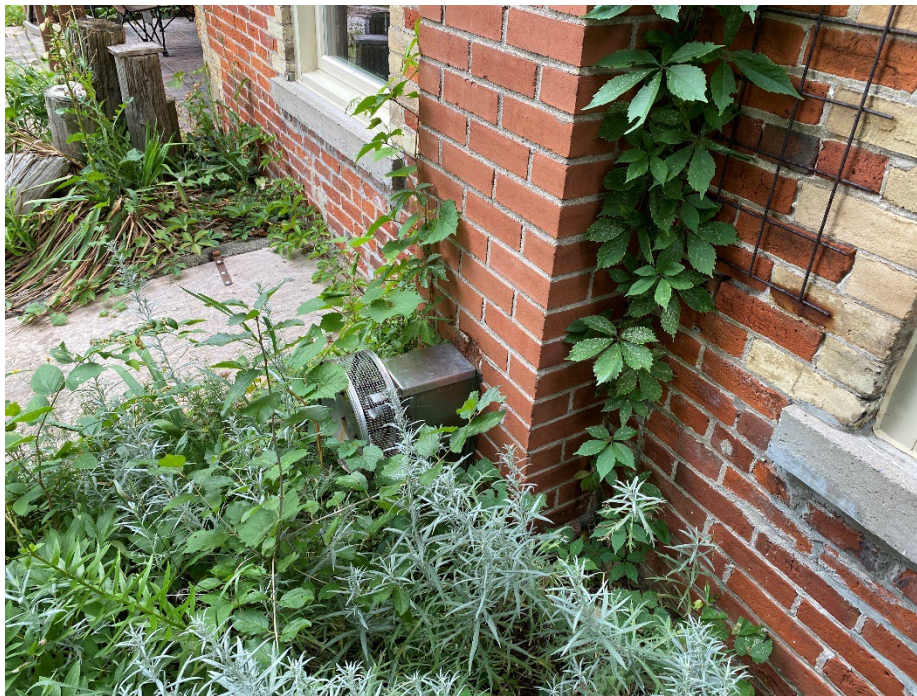
Photo 16: View of

The furnace vent termination (Photo 16) and gas meter (Photo 17) are located at grade in shrubbery.

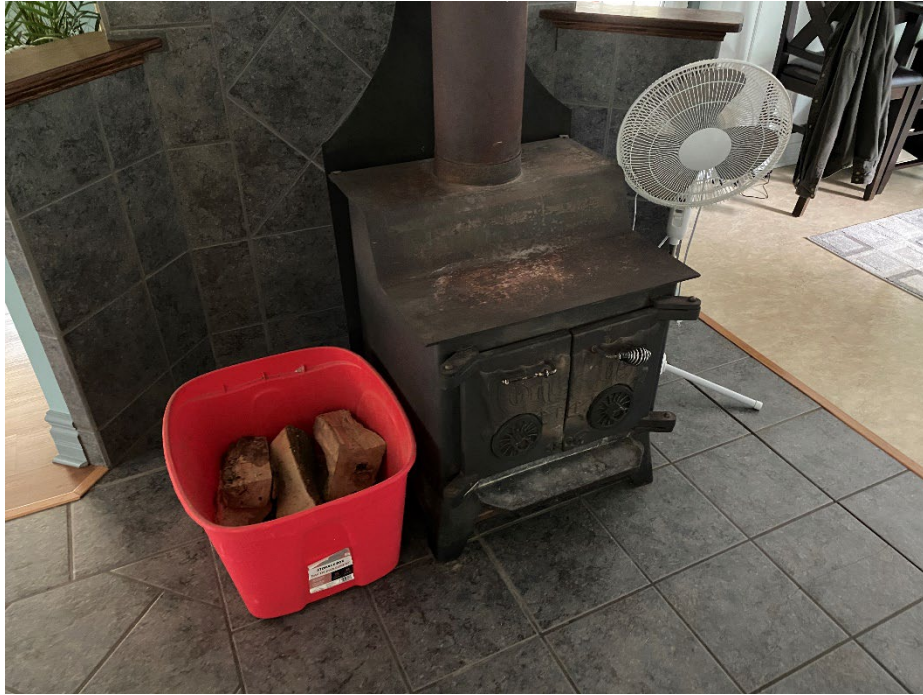
Photo 19:

There is a cast iron wood fireplace (Photo 19). A manufactured date was not able to be determined. However, based on a visual review the fireplace appears to be in good shape.

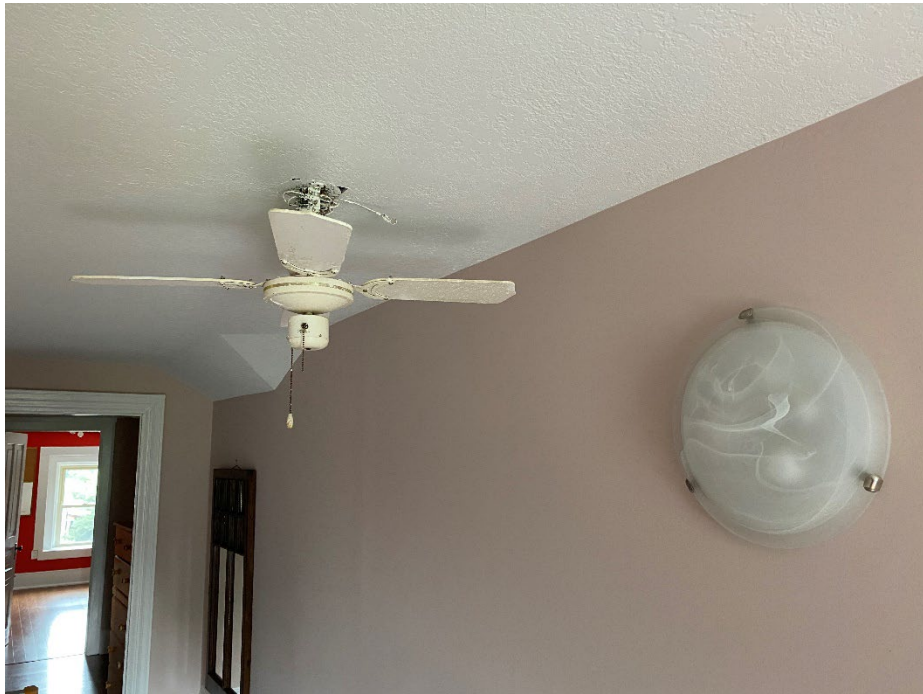
Photo 20:

Ceiling fans have been provided for throughout the building (Photos 20 & 21). A manufacturer, model and serial number could not be obtained. For the purpose of this report, the fans are assumed to be half-way through their life expectancy.

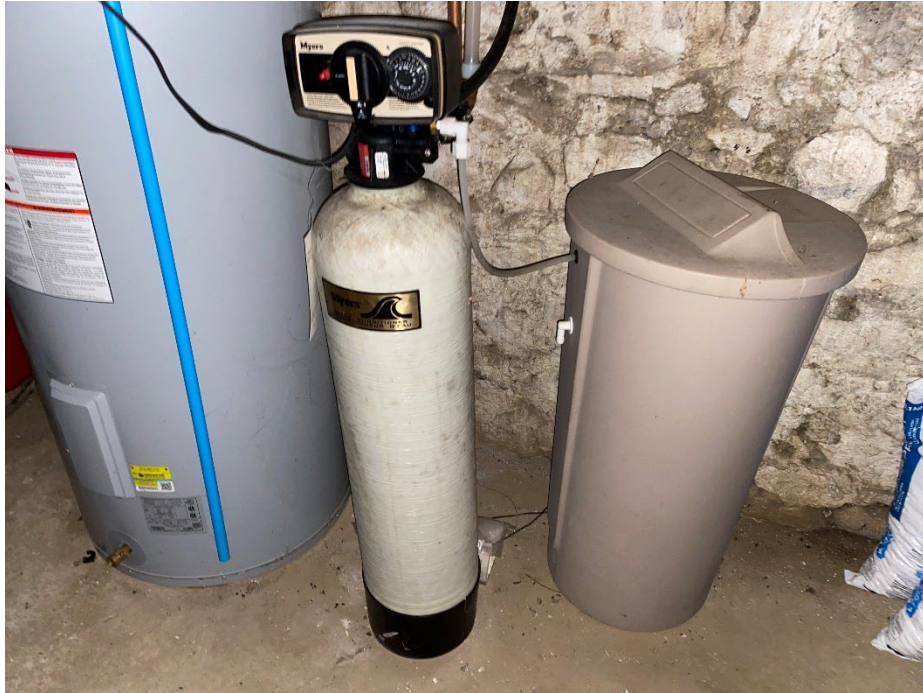
Photo 23:

There is a water softener (Photo 23) installed and was manufactured by Myers and has a model # 7370, a serial # 5799768 and appears to have been manufactured in 2005.

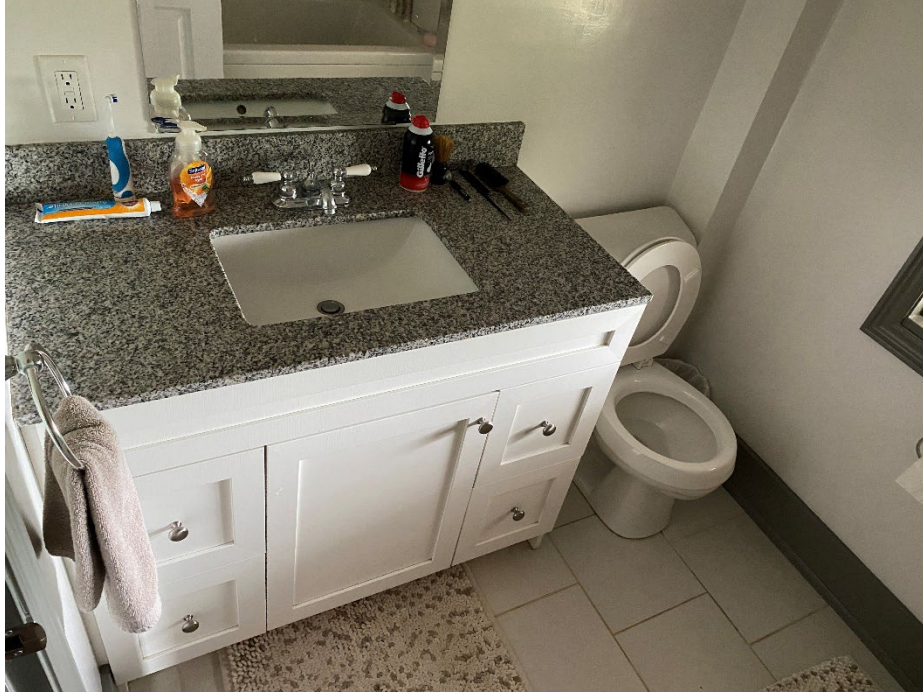
Photo 25:

There are two toilets (Photos 25 & 26), a lavatory (Photo 25), laundry sink (Photo 27) and a double kitchen sink (Photo 28).

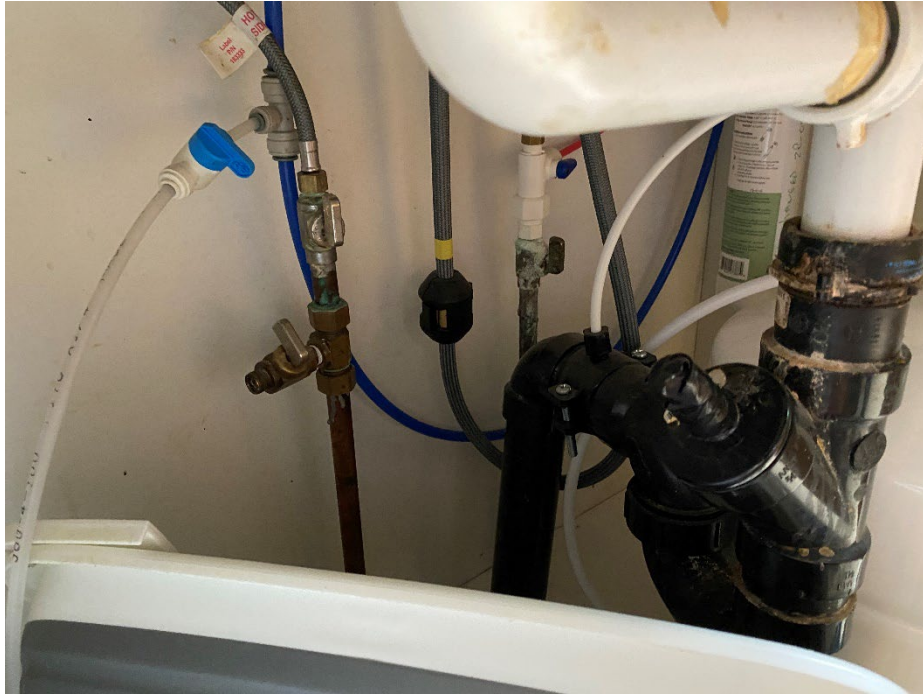
Photo 29:

Exposed hot and cold-water piping was observed to be copper, while sanitary drainage was abs dwv (Photo 29).

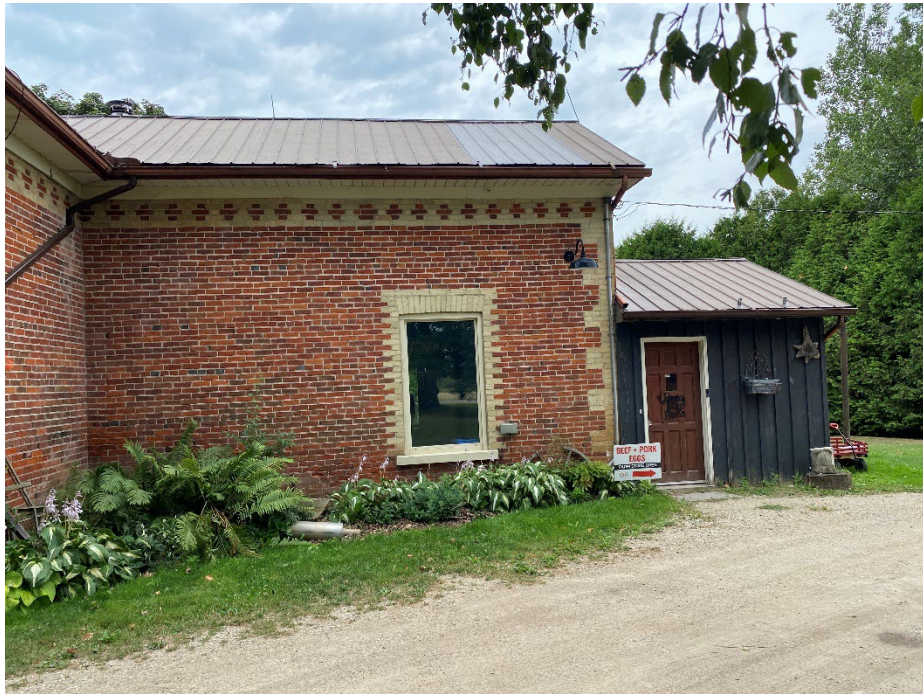
Photo 30:

Electrical service to this building enters through the exterior wall (Photo 30). Burnside was unable to locate the hydro meter. The power is supplied to the main 100A electrical panel in the basement (Photo 31) and a 60A sub-panel and disconnect switch on the second floor. (Photo 32).

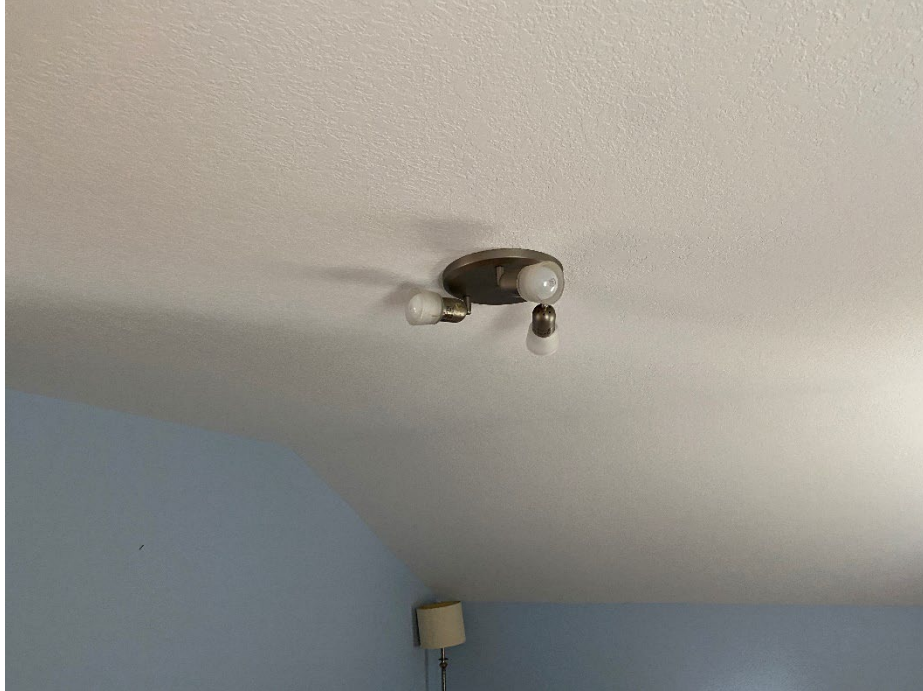
Photo 33:

Indoor lighting is provided via various lighting fixtures, (Photos 33, 34 & 35). Exterior lights were provided by wall mounted light packs (Photos 36, 37 & 38).

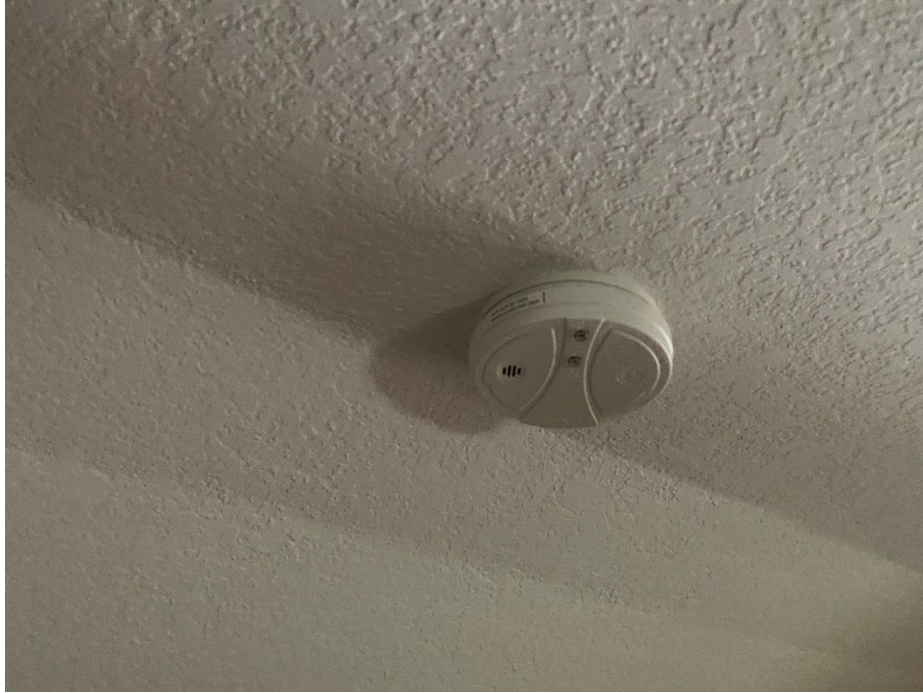
Photo 39:

A single smoke alarm has been installed. (Photo 39). For the purpose of this report, the smoke alarm is assumed to be half-way through its life expectancy.
