FERGUS DEVELOPMENT INC.

**FERGUS GOLF CLUB
REDEVELOPMENT –
SERVICING STUDY**

FEBRUARY 2022

TMIG PROJECT NUMBER 10402

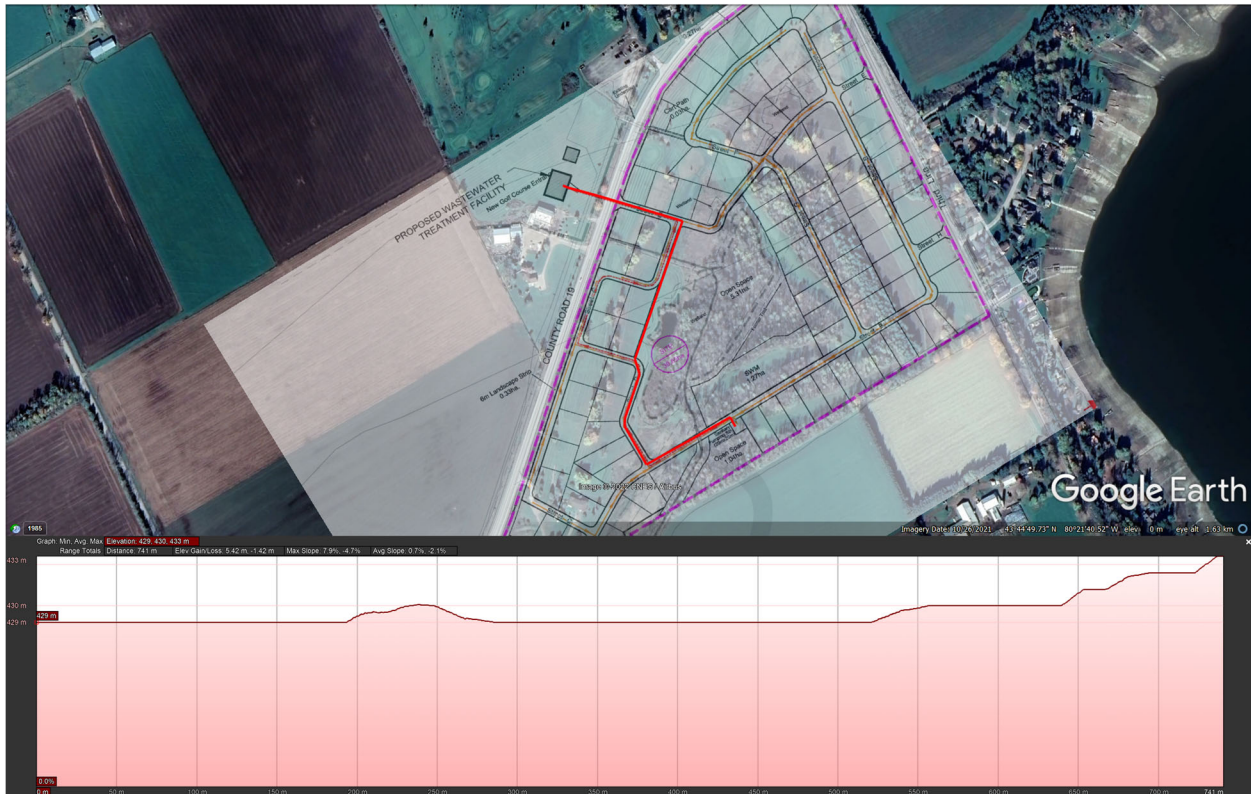
Figure 5 – Proposed Forcemain Vertical Alignment (Google Earth)

The current forcemain alignment and general profile based on topographic information extracted from Google Earth has been identified in Figure 5.

The forcemain vertical alignment shall be designed to remain full during pump cycling. Keeping the forcemain full will reduce the impacts of hydraulic transients from occurring within the system.

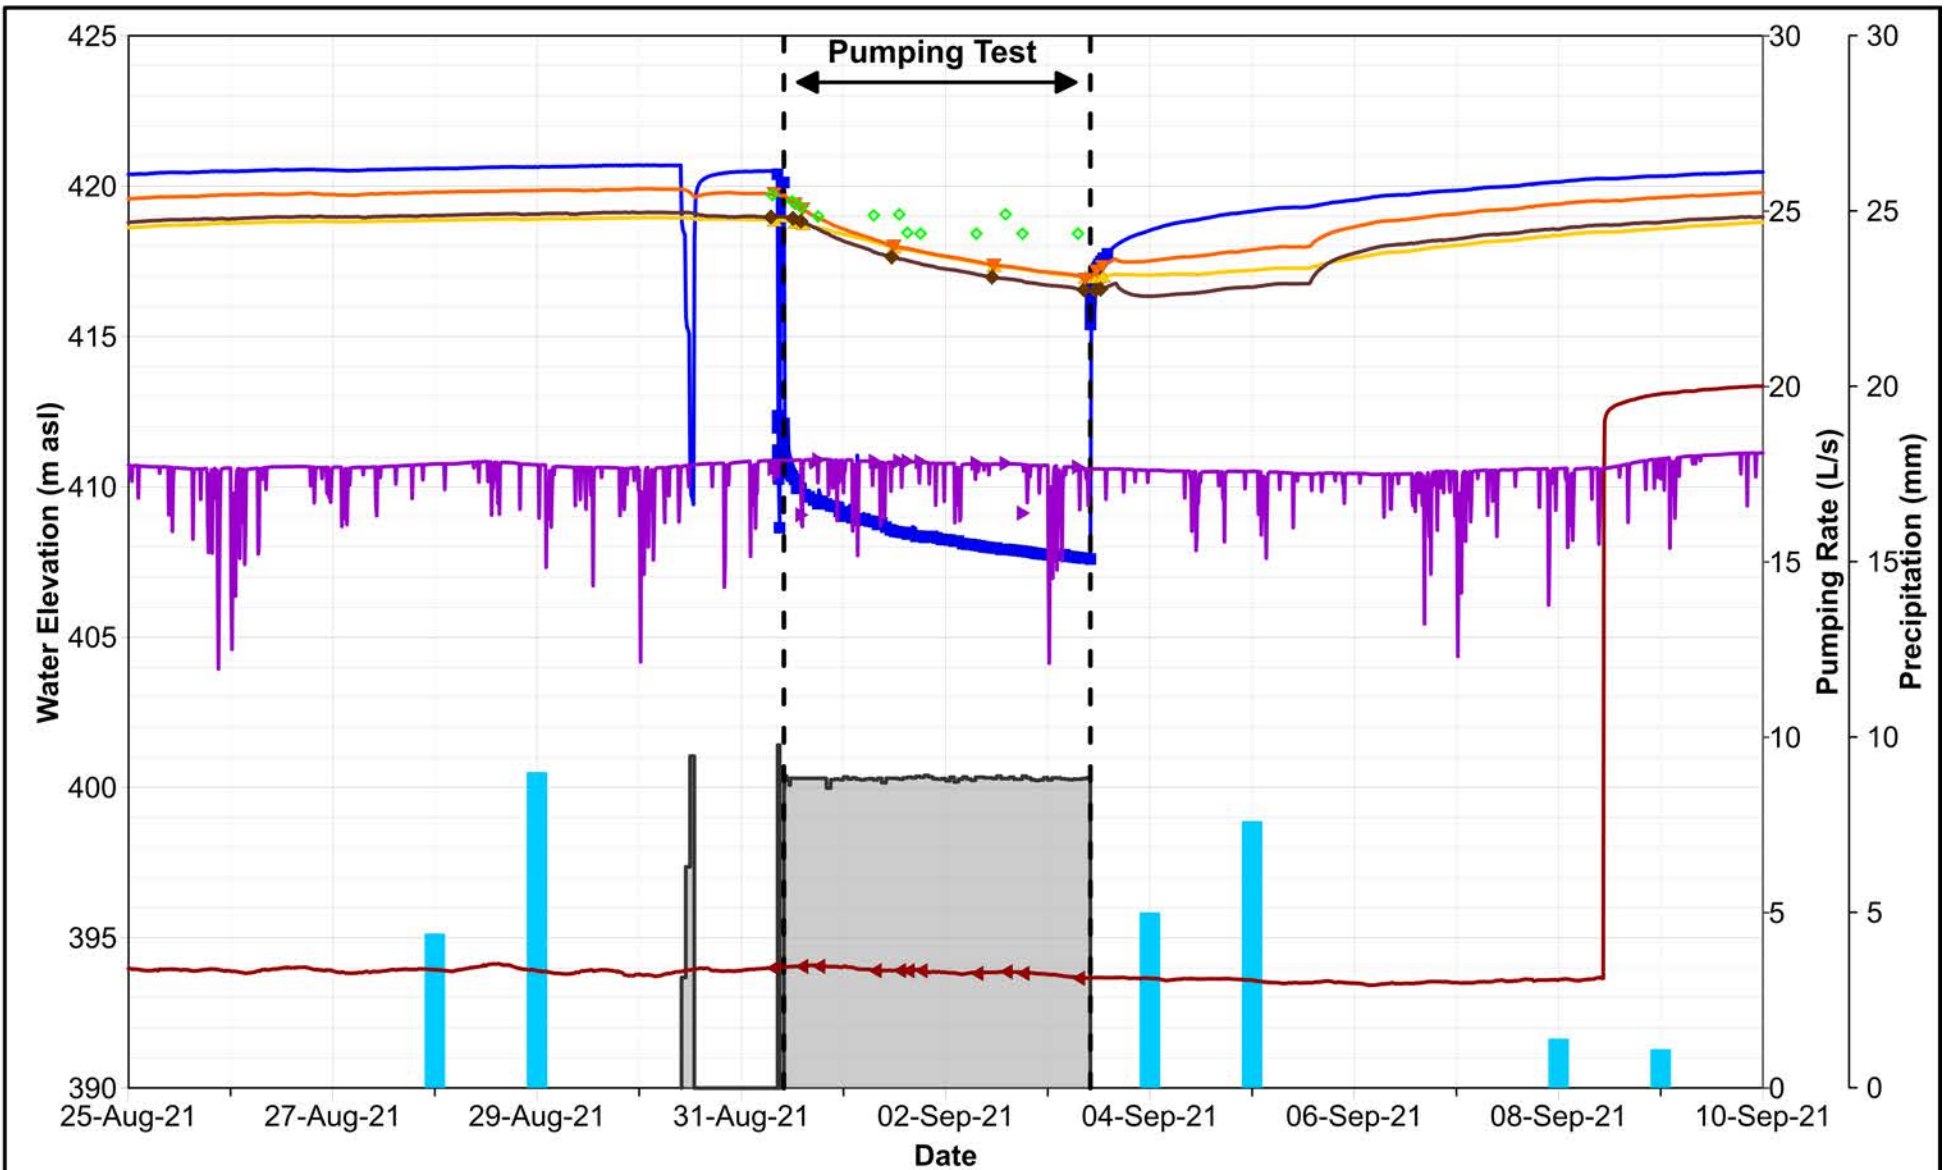
FIGURE
 D1

- PW21-1 ◆ MW102 ▼ Old Clubhouse ◇ Clubhouse Well ■ Precipitation (mm)
- ▲ MW101 ▼ MW103 ◀ South Irrigation ■ Pumping Rate (L/s)

Hydrographs for the monitoring wells screened in the bedrock, the overburden and surface water are shown on Figures D1, D2 and D3 in Appendix D, respectively and a table of observed drawdown is included in Table 3. The hydrographs show the water level measured in the well along with the pumping rate at PW21-1 and daily precipitation. Figure D4 presents the drawdown versus elapsed time for these same key bedrock wells and a graph of observed drawdown versus distance from the pumping well is included on Figure D5.

- A definitive response to pumping was observed in the monitoring wells within 700 m of PW21-1;
- Drawdown in the bedrock monitoring wells ranged from 0.3 m (Old Clubhouse Well) to 2.8 m (MW103); and
